HIGH-RESOLUTION ANALYTICAL ELECTRON MICROSCOPY CHARACTERIZATION OF STRESS CORROSION CRACK TIPS

S. M. Bruemmer and L. E. Thomas

Pacific Northwest National Laboratory
P.O. Box 999, Richland, WA 99352

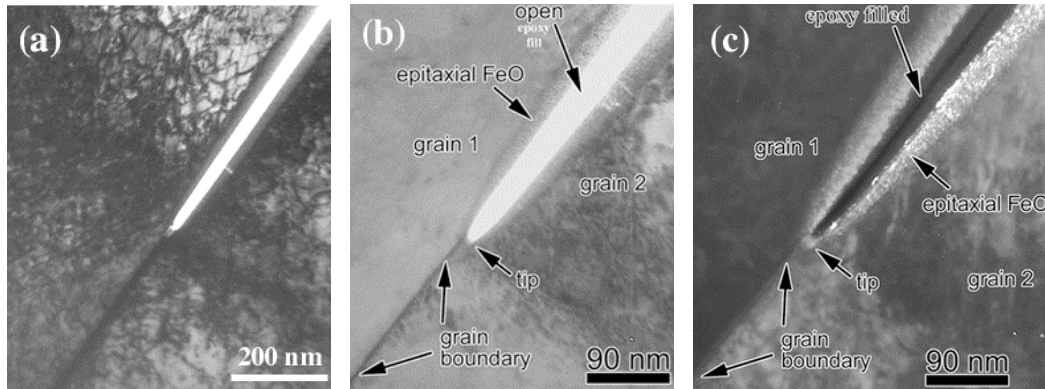
Figure 1: Example of a typical crack tip in the 316SS samples: (a) bright-field image with matrix dislocation structure in contrast, (b) bright-field image with matrix structure out of contrast to elucidate crack tip, and (c) FeO darkfield image highlighting epitaxial oxide on wall and at tip.

The 316SS samples that will be discussed were removed from a service component after many years in a 250-290°C, deoxygenated water environment [6,7]. Cracked samples from several locations have been examined and many crack tips characterized. In nearly all cases, wide (>~0.5 μm) cracks were filled with a multi-layer corrosion product oxide, consisting of a Cr-rich FeO and spinel inner layer plus large-grained magnetite (Fe₃O₄) filling the center of the crack. This multi-layer film is similar to that reported at stainless steel surfaces [8,9] with the exception of the FeO-structure oxide. The focus here is on the crack tips as illustrated in Figure 1. A somewhat “classic” appearance of a SCC crack tip in a passive alloy is seen with a non-porous, epitaxial FeO-structure oxide film on the walls. The crack narrows to ~10 nm at the tip comparable to the oxide film thickness ahead of the tip and on the adjacent crack walls. Evidence of significant deformation (high dislocation density) is present in the metal surrounding the tip as illustrated in Figure 1(a), but localized slip bands have not been observed intersecting the crack. However, twins are seen at or near primary or secondary crack tips as demonstrated in Figure 2. Scanning electron microscopy indicates that most twins are present before the propagation of SCC cracks and that many cracks end at intersections of twins with grain boundaries [10]. The examples presented in Figure 2 show deformation twins immediately ahead of a crack tip in (a) and a crack that has propagated through several twins in (b). Oxide films at these crack tips were again found to be non-porous, but were predominately a nanocrystalline FeCr spinel versus the epitaxial FeO-structure oxide seen at other tips. Low levels of solution impurities (e.g., Na) were discovered in the oxides indicating that a caustic environment may have been in cracks.

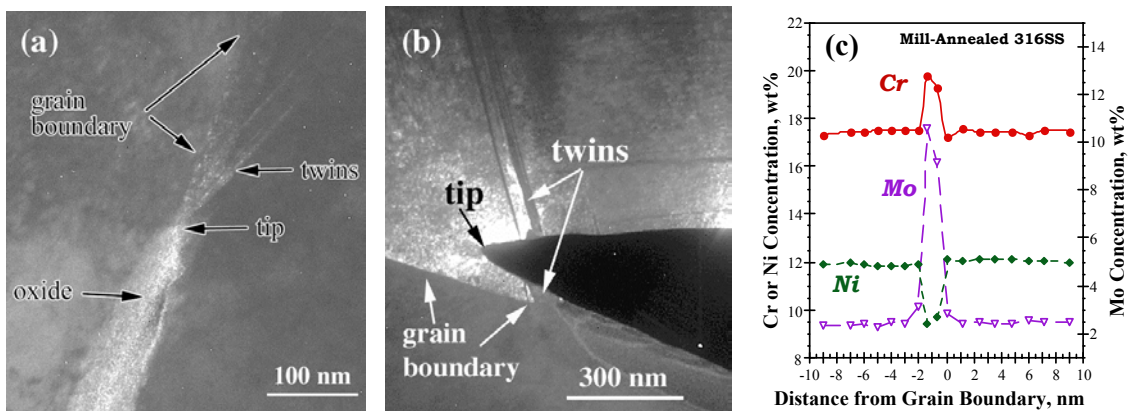
Figure 2: Crack-tip interactions with matrix twins in a 316SS sample with twin present immediately ahead of the crack tip in (a) and immediately behind the tip in (b) where the crack is clearly displaced off the grain boundary plane. The composition profile in (c) was taken across the grain boundary in a non-attacked base metal region well ahead of the crack tip.

A final important crack characteristic illustrated in Figures 1 and 2(b) is the crack-tip locations that are often adjacent to, and not centered on, the grain boundary. Crack propagation along a path several nm off the boundary was clearly evident at about one-third of the crack tips examined. The only measured material feature in these mill-annealed 316SS samples that may play a role is the grain boundary composition. Significant Mo and Cr enrichment is present at grain boundaries as shown in Figure 2(c). This non-equilibrium segregation has been seen in many mill-annealed stainless steel heats (often with B enrichment) and is most likely produced during initial processing before service [11]. The profile presented was obtained ahead of a crack tip that was centered off the boundary interface and it reveals the maximum segregation adjacent to the boundary. It is possible that the altered local composition influences dissolution and passivation, thereby SCC propagation.

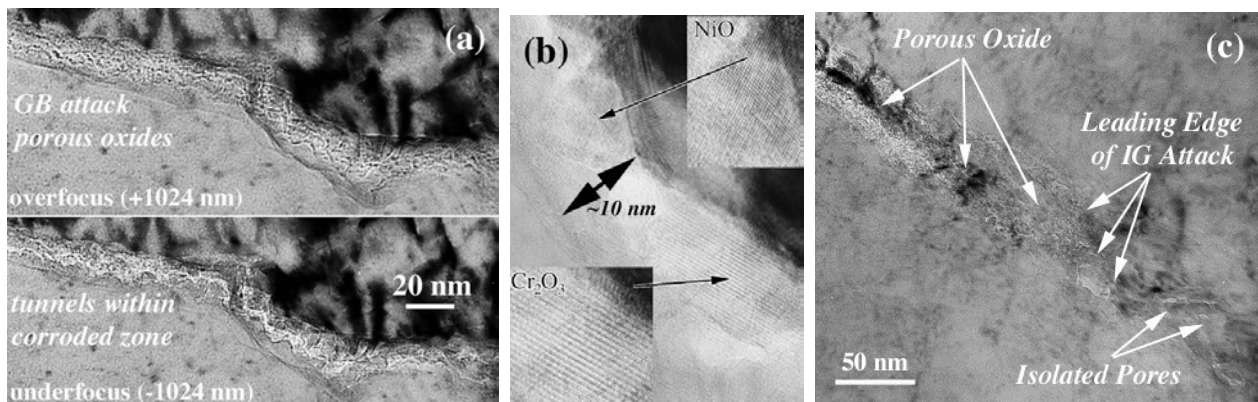
Recent work [3-7] on cracked alloy 600, pressurized-water-reactor (PWR), steam-generator tubes has shown a remarkable tendency for IG attack along with SCC. TEM examinations of samples cracked in various high-temperature water environments has revealed narrow oxidized zones, 5-to 20-nm in width and up to tens of μm in length, along nearly every intersected grain boundary in the wakes of cracks. An example of these IG corrosion zones is shown in Figure 3 for mill-annealed alloy 600 after long-term exposure to PWR primary water at 330°C. TEM images show no visible cracks in the corrosion zones and no significant deformation of the surrounding metal matrix. Fresnel contrast imaging in Figure 3(a) shows that these structures are highly porous on a scale of 1-2 nm. Electron diffraction analyses revealed that the corrosion product consisted of nanocrystalline oxides (NiO, Cr_2O_3 and/or spinel depending on the particular environment). Lattice imaging identified individual crystallites with sizes down to a few nm as demonstrated in Figure 3(b). The fine porosity at the tip of a corrosion zone is illustrated in Figure 3(c). A complex network of nm-size voids and tunnels is present in the narrow oxide layer along an inclined grain boundary, as well as voids along the grain boundary plane ahead of the tip. The oxide at the attack tips was Cr_2O_3 , even though the predominant oxide some distance (>100 nm) behind the tip was NiO (Cr and Fe levels similar to the matrix). Significant Cr enrichment at the oxidized tip was measured by high-resolution EELS, but the adjacent matrix was not depleted. The observation of pores in the metal ahead of the oxidation front suggests that vacancies may be injected during the corrosion process. Due to the narrow dimensions of the corroded IG zones in alloy 600, these structures have been undetectable by other examination methods including optical metallography, SEM or secondary-ion mass spectroscopy.

Figure 3: Intergranular attack of alloy 600 in high-temperature PWR primary water: (a) Fresnel contrast images showing narrow porous oxidized zone, (b) lattice images identifying crystallites of Cr_2O_3 and NiO in the corroded zone and (c) leading edge of attack with oxidized material ending within grain boundary plane and presence of isolated pores ahead of corroded region.

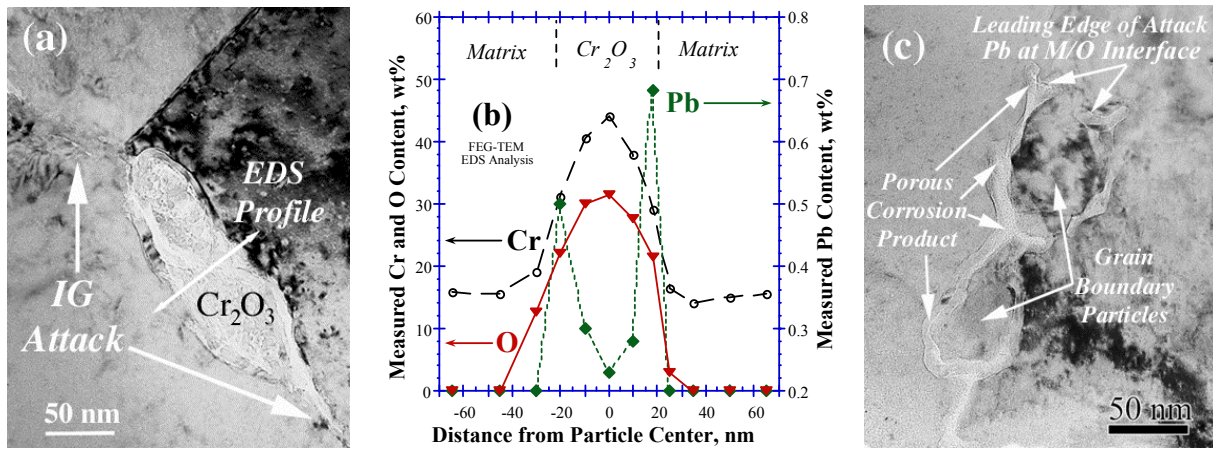
Exposure to secondary water or steam environments can produce similar IG attack and aggressive degradation of precipitates in alloy 600 samples [6,7]. An example of this behavior is shown in Figure 4 for once-through steam generator tubing removed from the high-superheat (steam) region. Alloy 600 tubing is put into service in the stress-relieved and sensitized condition with closely spaced

Figure 4: Intergranular attack of alloy 600 in high-temperature PWR secondary water: (a) former grain boundary Cr carbide converted to Cr oxide, (b) composition profile across attacked particle showing Pb enrichment at the metal-oxide (M/O) interface and (c) porous corrosion product oxides around grain boundary particles with Pb present at leading edge of attack.

Cr₇C₃ carbides and Ni₂₃B₆ borides. The porous oxide structure in the IG attack zones was similar to the primary-water samples, but the carbides were converted to fine-grained Cr₂O₃ oxides and borides were completely removed. Solution impurities appear to have a strong influence on the stability of these particles. EDS analyses of the oxidized particles (Figure 4a) revealed that environmental impurities, notably Pb, had penetrated the structures and concentrated in the reaction layers along the metal-oxide interfaces (Figure 4b). Further observations at the leading edges of attack showed tunnel-like corrosion zones formed around the IG particles as presented in Figure 4(c). A penetrative porous oxide is seen to envelop a partially converted Cr₇C₃ precipitate and end adjacent to a Ni-rich particle (former boride). The corrosion product in these tunnels consisted of nanocrystalline Cr-Ni spinel containing high concentrations of Pb at the leading edge of attack. This is consistent with Pb promoting dissolution and/or impairing passivity to enhance boundary and precipitate degradation.
