DESTRUCTIVE EVALUATION AND EXTENDED FATIGUE TESTING OF RETIRED AIRCRAFT FUSELAGE STRUCTURE

John G. Bakuckas, Jr.¹ and Aubrey Carter²

ABSTRACT

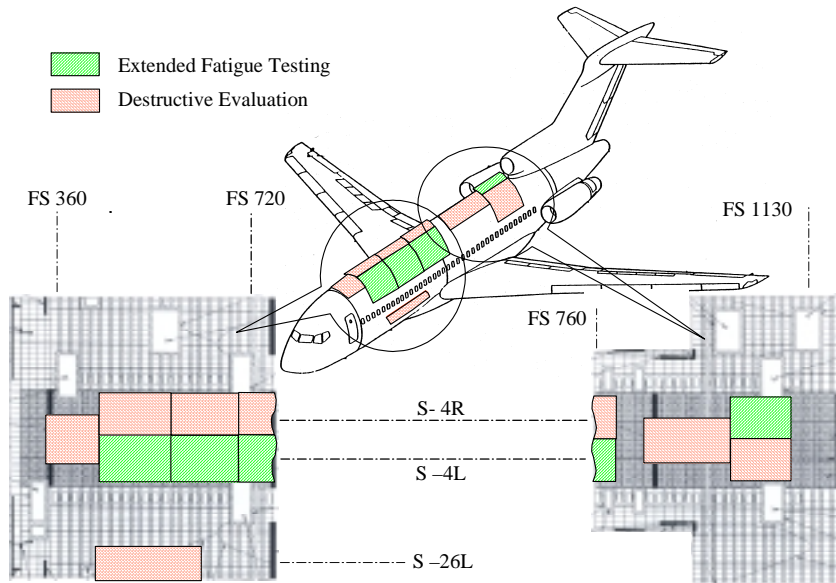
Eleven fuselage lap joint areas susceptible to WFD, each approximately 8 by 12 ft, were removed from the aircraft, seven will be destructively evaluated and four will be subjected to extended fatigue testing, Figure 1. Prior to removal, all target sections were labeled with boundaries and identification marks to indicate the location and orientation of the section with respect to the aircraft. In addition, weight and balance analyses were conducted to properly support the structure as well as to properly define the cutting sequence during removal. Ten of the fuselage lap joint areas are located on the crown of the fuselage along the lap joint at stringers S-4R and -4L. One large area located in the bilge of the fuselage along stringer S-26L will also be examined in this study. Based on in-service experience findings from fleetwide inspections subsequent to AD 99-04-22, it is anticipated that cracks will be found in the target structure of the selected aircraft.

Figure 1. Target structure for test and analysis

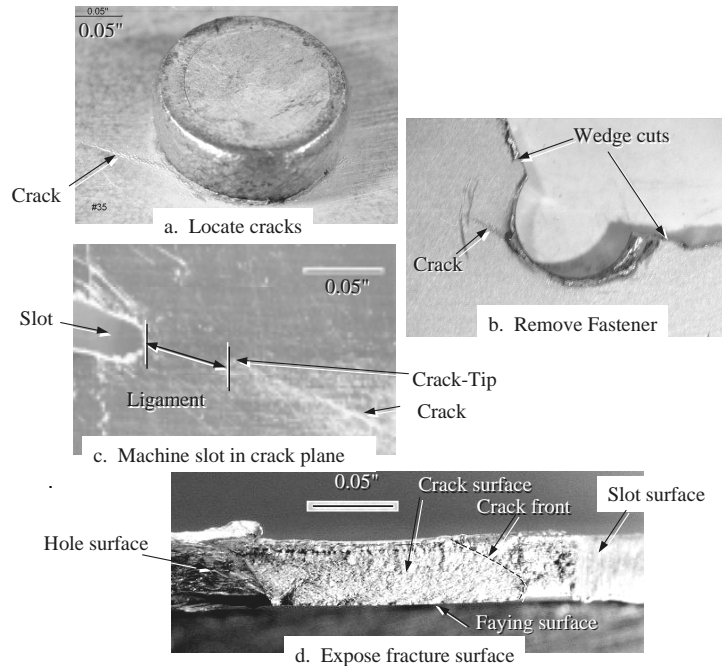
Figure 2. Steps in teardown procedure

1. The primary origin of the cracks were at the corner of the hole and the faying surface.
2. The general direction of the cracks were normal to the hoop direction.
3. The crack fronts were semi-elliptic with the longer side on the faying surface.
4. The cracks ranged in size from 0.01" to 0.2"
5. The fracture surfaces were free of corrosion and any gross mechanical rubbing damage.
