# MECHANISTIC INSIGHTS ON ENVIRONMENTAL DEGRADATION FROM NANOMETER-SCALE CRACK-TIP MEASUREMENTS

S. M. BRUEMMER & L. E. THOMAS  
Pacific Northwest National Laboratory  
Richland, Washington 99352 USA

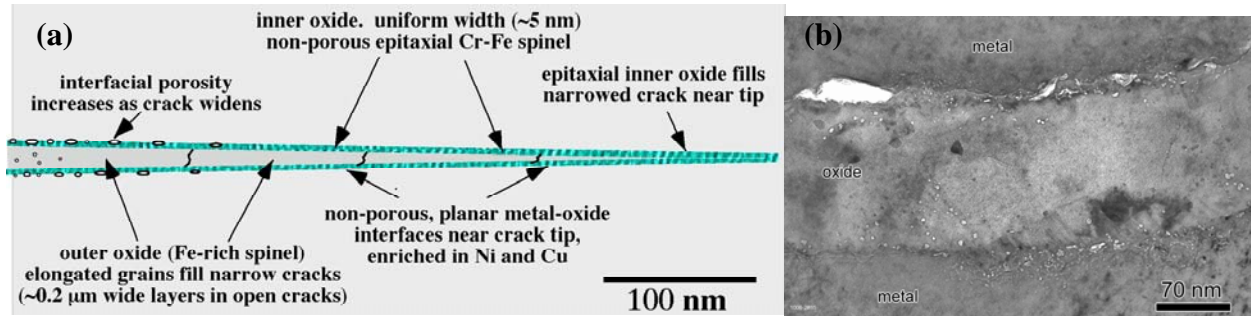
TEM examinations of cracks in the BWR top-guide material included multiple branch cracks up to a distance of ~0.5 mm behind the furthest advanced tip. The corrosion products in cracks consisted of uniform thin films of dense, epitaxial Fe-Cr-Ni spinel (Cr enriched relative to the metal matrix) next to the metal and Fe-rich spinel toward the crack centers. Open gaps between the oxide layers appeared in cracks wider than ~100 nm. The oxide-filled cracks continued over distances of tens of μm along all the intersected grain boundaries off major cracks, and the cracks tapered very gradually to the tips. As cracks narrowed, the width of the central magnetite layer gradually decreased until only the Cr-rich inner oxide remained. Figure 1(a) schematically illustrates the corrosion structures in the oxide-filled cracks and emphasizes the gradual tapering and regularity of the cracks as they narrow toward their tips. Major characteristics of the crack-wall structures were thin layers of crystallographically oriented spinel along the metal/oxide interfaces and elongated Fe-rich spinel grains filling the cracks between the Cr-rich spinel layers. Fine porosity (~2- to 5-nm-diameter cavities) appeared along the metal/oxide interfaces at distances greater than ~500 nm behind the acute crack tips, but the interfacial porosity was generally absent near the tips. An example of the crack and crack-wall structures many μm behind the crack front is shown in Figure 1(b). The microstructure in this area consisted of an essentially single-crystal layer of Fe-rich spinel (magnetite) bounded by narrow layers of epitaxial Cr-rich spinel along porous, rough metal oxide interfaces. Although this micrograph shows the metal/oxide interfaces slightly inclined to the viewing direction, tilting the sample to view the structures edge-on indicated the porosity was actually at the interfaces. Minor fine cavities also appeared aligned in lines or sheets within the Fe-rich spinel, apparently due to preferential formation of the cavities along dislocations or other internal defects in the oxide. EDS analyses showed traces of S throughout the oxide of this area, and EELS analysis further indicated Mn in the oxide. Figure 2(a) shows the oxide structure in a narrow crack only ~20 nm wide. As in the previous example, oxide filled the available volume. In areas such as this, the cracks characteristically contained oxide layers with nearly planar, nonporous metal/oxide interfaces. EDS composition profiles given in Figure 2(b) reveal the narrow Cr-rich inner oxide and Fe-rich center layer along with Cu and Ni enrichment at m/o interfaces.

Figure 1. Oxide-filled cracks in BWR top-guide material: (a) schematic illustrating crack structure as it approaches the tip and (b) TEM brightfield image showing magnetite-filled crack region  $\sim 15 \mu\text{m}$  behind the crack tip.

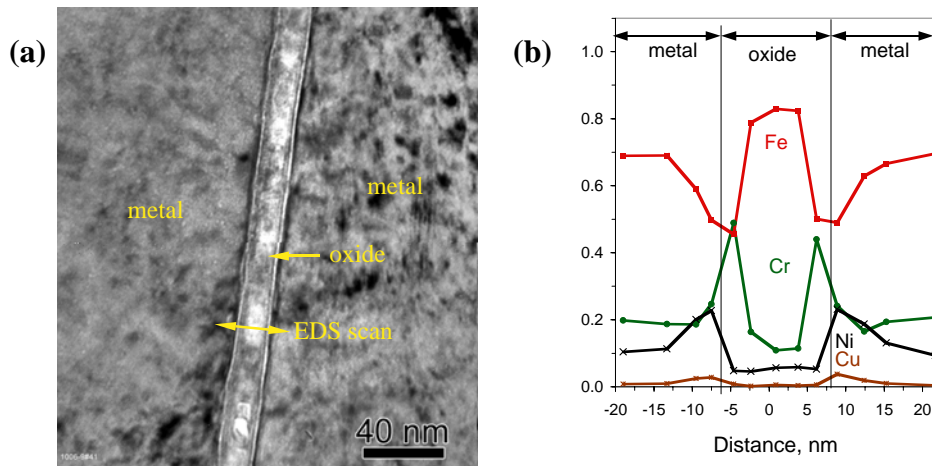
Figure 2. Narrow oxide-filled crack near a crack tip in the top-guide sample: (a) TEM brightfield image and (b) fine-probe compositional profile showing Fe-rich oxide in center of crack and Cr-rich oxide at crack walls.

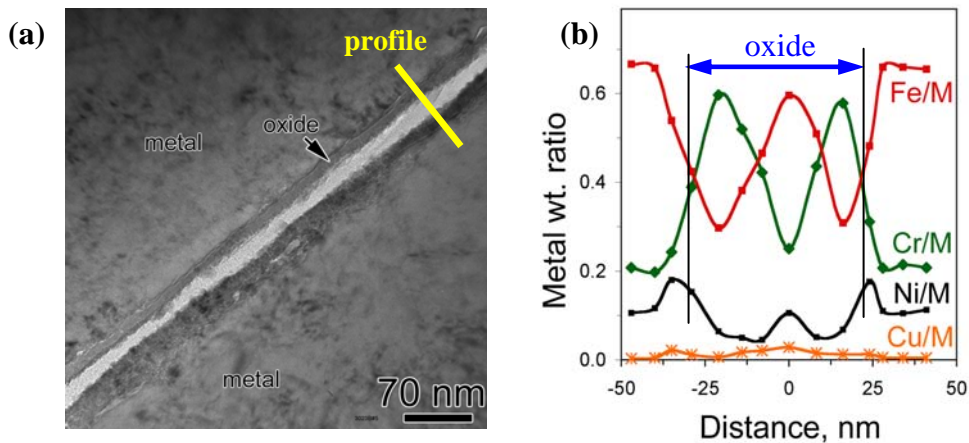
Cracks and crack oxide structures in the laboratory crack-growth sample were generally similar to the service sample even though the exposure times to  $288^\circ\text{C}$  water was quite different. Once again, epitaxial Cr-rich spinel was seen next to the metal and Fe-rich spinel in the crack centers as illustrated in Figure 3. Unlike the cracks in the service sample, many cracks produced in the laboratory test sample contained open central gaps that had become filled with epoxy during the preparation. In some cases, the cracks appeared open nearly to the tips. The narrow Cr-rich spinel layers along the crack walls continued all the way to the tips. As shown by a compositional profile in Figure 3(b), minor Ni and Cu enrichments occurred at the metal/oxide interfaces.

Figure 3. Oxide-filled crack about  $1 \mu\text{m}$  behind tip in the laboratory sample: (a) TEM brightfield image showing bi-layer film and (b) compositional profile showing Fe-rich oxide in center of crack and Cr-rich oxide at crack walls.

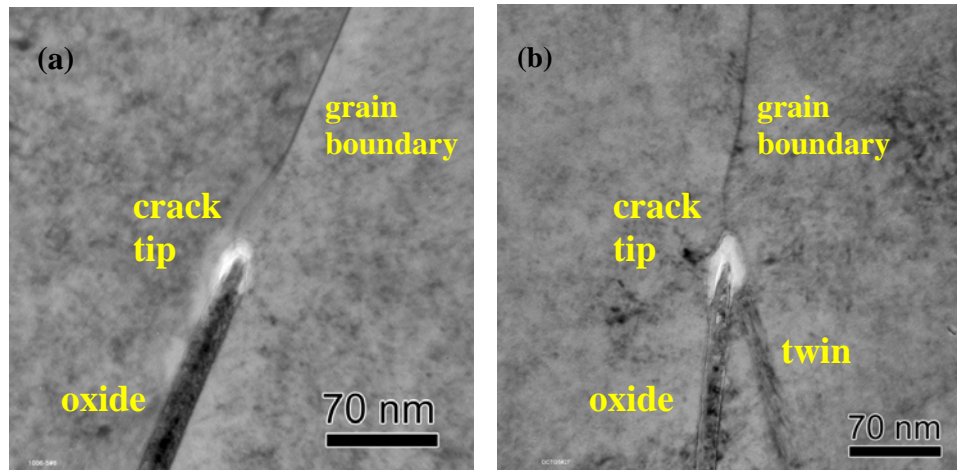
Extensive crack branching in this BWR top-guide material produced numerous crack tips for detailed TEM analysis. Nearly all crack tips examined in detail had the following characteristics in common. The oxide-filled cracks gradually tapered over many  $\mu\text{m}$  to end at “expanded” porous tips at the metal grain boundary. For example, the oxide-fill width decreased from  $\sim 35\text{ nm}$  to  $\sim 15\text{ nm}$  over the final  $\mu\text{m}$  leading up to the crack tip. Porous-tip structures are illustrated in Figures 4(a) and 4(b) showing the oxide fill ending immediately behind the actual tip. Another distinctive characteristic of most tips was a marked deflection of the grain boundaries just ahead of the tips as seen in Figure 4. Most tips also exhibited distinctive finger-like porous structures at their ends. In order to better elucidate this structure at the tips, Fresnel-contrast imaging was obtained from edge-on and inclined views in Figure 5. Finger-like porosity can clearly be seen along the attack interfaces into the metal beyond the corrosion-product oxide. These pores were generally elongated in the growth direction, and had  $\sim 10\text{ nm}$  equiaxed diameters and  $\sim 10\text{-nm}$  inter-pore spacings. Stereo pairs were recorded confirming the 3-dimensional porosity of the tip structures both in the leading edge metal and in the oxide.

Figure 4. TEM images showing two crack tips in the BWR top guide sample: (a) narrow oxide-filled crack over last  $\mu\text{m}$  leading to tip, insets show details of porous tip and oxide-filled crack; (b) and (c) document typical crack tip appearance with oxide ending in a porous region and grain boundary deviation immediately ahead of tip.

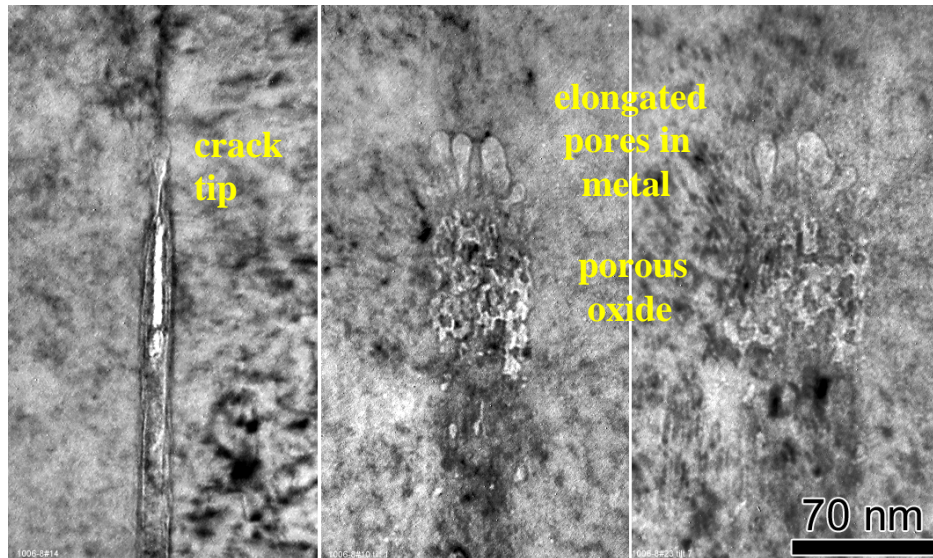
Figure 5. Crack tip shown at 3 tilt inclinations using underfocus TEM brightfield: (a) crack edge-on at  $0^\circ$ , (b) crack inclined by  $30^\circ$  and (c) inclined by  $45^\circ$ .

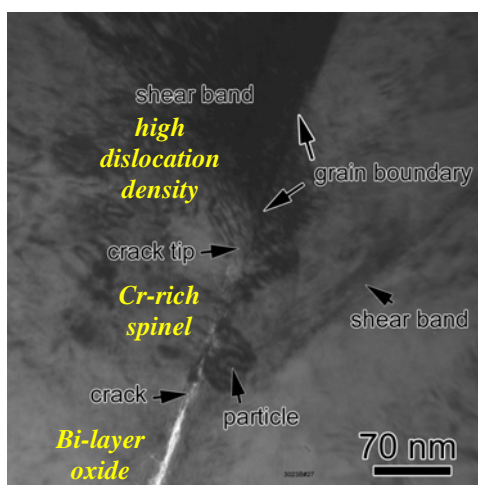
Structures and local compositions were quite different at the crack tips in the laboratory sample. The bi-layer oxide continued to ~100 nm behind the tips then transitioned to only Cr-rich spinel similar to the service cracks. However, the dense, oriented oxide on the crack walls continued to the tips, and there was no evidence of porous oxide or Ni-rich metal at the tip as seen in Figures 4 and 5 for the service sample. An example of a tip region is shown in Figure 6. Extensive deformation structure is present throughout along with evidence of local shear bands intersecting the crack walls and grain boundaries in metal. Fine-probe EDS measurements have not found any significant compositional change (e.g., Fe/Cr depletion and Ni enrichment) in the metal immediately ahead of the crack tip.

Figure 6. TEM image showing an oxide-filled crack tip in the laboratory crack-growth sample.
