# Damage of protective coating due to unstable engine running

## Abstract

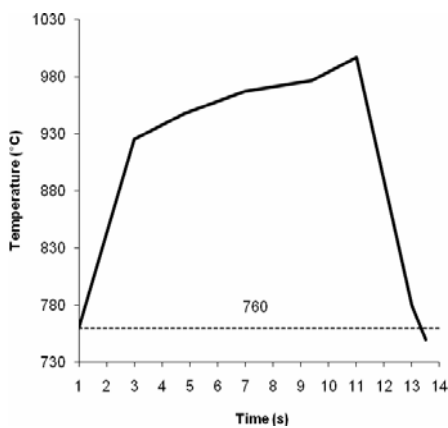
Fig. 3 Waveform of critical temperature excess of engine 92040

Significant microstructural changes of coated blades depend on the degree and time of overheating. A few of examples of these changes are described below. Engine 92040 had 167 hours and 37 minutes of flight operation when surging performed at the Egyptian operator. The critical temperature of outlet gases  $T_{4C}$  rose to 997 °C and the duration of critical temperature excess was 12 s (Table 3, Fig. 3). This short overheating caused degradation of coating blades. Their microstructure is visible in the Fig. 4.

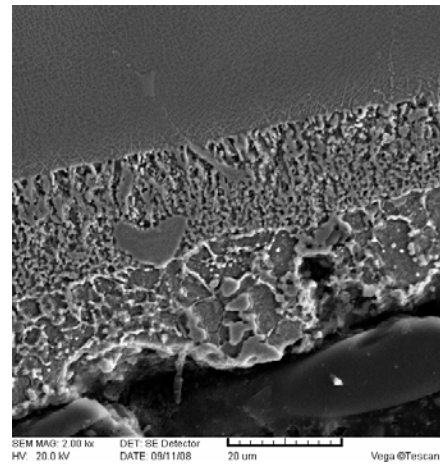
Fig. 4 Microstructure of AlSi layer on the convex side of 92040

In the Fig. 4,5,6 are clearly visible difficulties of damage on individual parts of blade 92040.

The leading edge and the concave side were more loaded than the convex side and their outer zones are more damaged, some of outer areas were removed from surface.

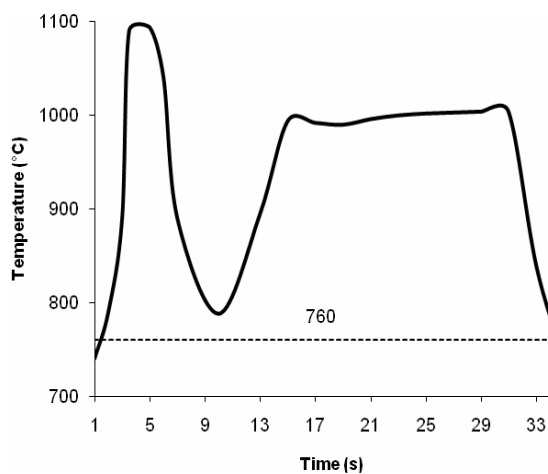
Fig. 7 Waveform of critical temperature excess of engine 91016

The engine 91016 ran 25 hours and 18 minutes when overheating was caused by surging at the Egyptian operator during 7 seconds. Another 27 s of overheating occurred due to a control fault. The temperature peaks reached 1094 °C (Fig. 7). Microstructure of engine blade is presented in the Fig. 8.

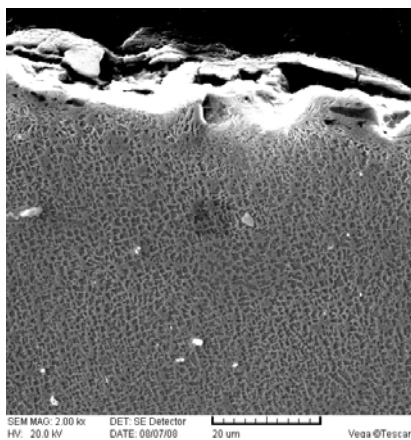
Fig. 8 Microstructure of 91016 engine blade

In spite of that the engine had only 25 hours and 18 minutes of flight operation, surging and consequently a control fault in total duration time 34 seconds caused complete loss of coating. This example of overheating approves very rapid damage of coating by spallation and surface of JS6K alloy underwent the state of plastic flow (Fig. 9).

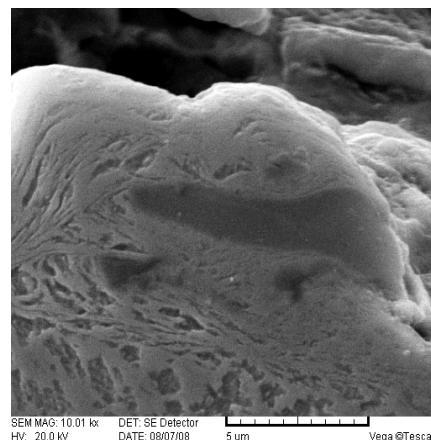
Fig. 9 Microstructure of damaged blade

The microstructure illustrated in the Fig. 9 proved that unstable service conditions and thermal-mechanical overloading caused very rapid and non-permissible damage of coatings. The engine can not be in working operation under these aspects and is subjected to repair.

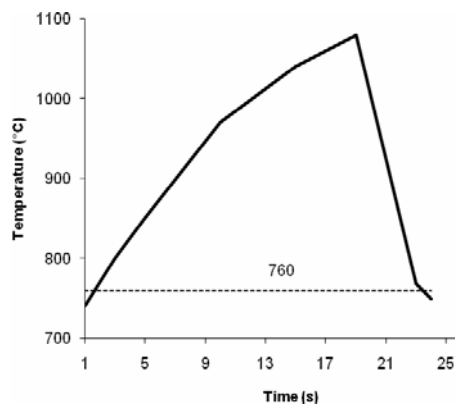
Fig. 10 Waveform of critical temp. excess for engine 94076

Compared to the previous analysed blades, engine 94076 had the highest number of hours of flight operation, i.e. 342 hours and 7 minutes when suddenly the engine stopped in the range of 10 seconds. The maximum overheating temperature reached 1079 °C and the duration of temperature excess was 20.6 s (Fig. 10). Microstructure of the blade on the convex side (Fig. 11) is different from the one on the concave side (Fig. 12).

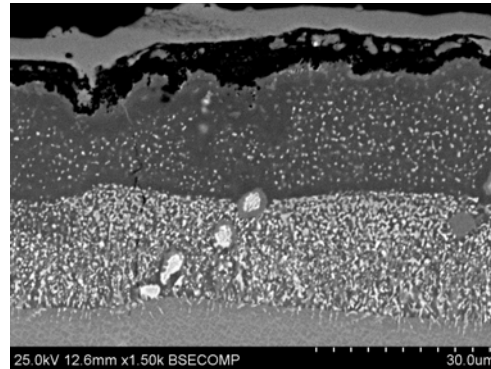
Fig. 11 Convex side of 94076 blade

Sudden stopping of engine 94076 and its temperature excess caused wider range of deterioration in the outer zone of AlSi concave side. The AlSi coating of the convex side is without damage besides inconsiderable phase changes.

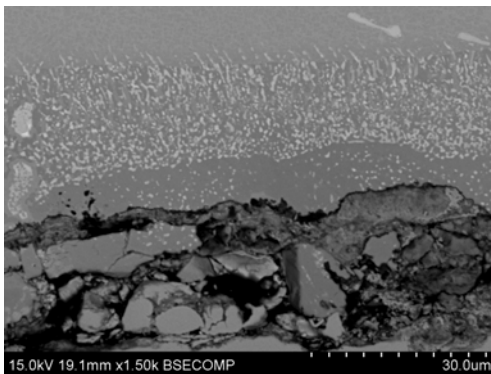
Fig. 12 Concave side of 94076 blade

The concave side of the blade is covered by corrosion phases and so the damage is different from the previous mentioned blades 92040 and 91016. Corrosion products occupied a half of AlSi zone, while surging of 92040 and 91016 engines caused removal of AlSi coating. The microchemical analysis of corrosion products (Fig. 13) is presented in the Table 4.

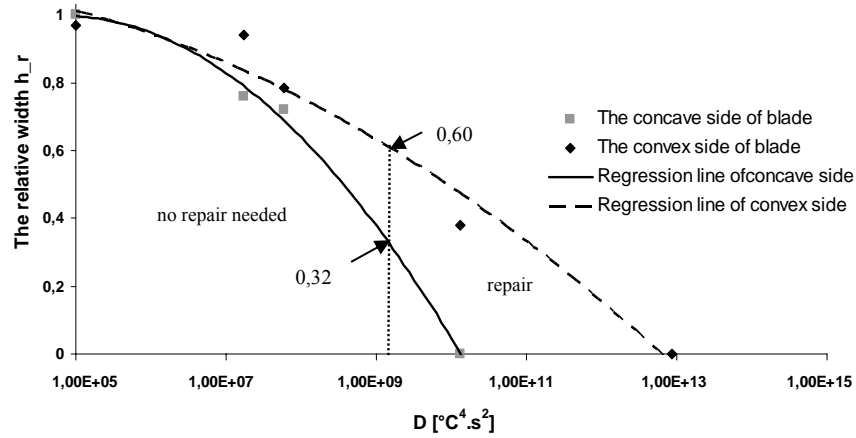
Fig. 14 Dependence of the layer width  $h_r$  on the parameter  $D$  for the concave and the convex side of investigated blades.

By means of this procedure the producer meets a statement concerning the performance capability. The limit between operation and repair of engines was appointed by producer to be  $D < 1.5 \times 10^9 \text{ }^\circ\text{C}^4\text{s}^2$ . These relations and limit has been verified and established. There has been detected that the degradation level  $D$  does not able to provide reasonable information in two special cases:
