FRACTOGRAPHIC ANALYSIS OF SHEAR FRACTURE OF A  
FORGED STEEL AXLE SPINDLE

D. K. Felbeck\*

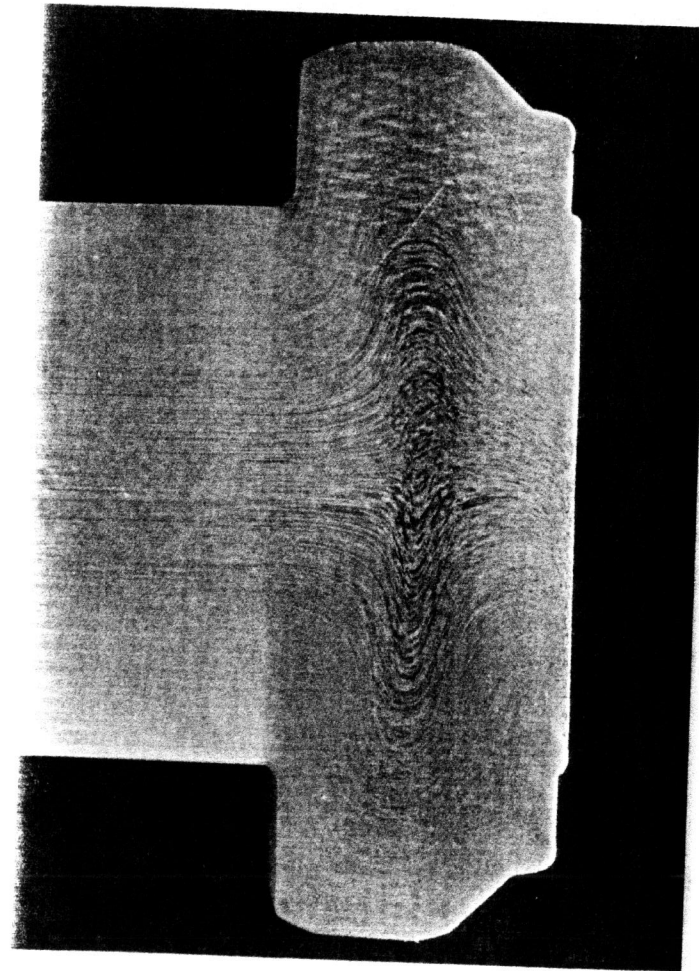
Several identical AISI-SAE 1008 (0.08%C) cold-forged axle spindles for truck semi-trailers fractured under loads less than the anticipated service loads after a very short time in service. The fracture surfaces were examined with the goal of identifying the cause of the failures. Figure 1 shows the macro-etched cross section as it appears after the right (inner) end is upset by forging. The smaller diameter here is 79.4 mm and the largest diameter of the upset end is 133 mm. The diameter on the right is reduced to accommodate a hollow shaft of about 133 mm outside diameter that is arc welded to the spindle. The spindle at its largest diameter is subjected to stresses from bending and from double shear, in both cases at levels well below the yield stress.

Figure 1 Macro-Etched Cross Section of the Spindle

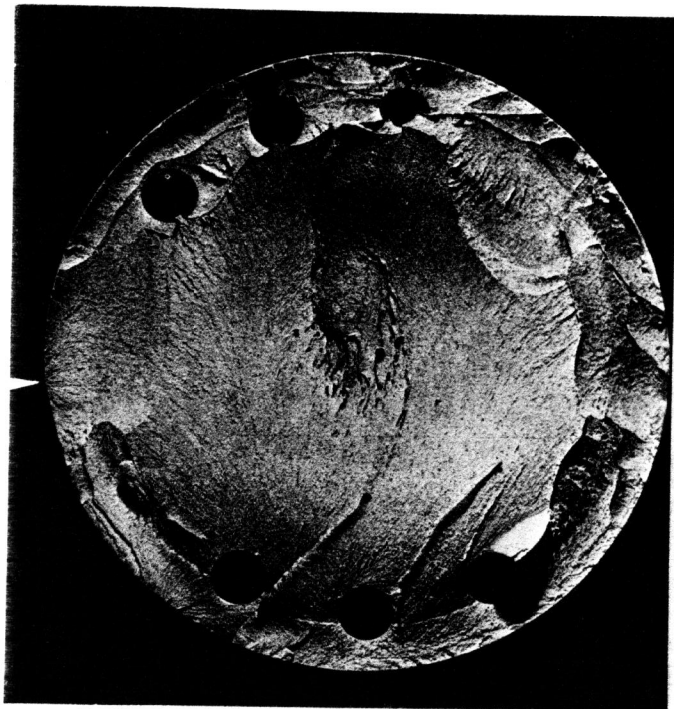
Figure 2 shows the complete 133-mm diameter fracture surface. The fracture occurred in the most severely deformed region of the upset end of the spindle. As this portion of the spindle corresponds to the left part of Figure 1, it will be termed the left portion and its matching face the right portion. The 6 holes are drilled parallel to the spindle axis in the larger diameter region to about its mid thickness, and tapped. This fracture surface is almost exclusively comprised of an overlapping double shear mode such as would be expected from the stress applied [1], except that the scale of the resultant shear feathers is much larger than might be expected; i.e., visible to the naked eye.

Figure 2 Fracture Surface of the Left Portion of Spindle. The Arrow Indicates an Initiation Site near the Neutral Axis in Bending

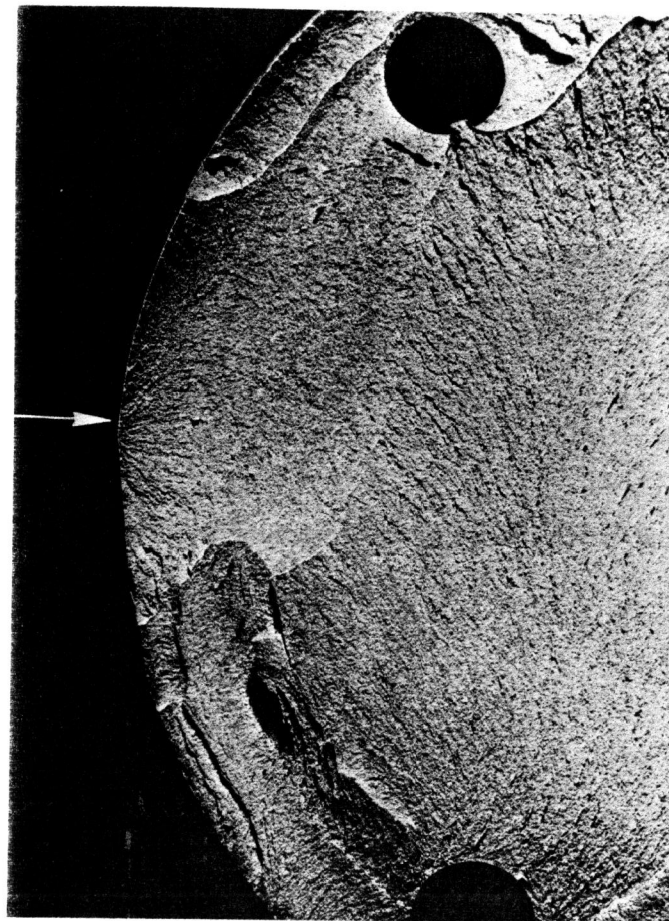
A closer view of the initiation region at an approximately 9 o'clock position (looking at the face as of a clock, with 12 o'clock at the top) is shown in Figure 3. The fine-scale regions have an appearance here similar to cleavage fracture of steel, but closer examination, as in Figure 4, which is at the center of Figure 2, shows finer shear feathers. These two photographs show that the orientation of the feathers or ligaments opened up in shear varies greatly from point to point, suggesting that as the crack advances over an irregular front the shear stress orientation varies from the expected 12:00 - 6:00 orientation.

Figure 3 The 9:00 Initiation Region of Figure 2

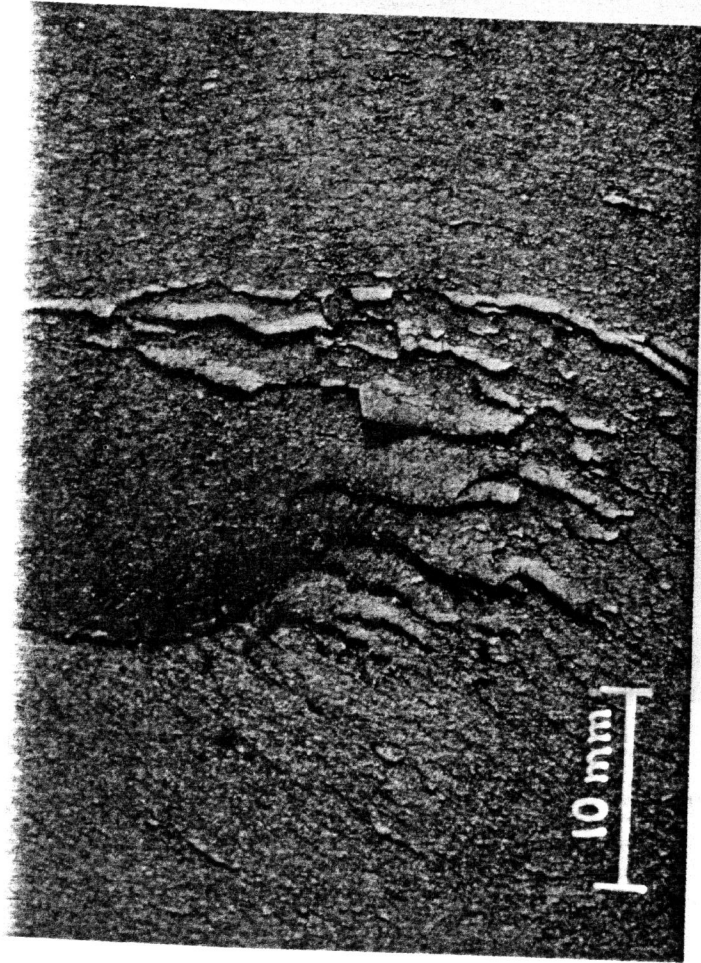
Figure 4 Detail at the Center of Figure 2

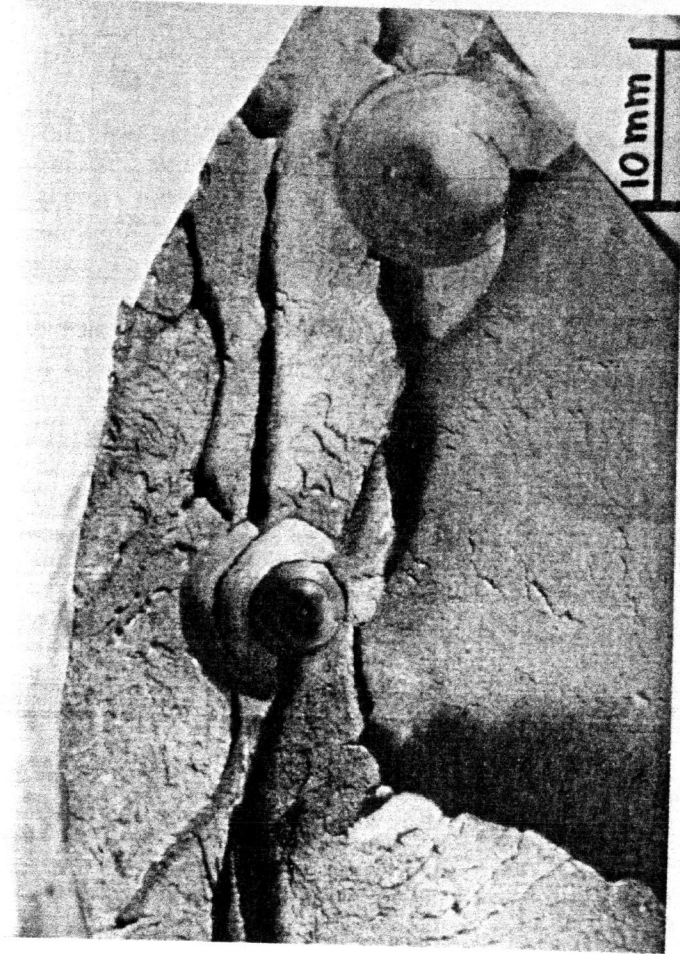
A view near the 12:00 position of the matching right portion of this fracture is shown in Figure 5. The bottoms of two of the holes lie approximately in the plane of the fracture. A detailed survey of the orientation of the shear feathers on the matching fracture surfaces revealed several regions where the feather edges pointed in opposite directions, as would be expected, but by no means all of the fracture surfaces could be so described.

Figure 5 Detail at 12:00 on the Right Fracture Surface

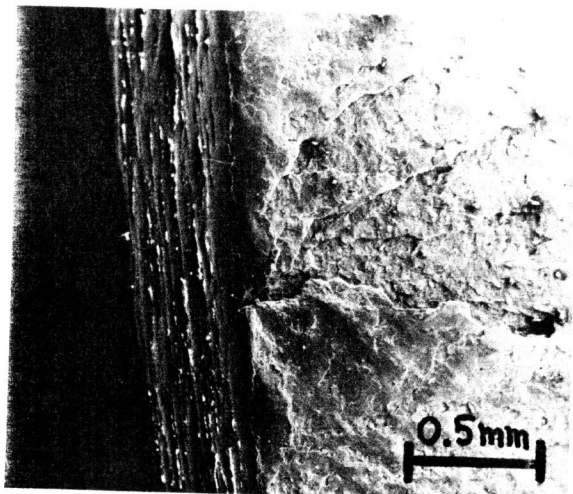
A detailed scanning electron microscope (SEM) examination was made of several areas on the fracture. As all areas indicated similar features, two are illustrated here. Figures 6 and 7 show the appearance in the initiation region that can be seen at 7:00 in Figure 2. Figures 8 and 9 are of a region well removed from the 9:00 initiation point on the left fracture. Note that the shear stress direction here was in the 3:00 - 9:00 direction, in contrast to the external loads which would cause shear in the 6:00 - 12:00 direction.

Figure 6 The Initiation Region at 7:00 on the Left Fracture Surface, by SEM. The 12:00 Direction is to the Upper Right

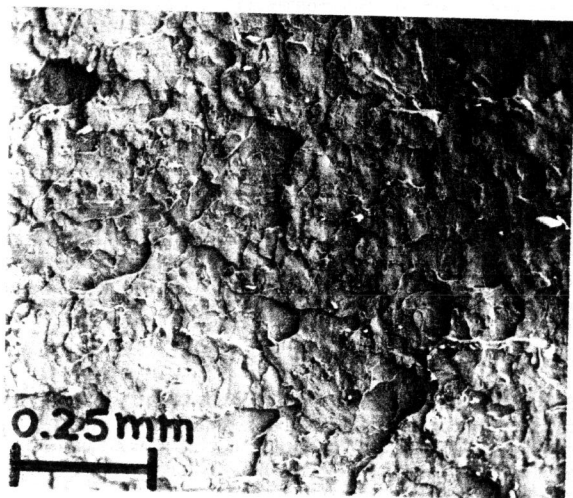
Figure 7 The Same Area as Figure 6, 5 mm Inward from the Edge. The 12:00 Direction is to the Upper Right

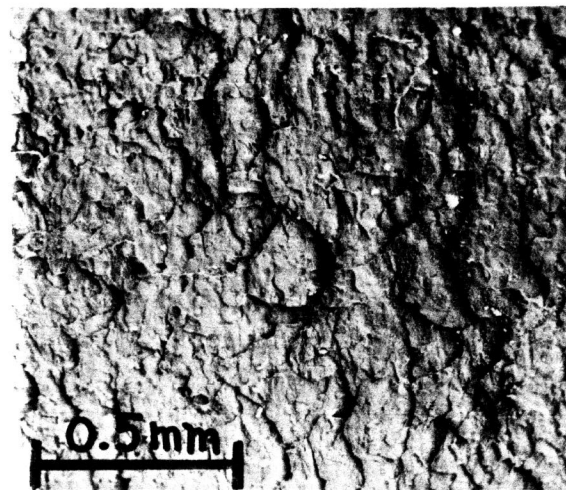
Figure 8 Fracture Surface at 15 mm Inward from the 9:00 Initiation Point in the Left Fracture Surface. 12:00 is Straight Up

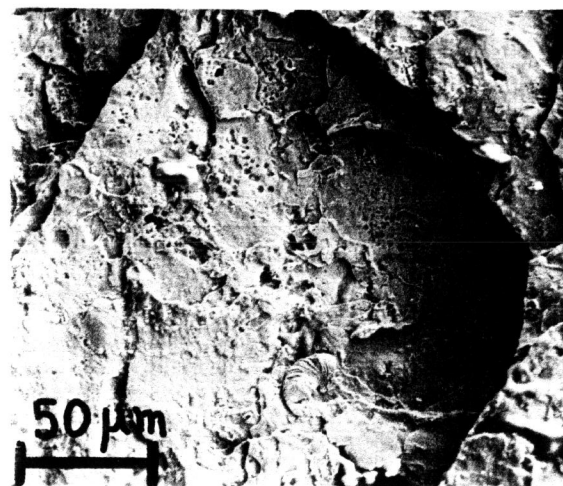
Figure 9 At the Exact Center of Figure 8
