CREEP CRACK GROWTH IN A CrMoV THROTTLE VALVE PRESSURE VESSEL

M.C. Coleman

Central Electricity Generating Board,  
Marchwood Engineering Laboratories,  
Marchwood, Southampton SO4 4ZB, U.K.

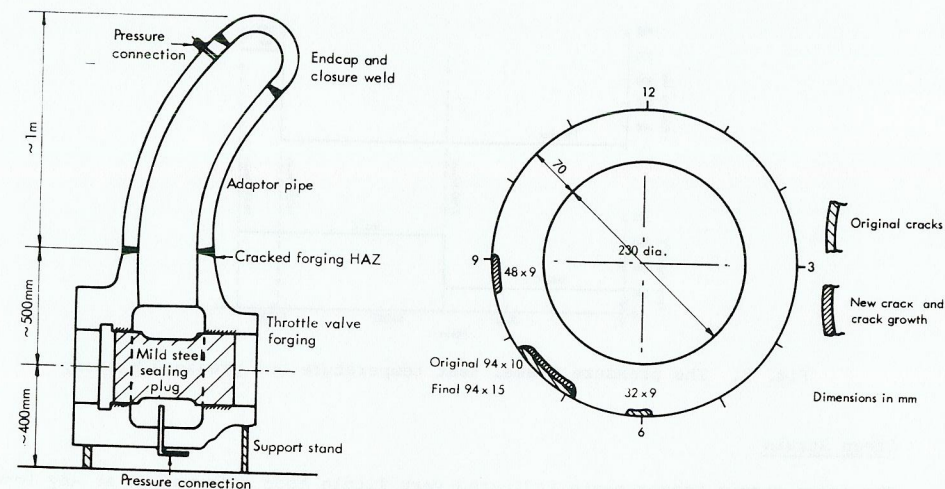
Fig. 1. (a) Pressure Vessel Design

(b) Location of Forging HAZ cracks

After 1800 hours at operating plant conditions, the acoustic emission count rate increased by a factor of 5 on the background level and inspection at 2000 hours revealed that a new crack had initiated at position 9, Fig. 1(b). Over the next 1000 hours, the potential drop equipment indicated that about 5mm growth had occurred at the deepest original defect although no additional acoustic activity was detected. Non-destructive inspection at 3100 hours confirmed that the defect had grown to a maximum depth of about 15mm, Fig. 1(b). During the remaining period of testing at  $540^\circ C$  and all subsequent testing at  $565^\circ C$ , no further crack initiation or growth was detected by any of the monitoring or inspection techniques.

Macrocracking was only observed in sections taken from the three defective regions, Fig. 1(b), and was confined to the forging HAZ adjacent to the top weld bead, Fig. 3(a). At positions 6 and 9, single straight cracks normal to the surface were observed starting adjacent to the fusion boundary and finishing close to the parent material/HAZ interface. These cracks had a depth of 7mm which agreed with the

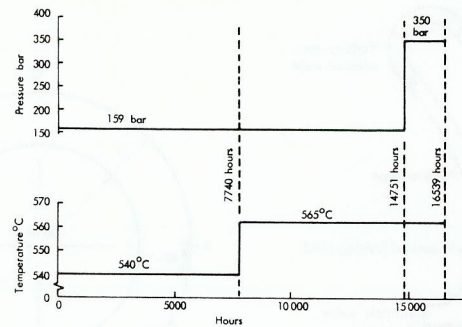
The pressure vessel temperature and pressure test history are shown in Fig. 2. The first period of testing provided about one year of contingency cover to the power station, which was also operating at  $540^\circ C$  and 159 bar. Subsequent testing at  $565^\circ C$  was aimed at providing further information relevant to normally operating plant, while increasing the pressure to 350 bar was a deliberate attempt to generate more creep crack growth data.

Fig. 2. The pressure vessel test temperature and pressure history

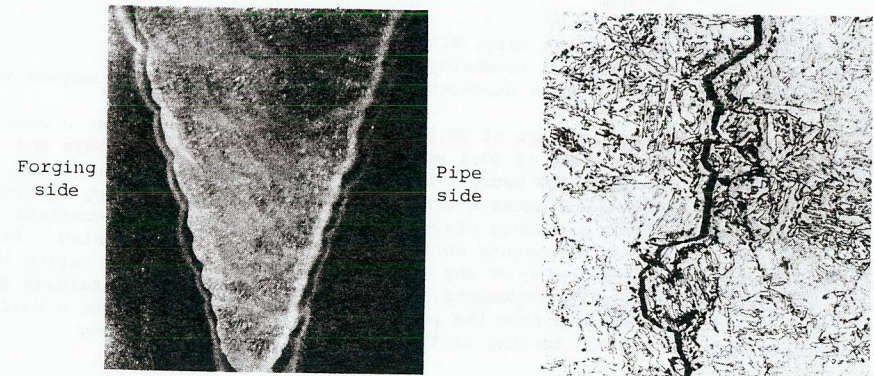
The same general features were observed on all sections examined, Fig. 3(a), and were typical of CrMoV components welded with 2CrMo manual metal arc (MMA) electrodes in a horizontal-vertical manner (weld centre line horizontal, pipe centre line vertical). The forging being the lower face was welded with the electrodes almost normal to the interface and was filled with the root runs plus about 7 beads. On the pipe side the electrodes were roughly parallel to the interface and about 14 beads overlapped along this fusion boundary.

ultrasonic maximum size assessment of 9mm. Similar observations were made between positions 7 and 8, but in addition discontinuous cracking, following the fusion boundary curve, but still remaining normal to the pipe surface, gave rise to a stepped crack appearance. Here, a 15mm deep crack had been expected from the ultrasonic examination but again macrocracking only extended to about 7mm.

Fig. 3. (a) Forging to pipe weld, x 0.8. (b) HAZ intergranular creep crack, x 200

In the macrocracked regions of the forging HAZ, the cracks started in the coarse grained bainite, Fig. 3(b) and propagated normal to the pipe surface for about half their length. Where single cracks were present, the cracks continued in this direction finishing in the refined extremity of the HAZ. For stepped crack regions, cracking reinitiated in the coarse grains following the fusion boundary curve. SEM revealed that, where the cracks ran into the refined structure, branching occurred and widely dispersed creep cavitation was found ahead of the crack, Fig. 4. In contrast, in the coarse grained region the cracks followed a singular path with microcracking and cavitation down to the depth of the first fusion boundary cusp, generally on grain boundaries at right angles to the pipe surface. Cavitation was also found adjacent to the second weld bead and in some positions, particularly between 7 and 8, linked to give microcracks 15 to 20mm below the pipe surface. This corresponded to the position where ultrasonics had indicated a 15mm maximum depth crack. Below the second weld bead depth extensive examination failed to reveal any further cracking or cavitation.

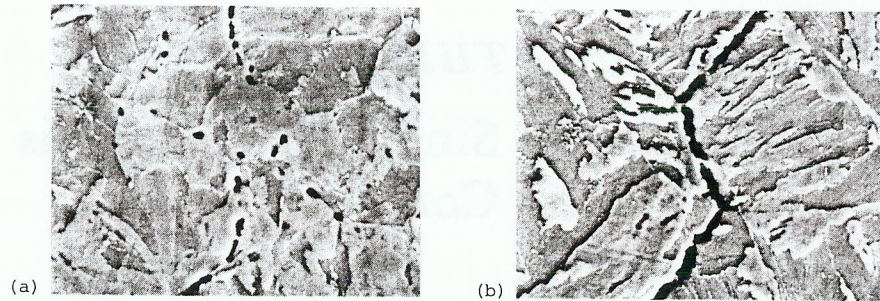
Examination of the nominally sound regions of the forging HAZ revealed small microcracks and cavitation adjacent to the top weld bead, and incipient cracking in the form of grain boundary networks of cavities in the second weld bead HAZ. Similarly, on the adaptor pipe side microcracks were observed in the top weld bead HAZ with

cavitation occurring down to the depth of the fourth weld bead. On each side of the weld therefore, the top third of the HAZ contained creep damage, while the remainder appeared clear.

Fig. 4. SEM's of (a) Dispersed cavitation in refined HAZ and (b) Cracking in the coarse grained HAZ x 1000
