STRESS CORROSION FAILURE OF 304 TYPE STAINLESS STEEL PIPE IN SEAWATER ENVIRONMENT

ABSTRACT

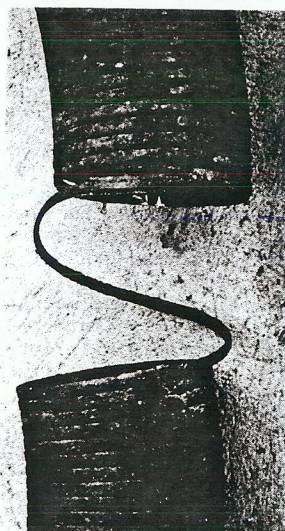
Complete failure occurred in this stainless steel pipe in the area shown in Fig. 1 after four months of operation. The failure was in the form of rust and leaks at the bend-section (Fig. 1b). The temperature in this section often reached 400°C and was under repeated thumping action of the exhaust gases (Fig. 1b). Figure 1 shows a general view of the rusted and fractured section of the stainless steel flexible pipe.

Fig. 1. (a) Showing the corroded stainless steel pipe.

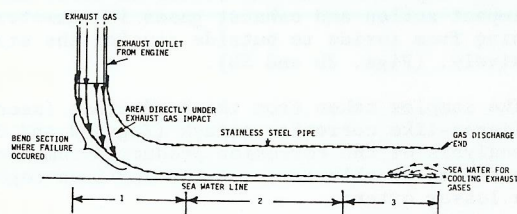
(b) Showing layout of the pipe attachment to the engine, discharge end, seawater line damaged areas and samples taken for the investigation (schematic).

Three samples were taken from the failed stainless steel pipe (Fig. 1b). Sample 1 represented the bend-section where failure actually occurred. Sample 2 was about 300 mm from the bend-section, while sample 3 was from the discharged end about 900 mm away from the failed section. The temperature of the bend section (failed section) ranged from 300 to 350°C while outside the surface temperature was about 250 - 300°C. Temperature measured using a recorder showed that it exceeded 400°C.

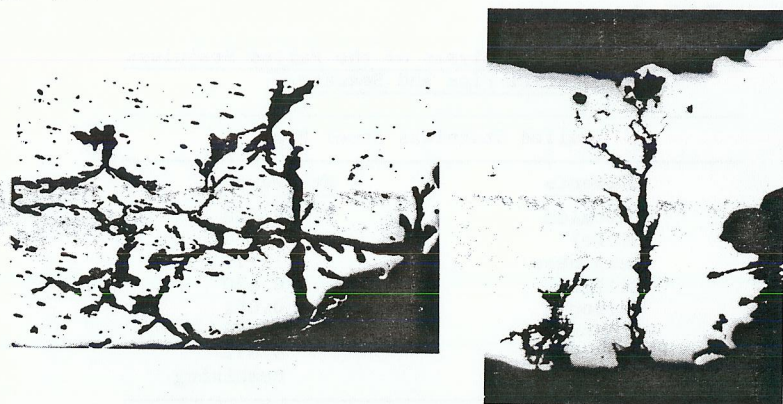
Samples from section 1 (bend-area, Fig. 1b) of the pipe that had failed were examined at low magnifications (50 to 100X). Extensive cracking and pitting was found (Fig. 2). Most of the pits were 50 to 2000 microns in diameter. In several areas the pitting was severe, several pits were joined together giving the appearance of cracks. Cracks were running from inside edge to outside (Fig. 2b).

(a) Cracking in a Zig-zag mode (b) Showing severe intergranular cracking

Fig. 2. Pattern of corrosion cracking in the failure areas. Unetched. 100X.

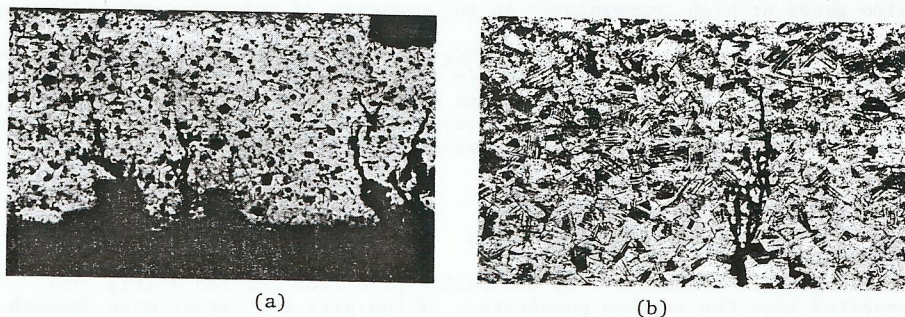
Metallographic examination of the failed pipe from section 1 (Fig. 1b) revealed that the average penetration of the pits and cracks were through the wall of the pipe (Figs. 2 and 3). Some pits and cracks formed "caverns" where penetration was complete (Fig. 3b).

Fig. 3. (a) Showing fingerlike corrosion; (b) Transgranular and intergranular corrosion cracking. 100X.

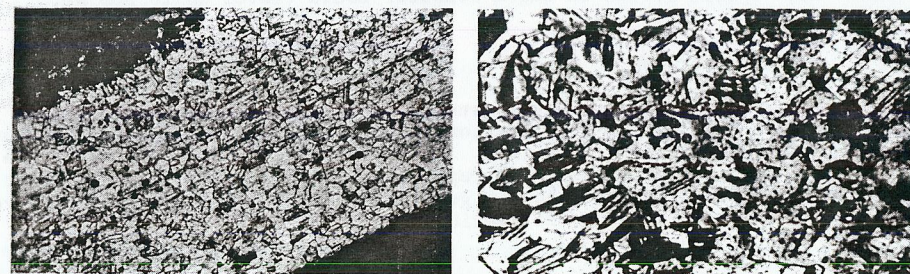
(a) 100X (b) 500X

axed grains with extensive pitting and carbide precipitation. This clearly indicated some degree of sensitization had occurred (Fig. 4). The deformation lines (slip lines) strongly indicated the presence of internal stresses caused by repeated action of heating and cooling by seawater. The x-ray diffraction analysis strongly indicated that the precipitates at the grain boundaries and slip lines were to be $M_{23}C_6$ (chromium carbide). The precipitation of chromium carbides in the grain boundaries and slip lines caused matrix to deplete in chromium content. The chromium depleted matrix areas were attacked by the chloride ions under impact type action of exhaust gases at high temperature causing formation of small pits. These small pits under high temperature in the repeated impact action of engine exhaust gases in seawater (chloride, sulphate etc) environment acted as nuclei to form intergranular and transgranular cracks (Fig. 5). These cracks were propagated

Fig. 4. Showing (a) pitting and (b) deformation lines and precipitation of carbide particles on grain boundaries and slip planes.

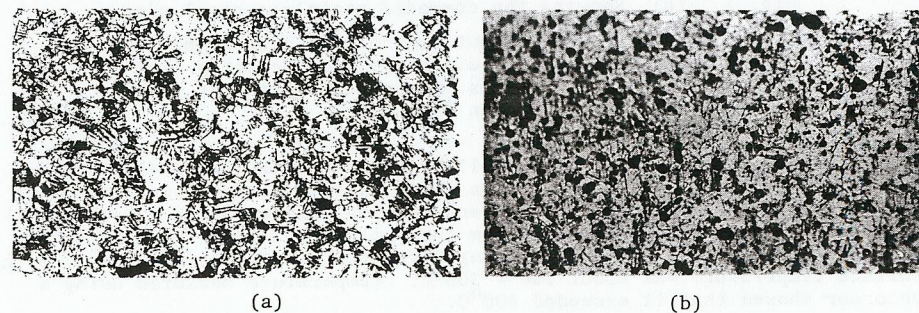
under repeated combined action of three factors (high temperature, repeated impact action and exhaust gases in seawater environment) by joining pits running from inside to outside causing the stainless steel pipe to leak extensively. (Figs. 2b and 5b).

Fig. 5. (a) Showing extensive pitting on the grain boundaries and within the grains. 100X. (b) Showing crack nucleation from the pits. 100X.

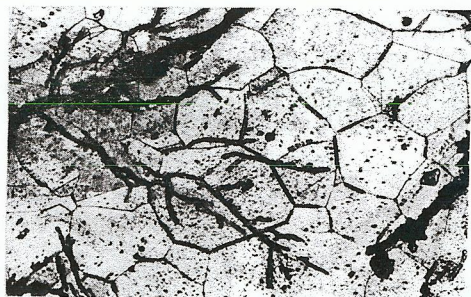
Furthermore, since the crack (Fig. 6) propagation showed a step-like growth, the question also arose as to whether these cracks should be considered as corrosion fatigue cracks produced by constant impact action of exhaust gases with seawater quenching effect from high temperatures.

Fig. 6. Showing branched transgranular and intergranular stress corrosion cracking and slip lines in the failed areas. 500X.

Since these cracks were intergranular and transgranular propagating in a step-like manner, the failure seemed to be due to a combination of stress corrosion cracking and corrosion fatigue mechanism. Furthermore, when pitting and stress corrosion cracking appear together, the SCC cracks originate from the pits and tend to run out of the pits (Figs. 4, 5 and 6). This can be reasoned by the increase chloride and sulphur concentration in the pit
