ADIABATIC SHEARING AND ASSOCIATED CRACKS IN BALLISTIC STEEL TARGETS

ABSTRACT

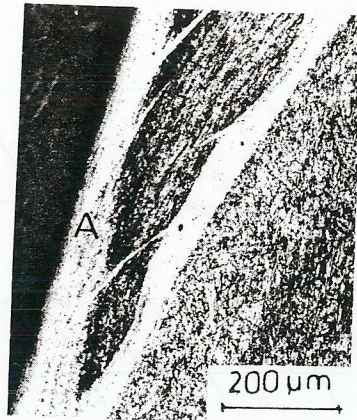
Fig. 1 Photomicrograph of a white etching layer (A) at the Projectile-target interface.

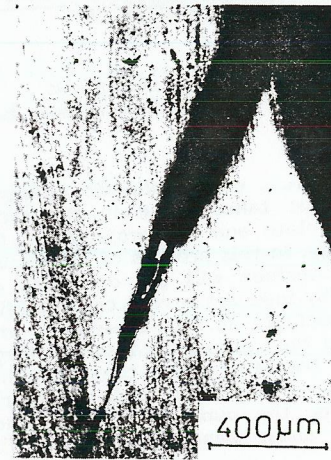
Often cracks are formed at the projectile-target interface and propagate to some distance along the shear band and finally terminate at one edge of the band, as shown in Fig.2a. Sometime small cracks along the length of the band are also seen to be present as shown in Figs. 2b, 2c and 2d. If these small cracks are very near to each other, they join up by a small 'hair line' crack as shown in Fig.2e. Long continuously running crack along the length of the shear band has also been observed as shown in Fig.2f.

Fig. 2a Crack that initiated at the projectile-target interface and terminated at one edge of the shear band.

When a projectile penetrates the target plate most of the kinetic energy is absorbed by the large, general deformation that takes place in the target metal. Due to high speed friction between the plate and the projectile a thin white layer is formed to absorb some more energy. In this process of penetration the grains of the target material along the interface will get deformed and elongated as schematically shown in Fig.3 thereby inducing severe compatibility stresses on the grain boundaries. Shear bands nucleate at such interfaces when conditions favour localisation of deformation and then propagate into the target metal along the planes of maximum shear. At the site where the thin white layer forms, the temperature is very high. Consequently the grain boundaries are weakened, providing a possible location for the nucleation of a crack. This crack can form and propagate along the shear band as shown in Fig. 2a.

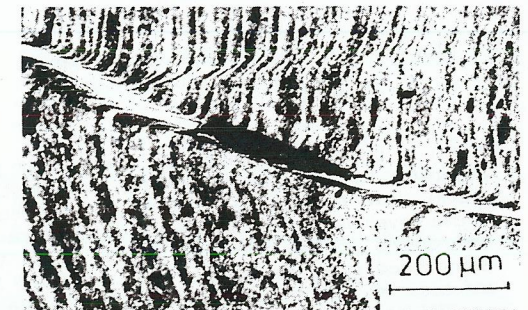
Fig. 2b Photomicrograph showing the initiation, propagation and termination of a crack in a shear band.

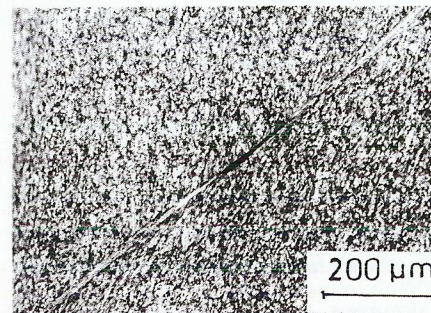
Fig. 2c Photomicrograph showing a small brittle crack in a transformed adiabatic shear band.

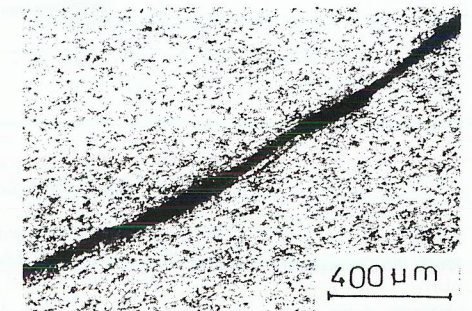
Fig. 2d Multiple, small cracks in a shear band.

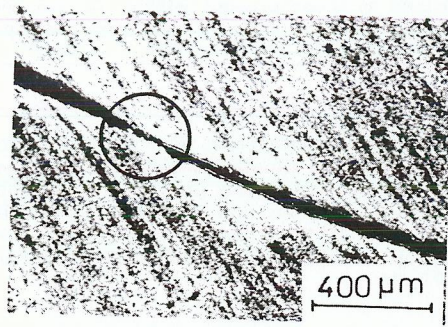
Fig. 2e Two small cracks in a shear band joined up by a 'hair line crack'.

When the temperature in the shear band exceeds the transformation range, austenite will form and this relatively soft layer will help to open up or widen the crack that is propagating in the shear band. This will result in a long continuous crack as shown in Fig. 2f. On cooling the transformed bands will be hard and provide a potential site for the nucleation of brittle type of crack whose propagation may be aided by the tensile stress waves. Such cracks will be small in length, formed only just to relieve the stress field in the transformed band which is of martensitic structure. Such a typical crack formation, either single or multiple in character, is shown in Fig.2c and 2d. Sometimes when these cracks are very near to each other, they may join together by a 'hair line' crack as shown in Fig.2e.

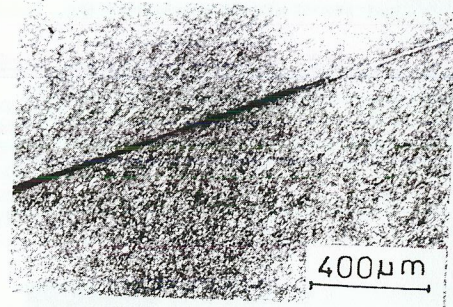
Fig. 2f A long continuous crack along a shear band.

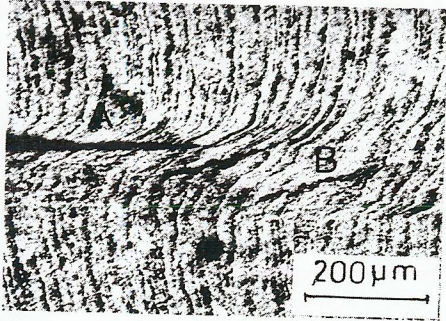
Cracks are seen to form many times along the flow lines as shown in Fig.5a and b. Fig.5a shows cracks along the flow lines at the tip of a shear band. Fig.5b shows clearly how a number of small cracks formed along the flow lines and joined up together appearing as long cracks on either side of the shear band. Cracks can nucleate along the flow lines as shown in Figs.5a and b in the following way.

in front of the shear band tip there is always present, a severely sheared region. Such a region is illustrated in Fig.5a. Obviously the flow lines within this severely strained volume is likely regions for the formation of cracks as found in Fig.5a. If these cracks are very near to each other they will join up by propagating under the influence of the reflected tensile waves and appear

Fig. 5a Photomicrograph showing cracks along the shear band (A) and the flow lines (B) ahead of the shear band tip.

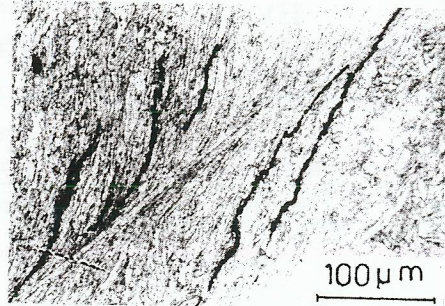
Fig. 5b Small cracks joined up with each other along the flow lines on either side of a shear band.

as long cracks as shown in Fig.5b. Here the band has propagated further after the cracks have formed along the flow lines. Thus we see long cracks along the flow lines on either side of the shear band.

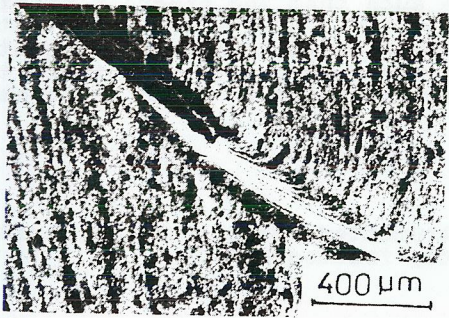
Fig. 5c Photomicrograph showing the severe shear displacement of the flow lines causing a shear band.

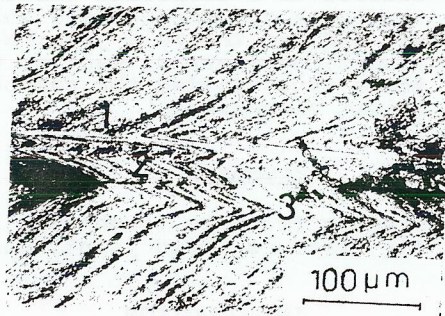
Fig. 6 Photomicrograph showing a transformed shear band (1) along with two deformed bands - one with a crack (2) and one another (3) yet to completely form.

A typical transformed adiabatic shear band along with two deformed shear bands - one with a crack and the other yet to fully form - is shown in Fig.6. The situation shown in this figure is an example of the complexity in the formation of shear bands and the associated shear cracks. Here the transformed adiabatic

shear band (1) formed at first and the deformed shear band (2) with a crack along it formed latter. Subsequently another deformed band (3) tried to form because of the shear displacements in the flow lines but it has not yet fully developed.

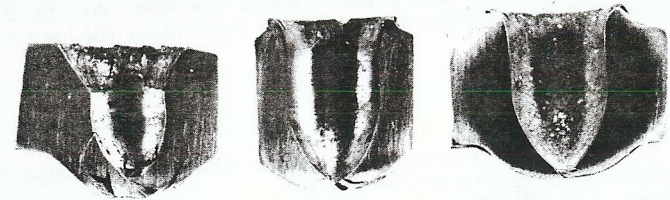
Cracking has also been observed in the portion of the target material just ahead of the projectile tip. These cracks follow some preferred paths. Typical cracking in this region is shown in Fig.7a. When the projectile hits the target plate

Fig. 7a Observed crack paths in the region just ahead of the projectile tip.

compressive waves are set up in the material. They travel to the back surface of the plate and are reflected back as tensile waves. When the intensity exceeds the fracture stress of the material, cracking occurs. These cracks have been found consistently to follow the logarithmic spiral slip planes as schematically shown in Fig.7b. These slip line fields closely match with the observed paths of the cracking.
