INVESTIGATION OF AN AIRCRAFT ACCIDENT BY FRACTOGRAPHIC ANALYSIS

Materials Science Division, National Aeronautical Laboratory, Bangalore 560017, India

ABSTRACT

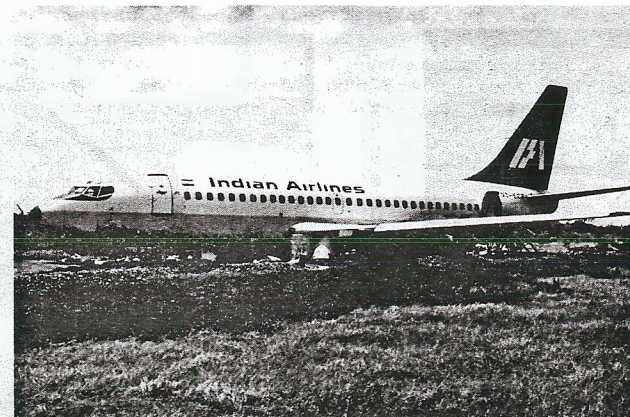
The general view of the damaged aircraft is shown in Fig.1. The engines and the landing gear got ripped off and the aircraft was resting on its belly near the outer fence of the airport. Extensive damage was noticed in the front toilet and the cockpit areas. Fragments were found lodged at various locations such as the pilot's seat, the observer's seat behind the pilot's seat in the cockpit, toilet panels and the panel opposite the toilet across the gangway.

Fig. 1. Wreckage of the aircraft

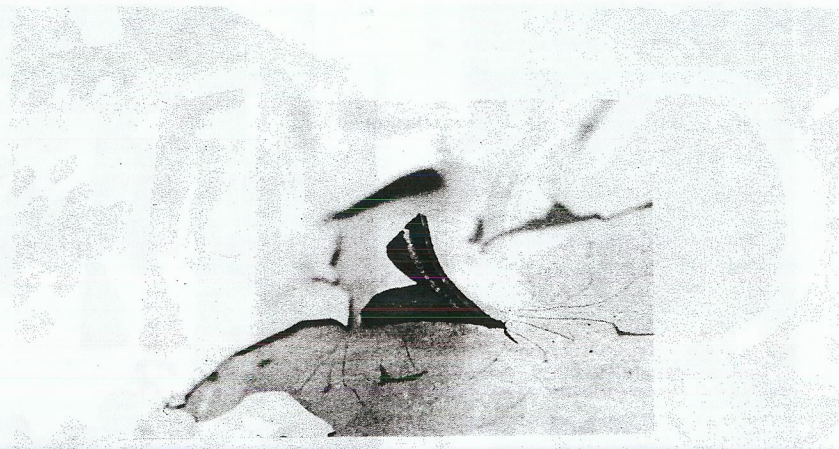
The three panels of the toilet compartment - one on the cockpit side, another on the gangway side and the third on the cabin side - had given way. There were indications of sharp projectiles passing through them. The floor board of the toilet below the wash basin had been destroyed. The paint on the external skin above the front toilet had peeled off at a few places as seen in Fig.1. On the external skin of the toilet roof, a hole was found, with its edges curling outwards as shown in Fig.2. Inside the toilet, the stainless steel wash basin was found severely deformed. The bulkhead, the side panel and the fittings below the wash basin were severely damaged. The glass mirror above the wash basin was found shattered and the pieces were found in the cockpit and also on the ground below.

Fig. 2. Hole on the external skin of the toilet roof

The observed damages to the structure and fittings in and around the toilet compartment further strengthens this view. A hole in the roof skin of the toilet, another in the pilot's seat back rest and a third in the plastic panel in the passenger cabin indicate that high velocity projectiles have travelled outwards in various directions from the toilet. The peeling off of the paint from the top skin of the fuselage between the cockpit and the front entrance, shown in Fig.1 could have happened only due to internal forces from underneath and not during or after landing. The orientation of the dent in the toilet bowl and the deformation of the wash basin indicate the centre of explosion to be under the wash basin. The larger pieces of the disintegrated aluminium waste paper receptacle have dents and holes indicating damage from inside to outside by an explosion. Further the innumerable craters which characterise the primary zone of chemical explosion were found in fragments from this container. All these evidences strongly point to this waste towel receptacle as the centre of explosion. This was also confirmed by the trajectory tracing method sketched in Fig.8. The residues collected from the inside surfaces of the fragments of the waste towel receptacle were got chemically analysed. The analysis indicated that a mixture of ammonium nitrate and fuel oil had been used as the explosive.

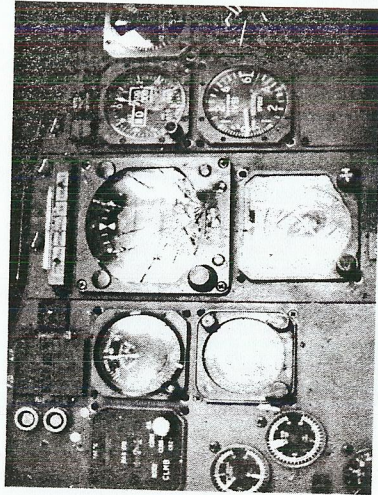
In the cockpit, the glass covers on many of the instruments were found broken as shown in Fig.4. A hole was found on the back rest of the observer's seat which is located between the pilot's seat and the toilet wall. The back rest of the pilot's seat had a hole pierced through it and was damaged as seen in Fig.5.

Fig. 4. Damage to the instrument panel.

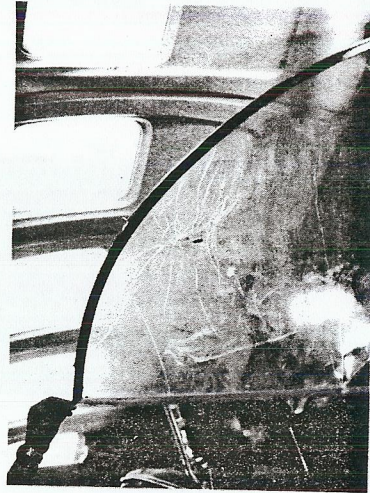
In the passenger cabin, the quadrant shaped translucent plastic panel located in front of the left front row of seats had a hole pierced through it as shown in Fig.6. The cabin crew's folding seat located in the passage between this panel and the front toilet was completely ripped off into small pieces and sharp metal pieces were found embedded in the foam.

Fig. 6. Hole in the plastic panel in the passenger cabin.

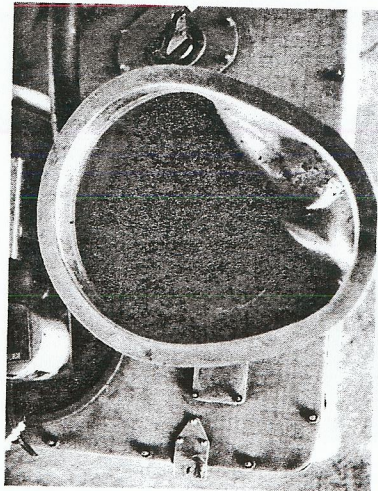
The waste towel receptacle which is an aluminium box kept under the wash basin was found disintegrated into a number of heavily deformed pieces. The toilet bowl located to the left of the waste towel cupboard was found caved in as shown in Fig.3, as though deformed by forces from the direction of the waste towel cupboard.

Fig. 3. Caving in of the toilet bowl.

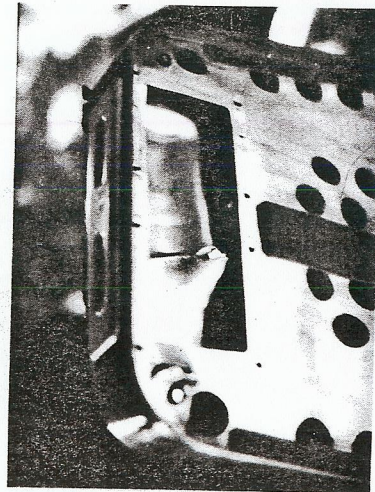
Fig. 5. Back rest of pilot's seat - Front view

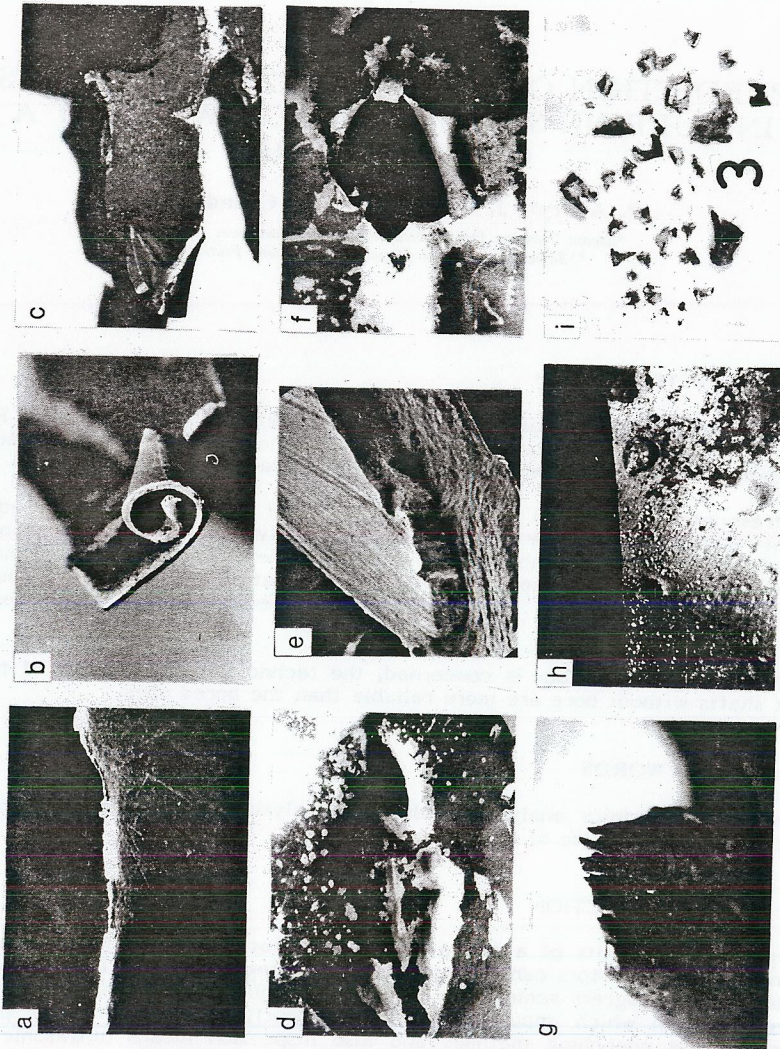
Reverse slant. A number of sheet metal fragments of the waste towel showed a stepwise fracture edge, the slope of the slant fracture reversing alternately along the edge, Fig.7a.

Curls. Some of the fragments of the waste towel receptacle were found curled as shown in Fig.7b, with the free end rolled over itself one or two turns.

Curved fragments. Fragments were also found curved at the edges with a small radius of curvature, Fig.7c.

Dents. Several sharp and glancing dents were found in some of the pieces of the waste towel receptacle, Fig.7d.

Spall. In one of the fragments, metal was found spalled along the midthickness plane. Figure 7e is a scanning electron fractograph of this feature.

Holes. In some of these fragments, small holes were found pierced through the thickness. On larger holes, petaling and outward curling were noticed on the outer surface of the fragments, Fig.7f.

Spikes. Saw tooth like spikes were noticed in some of the pieces. One such piece shown in Fig.7g was identified as part of the aluminium backing under the stainless steel wash basin.

Craters. In a few pieces identified to be parts of the waste towel receptacle, a cluster of small craters was noticed with raised ridges along the periphery, as shown in Fig.7h.

Nondescript fragments. In addition, there were many tiny nondescript fragments of aluminium, of various shapes in the debris collected from the front area, Fig.7i.

Fig. 7. Signatures of explosion: (a) Reverse slant (b) Curl (c) Curved fragment (d) Dent (e) Spall (f) Petaling and curling around a hole (g) Spikes (h) Craters (i) Nondescript fragments

The observed features described in the earlier section belong to this group of signatures produced on explosion. While some features like the reverse slant or some form of curled fragments may also be formed by other means, other features described above are produced only due to explosion. Craters with raised rims could not be caused by any other means during an aircraft crash and their presence is an almost certain proof of chemical explosion.

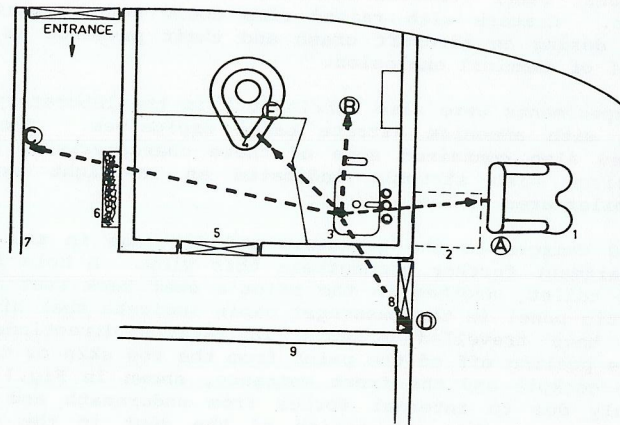
Fig.8. Trajectories of projectiles from the centre of explosion
