Fractography of Corrosion Fatigue Cracks in RPV Steels in Pressurised Water Reactor Environments

A. N. GREENWOOD and D. R. TICE
*UKAEA Northern Research Laboratories, Springfields, Salwick,
Preston PR4 0RR, UK*

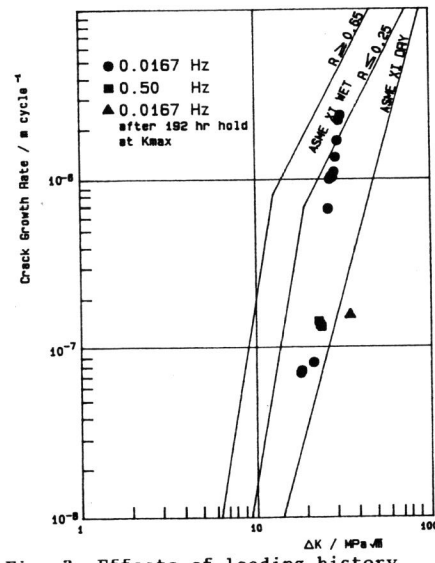
The crack growth behaviour, summarised in Fig. 3, was reflected on the fracture surface. During the first part of the test, i.e. before the cyclic frequency was increased to 0.5 Hz, the observed fracture morphology was typical of that already seen for non-enhanced cracking, whereas during the period of 0.5 Hz cycling typical non-enhanced features were found plus some areas resembling fan-like cracking. When the cyclic frequency was returned to 0.0167 Hz there was an immediate increase in the crack growth rate and a corresponding increase in the amount of fan-like cracking, Plate 8, until it covered a large D-shaped region in the centre of the specimen. On this part of the surface the fan-like cracking was not reliant on

Fig. 3. Effects of loading history for specimen B1.

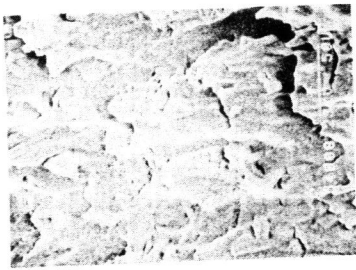
Two distinctive types of fracture surface were observed during the fractographic examination, depending on the crack growth rate. The two surfaces can be illustrated by comparing Plates 1 and 3 with Plates 4 and 5. Plates 1 and 3 show fracture surfaces typical of non-enhanced crack growth which are characterised by a rough surface appearance, extensive microbranching and, particularly at higher values of ΔK , irregular indistinct striations. In contrast, Plates 4 and 5 illustrate fracture surfaces for a specimen producing rapid environmentally assisted crack growth. The fracture was more planar, there was only a limited amount of microbranching and the surface was marked by tear ridges orientated approximately parallel to the direction of crack growth. Where striations were observed they were sharp, well formed and aligned across the crack normal to the tear ridges.

Plate 1 : A1 x 500, microbranching and irregular striations at low ΔK on a specimen showing no EAC.

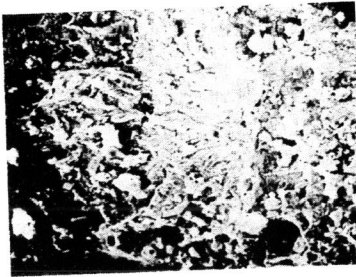
other specimens the overall crack propagation rate was not enhanced, but localised patches of enhanced growth were seen on the fracture surface, usually radiating from an inclusion site, e.g. Plates 2 and 6. Similar fractographic features have been reported by other investigators (e.g. Klemetti *et al*, 1984; Torronen *et al*, 1982; Atkinson and Bulloch, 1986). Some of these investigators have cited the apparently brittle appearance of the fracture surface on specimens showing enhanced rates of cracking as evidence for a hydrogen embrittlement mechanism of crack propagation. However, the typical features may alternatively be due to repeated dissolution at the crack tip during the straining part of the cycle. The regular striation spacing across the fracture surface may reflect the localised deformation needed at the crack tip to rupture the oxide and expose bare metal to the environment, so that crack extension is related to the duration of the straining part of the cycle and the corrosion rate of bare metal. The initial striation spacing was greater than the macroscopic crack growth per cycle suggesting that the crack extension in the early stages of a test was the average of discrete individual bursts of crack growth, whereas once full environmental enhancement was achieved the plateau crack growth rate per cycle equalled the striation spacing.

Plate 2 : A2 x 400, localised fan-like cracking around inclusion site.

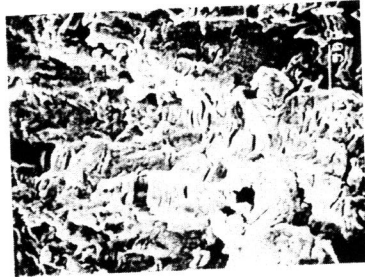
Plate 3 : D1 x 800, irregular striations and microbranching at higher ΔK for a specimen showing no EAC.

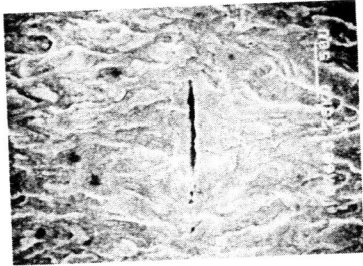
Plate 4 : D2 x 400, planar cracking at low ΔK on a specimen showing EAC.

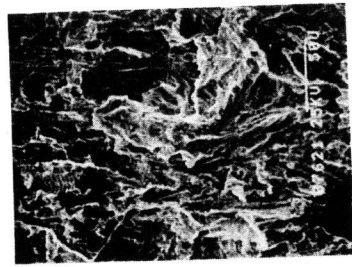
The second specimen, D2, tested at Westinghouse in low flow lithiated water, produced the greatest environmental enhancement of crack growth rate amongst the specimens examined, with crack growth rates from the start of the test being about two orders of magnitude above those in air, Fig. 1. Although the fracture was transgranular as for specimens A1 and A2, the fracture surface was far more planar and exhibited noticeably less microbranching, with the tear ridges aligned in the direction of crack growth, Plate 4. The general morphology of the surface at this point was comparable to the features on specimen C1. Where the crack had intersected an inclusion there was only a limited perturbation on the fracture surface. There were no observations of fans radiating from inclusion sites, although the overall fracture surface on this specimen bore a strong resemblance to that in the fan-shaped region of specimen A2. Isolated fatigue striations were first observed 5 mm into the water fracture at a ΔK of $15 \text{ MPa}\sqrt{\text{m}}$, becoming more numerous at higher ΔK , Plate 5. These striations were much more regular and planar than those observed on specimens showing no environmental enhancement (compare Plates 1 and 5) and had a regular spacing of $2-3 \mu\text{m}$ over the whole fracture surface.

Plate 5 : D2 x 200, regular striations at higher ΔK on specimen showing EAC.

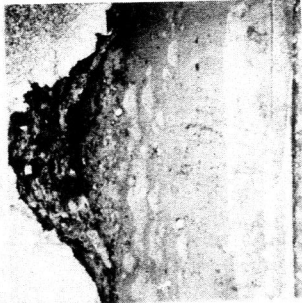
Plate 7 : B1 x 5, large areas of localised cracking in a HAZ specimen showing EAC (optical photograph).

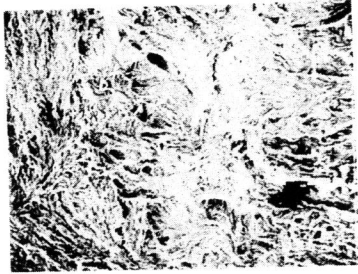
Plate 8 : B1 x 150, extensive fan-shaped cracking in a HAZ specimen.
