On The Way to Fracturedom

A. K. DAS

*Aircraft Design Bureau, Hindustan Aeronautics Limited,
Bangalore-560 017, India*

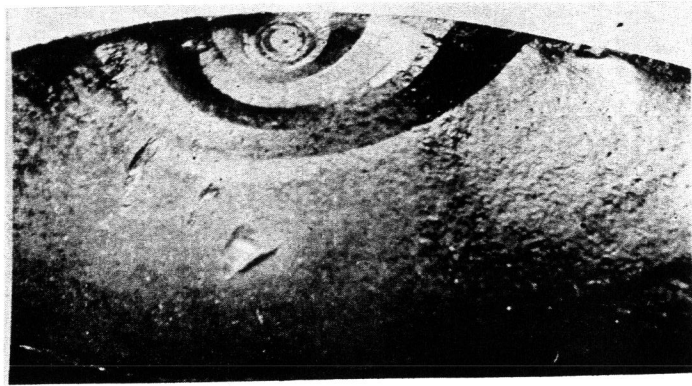
Fig.1 *A fascinating butterfly in a deflecting posture. X 1*

The above fractographs present here two such classical dances of propagation by fatigue event, leaving their marvellous imprints around the zone of initiation on the fractured surfaces of two critically loaded steel components.

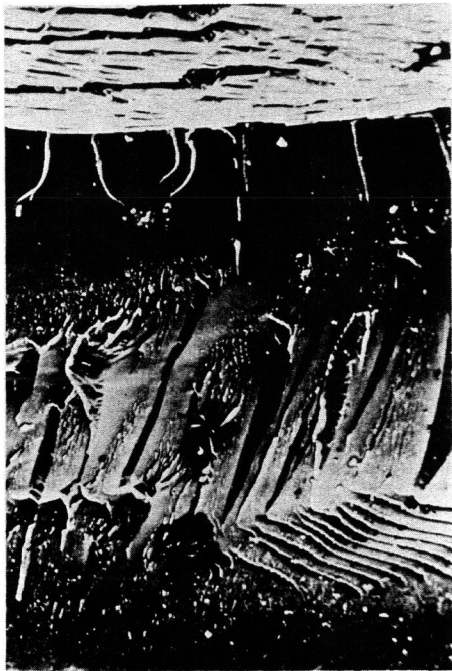
Fig.5 A unique composition of an enraged vulture formed through the stepwise (cleavage) fracture mechanism in a cast perspex (polymethyl methacrylate) material when subjected to tensile impact load. X 30

The above is a classic showmanship of the art during SEM examination of a broken perspex with the flying view of a bird coming down to the earth for a kill.

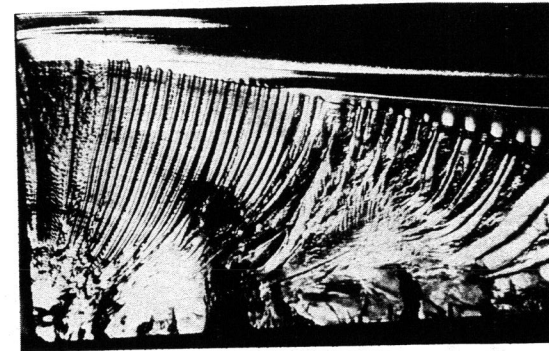
Fig.6 A display of unique creation of a perspex fracture deflecting the rare composition of a deep sea during its journey through fatigue cracking. X 70

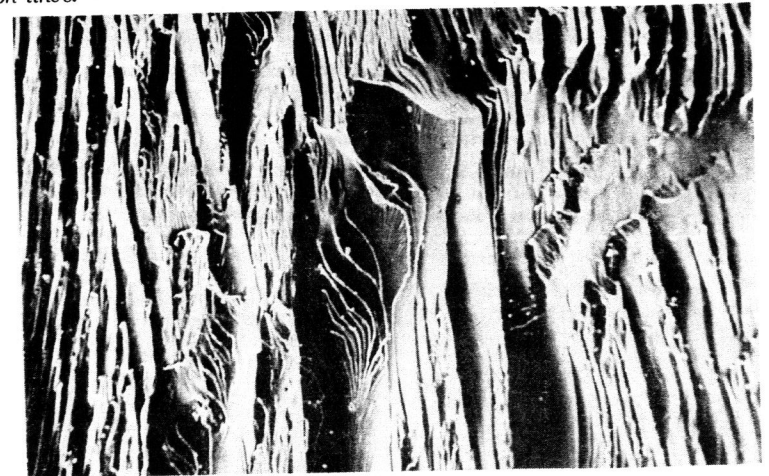
Fig.7 A fantastic resemblance of a typically hand made "Fan shape" structure formed during fatigue crack progression in a cast perspex while performing fatigue testing under 200 psi load condition. X 6

The fractograph shows that a polymethyl methacrylate type cast perspex under fatigue load cycle can create a gentleman like fracture, superimposed with light yet distinguishable signatures of slow moving linear crack fronts across the propagation lines.

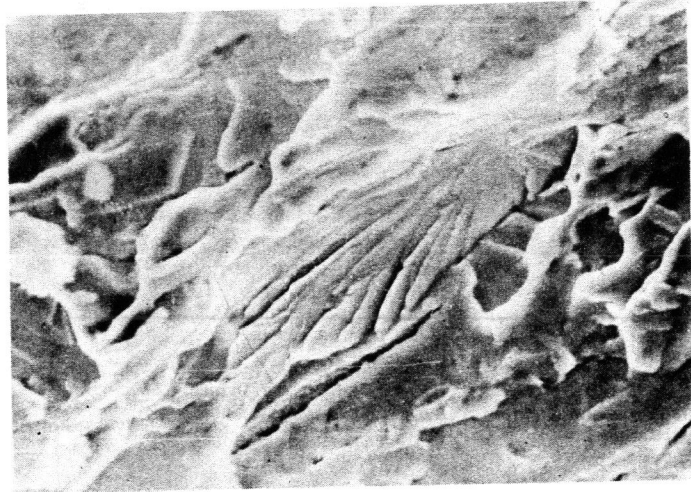
Fig.8 The shattered scenerio of a grim composition drawn out by the disintegrated profile of a non-metallic matrix during knock-off stage of a polymethyl acetate perspex material under the threat of a tensile impact load. X 30

SEM fractograph shows a row of long drawn bundles of pipes crumbling down fast under great flow stresses with signs of severe distortion and at the same time, bursting out the inner intricacies of the snapped off fibres.
