DETERMINATION OF CORROSION CAUSES IN INTER-SUPERHEATED PIPING

ABSTRACT

This paper introduces results obtained from examination of corrosion appearance in inter-superheated piping. A crater-type corrosion has been registered within a considerable number of inter-superheater steam pipes (primary inter-superheater), located on lateral area relative to pipe, which are arranged horizontally in 22 rows. Crater-type deterioration is cone-shaped with a diameter 8-12 mm for inner tube surfaces, and 3-6 mm for outer surfaces. Damages are distributed individually over a major part of the pipe surface area. Corrosion products have been reported around damaged area of the inner tube wall surface. For determining causes of damage, optical and scanning electron-microscopy (SEM) has been carried out.

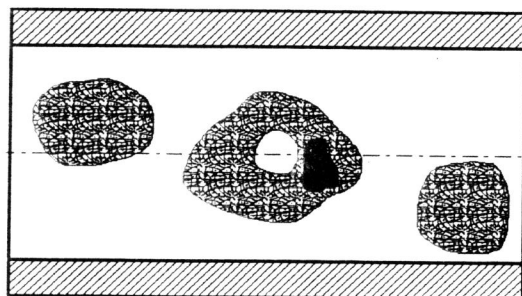
Pipes of the primary inter-superheater system, arranged horizontally in 22 rows, mainly on the lateral pipe side, corrosion appeared in the shape of singular cone shaped craters with diameters of 8-12 mm for inner tube surface and 3-6 mm on outer surfaces, Fig. 1. On the inner pipe side in the crater region, yellow coatings are visible. Corrosion deterioration occurred during a long standing period.

Fig. 1. Schematic view of corrosion damage

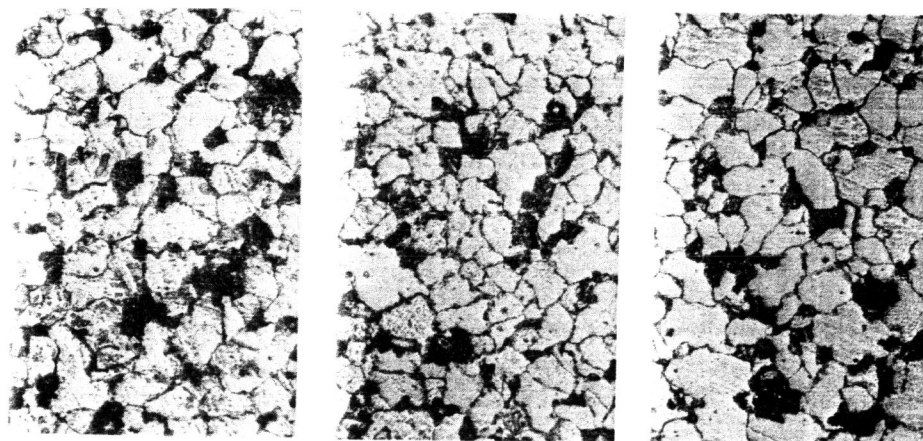
Figs. 3-5. Microstructures of corrosion areas

Order of presented microstructures respond to the following damaged area positions : Fig. 3 - near to the crater top, Fig. 4 - in the vicinity of the crater bottom and Fig. 5 - 5 mm collateral from crater. Basic structure is ferrite, but with complete degradation of the grain boundaries. Immediate

crater vicinity had not been observed due to great corrosion deterioration. Area 10-15 mm around the crater presents grain boundary degradation.

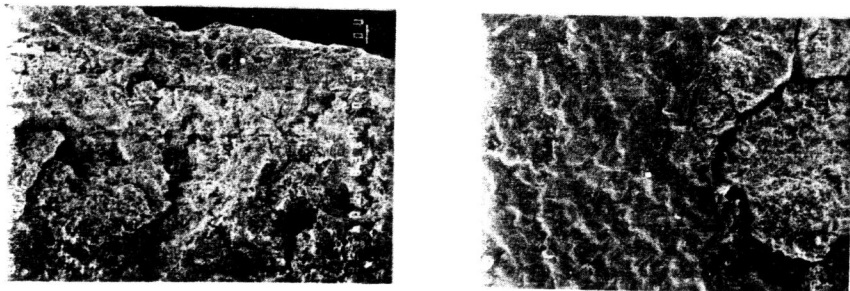
Scanning electron analysis and EDAX. It was necessary to conduct gold coating before SEM and EDAX analysis because crater area had heavily expressed corrosion products. Corrosion area around the crater is shown in Figs. 6 and 7, with typical intercrystal destruction.

Figs. 6 and 7. Intercrystal destruction with corrosion coatings

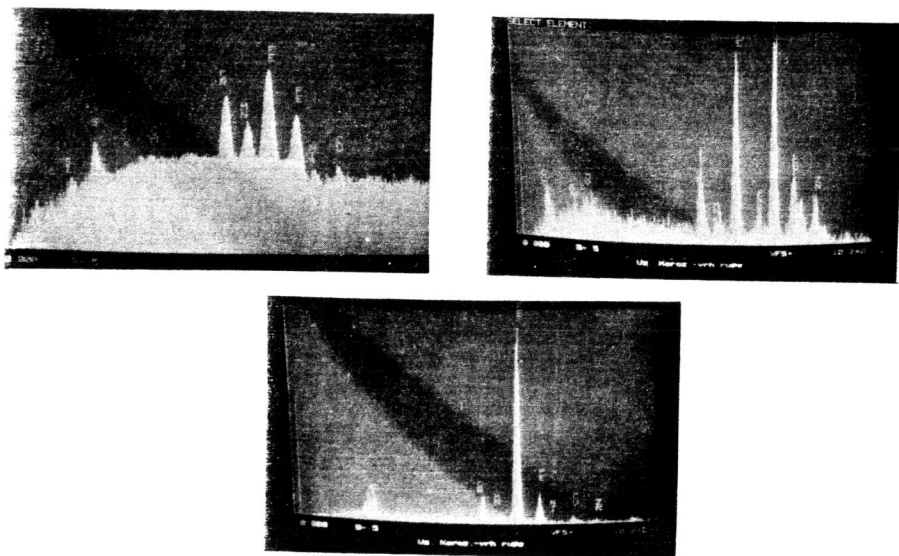
Respective EDAX analysis revealed the presence of: Si, S, Ca, Cr, Mn, Fe, Ni and Cu (Fig.8), Si, Mo, S, Cr, Mn, Fe, Ni, Cu and Zn (Fig.9) and S, Cr, Mn, Fe, Ni, Cu, Zn (Fig.10).

Figs. 8-10. EDAX from corrosion region

Copper and zinc presence inter-superheated steam pipeline was revealed by EDAX, Fig. 8-10. Very strong copper line, whose origin was not in material (lower amount than standard), as well as the zinc line, indicate that the particles, probably brass, were brought by working fluid into the inter-superheated steam pipeline system. Further analysis presented that primary water heater, made of brass, was possible particles source. Inquiry confirmed that inner surfaces of brass water heater are visibly damaged by erosion abrasion. Independent of the physical separation of primary water heater and primary inter-superheated steam pipeline, small brass particles, were infused by the working fluid in steam boiler. Beside the steam boiler has the filtering mechanism, it is possible that the particles smaller than 5mm reach the inter-superheated steam pipeline system and stop irregularly on the pipeline wall.

The possibility for that of corrosion appearance, could be minimized, if the inter-superheated steam pipeline system conservation had been done correctly. Considering that the damages perforates the pipe wall, serviceability of this super heater system until repaired.
