# HYDROGEN EMBRITTLEMENT OF METALS IN THERMAL POWER STATION WATER-STEAM CIRCUITS

A.B. VAINMAN

## ABSTRACT

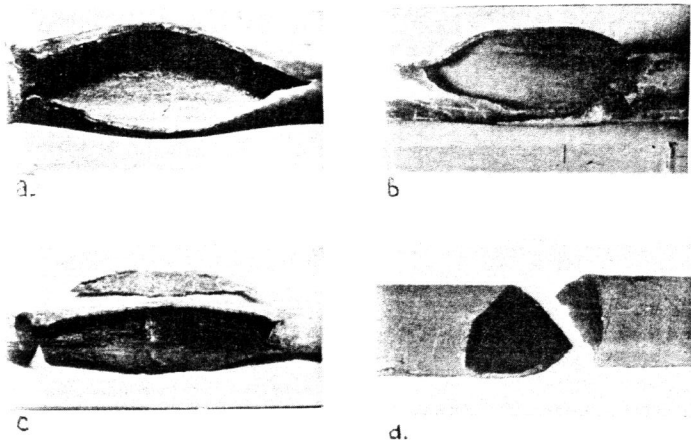
Evaporating Pipes. External appearance of evaporating pipes experienced hydrogen embrittlement is presented in Fig. 1, metal structure and crack mode in the fracture region are presented in Fig. 2. Metal hydrogen charging (steel - 20 or 12 Cr 1 Mo V steel) usually runs in the localized areas of "vapor phase delaying". These are:

Fig 1 Typical fractures (external appearance) of 15.5 MPa boiler evaporating pipes exposed to hydrogen embrittlement; operation time: a - 12,000 hours; b - 19,000 hours; c - 22,000 hours; d - 46,000 hours.

As a rule the pipe edges in the fracture region are blunt, torn and laminated, the pipe wall thinning is slight. Often and often two regions can be distinctly observed: the wide (50 - 90% of pipe wall thickness), rough and dark-coloured region of hydrogen embrittlement on the inside of the pipe and the smooth, light-coloured region of mechanical ductile failure on the

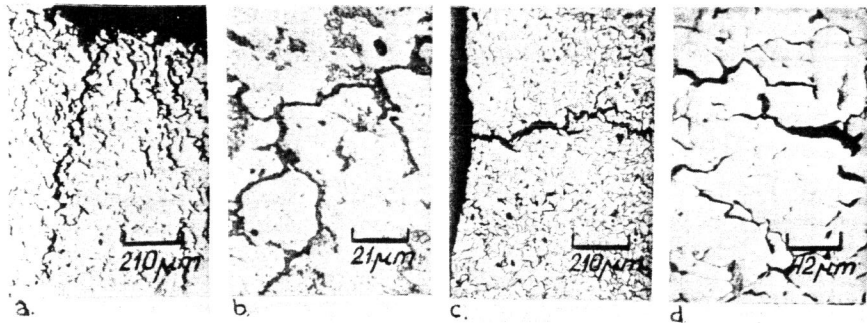
Fig 2 Crack propagation and metal structure in the hydrogen embrittlement region: a, b - the pipe is shown in Fig. 1, a; c, d - the pipe is shown in Fig. 1, b.

- c. partial or complete steel decarburization (Fig. 2);
- d. no metal overheating;
- e. high concentrations of residual hydrogen exceeding the initial ones for the given steel quality by 1 - 2 order (Vainman, 1985; Vainman and Melekov, 1988; Vainman et al., 1990). The volume hydrogen content has been determined by inert gas specimen melting (Leco RH-1 gas analyzer). The hydrogen distribution in the fracture region has been measured by Echo 4 M lazer mass spectrometer (Ukrainian Institute of Electric Welding) (Fig. 3). The fractography of metal exposed to hydrogen embrittlement confirms the brittle nature of intercrystalline cracks, the partial or complete dissolution of cementite platelets in pearlite grains (Fig. 4, a-b). The mechanical failure region shows the ductile fracture with the cup-shaped and comb-shaped profiles (Fig. 4, d): The essential recommendations for the prevention of the evaporating pipe hydrogen embrittlement: steam boiler design should provide for its service with heat flows far from critical over a wide range of loads; decrease in maximum heat flows ( $q$ ) and their even distribution; potentially acid organic compound detection and prevention of their ingress into the feed circuit; use of nonvolatile alkali (sodium hydroxide) for correction of boiler water conditions and for boiler water pH maintenance (if necessary); application of internally spiral-finned tubes in the regions of very high heat flows ( $q$ ) and in the areas of "vapor phase delaying".

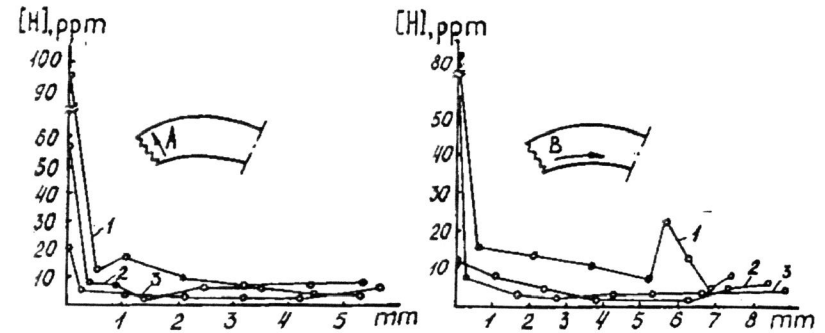
Fig 3 Hydrogen distribution in metal of 14,0 - 16,0 MPa boiler evaporating pipes (1, 2, 3): A - in pipe wall thickness (near the area of fracture); B - in perimeter (on the inside of pipe)

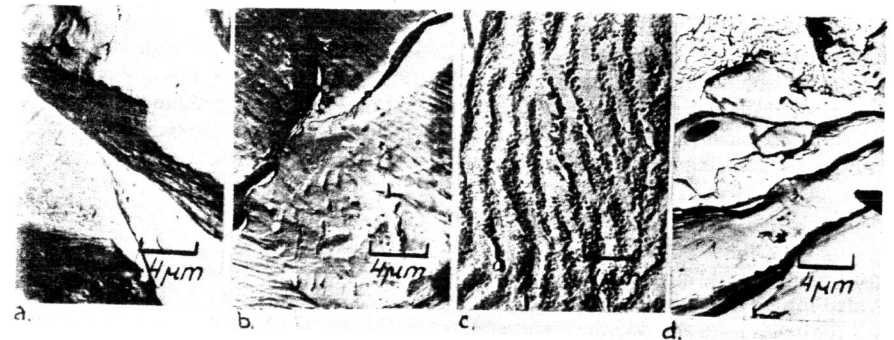
Fig 4 Evaporating pipe fractography: a - area of intergranular crack (embrittlement region); b - area of pearlite grains (crack region); c - area of pearlite grains (region perpendicular to cementite platelets); d - mechanical failure region.

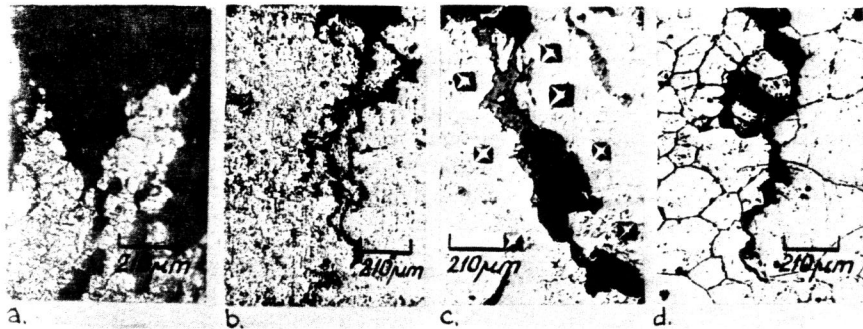
Fig. 5 Mode of pits (a) and cracks (b,c,d) on the inside of superheater pipes (a,b,c-12 Cr 1 Mo V steel, d -12 Cr 18 Ni 10 Ti steel)

for the superheater pipes of austenitic steel (1 Cr 18 Ni 12 Ti, 12 Cr 18 Ni 10 Ti, 12 Cr 18 Ni 12 Ti) in the fracture regions. Under gas corrosion the intensive hydrogen charging and embrittlement of metal (pearlitic and austenitic steels) can also occur on the outside of the superheater pipes, especially when firing liquid vanadium-and sulfur-containing fuels, and with incomplete combustion products in flue gases including hydrogen sulphide. Besides, the principal causes of damages of the protective oxide films on metal surface for the superheater pipes are: accelerated steam boiler cooling after its shutdown; shutdown boiler filling with relatively cold water by the non-cooled superheater pipes; downtime corrosion of the undrainable superheater coils, especially with acid organic compounds in steam condensate; thermal shocks in forcing out the condensate from the vertical (undrainable) superheater coils during starting up the steam boiler, and also at the ingress of boiler water into the superheaters; temperature variations of the flue gases and the superheater pipe metal at the steam boiler starting and cycling; unstable operation of the automatic injection vapor coolers, damage of their jackets or condensate injection pipes; scale growth at load operation. Hence it is necessary to take account of correlation of metal damage processes at all stages, i. e. steam boiler shutdown, downtime, starting up and load operation, with reference to hydrogen embrittlement and brittle fractures of the superheater pipes.

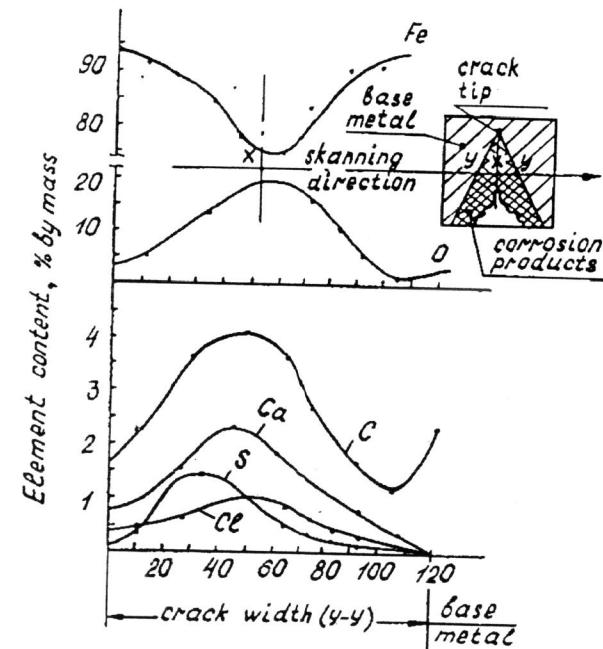
Fig. 6 Element distribution in section perpendicular to microcrack axis (Auger spectrometer linear scanning, crack is shown straight)
