CREEP DAMAGE OCCURRENCE IN AN INTER-SUPERHEATER STEAM PIPE AFTER 90,000 HOURS OF OPERATION

ABSTRACT

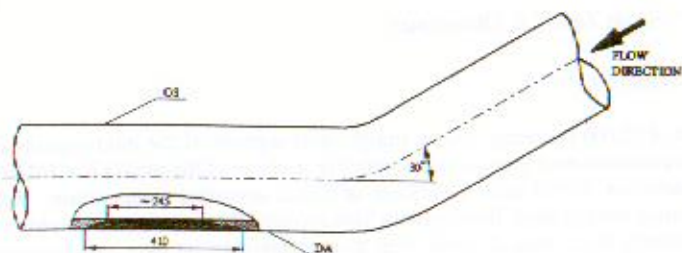
Failure occurred as a long axial crack on the bottom of the straight part of the 30° bend of the inter-superheated steam pipeline, Fig. 1. Crack propagated through the pipeline wall thickness, in length on the outer side of approximately 410 mm, i.e. 245 mm on the inner side. Pipeline, made of 14MoV63 steel (DIN17175), with dimensions $\phi 609 \times 25$, had been designed for exploitation life of 100.000 hours under service conditions 540°C and 45 bars, but its exploitation period to the failure was 90.000 hours.

Fig. 1. Schematic view of failure area

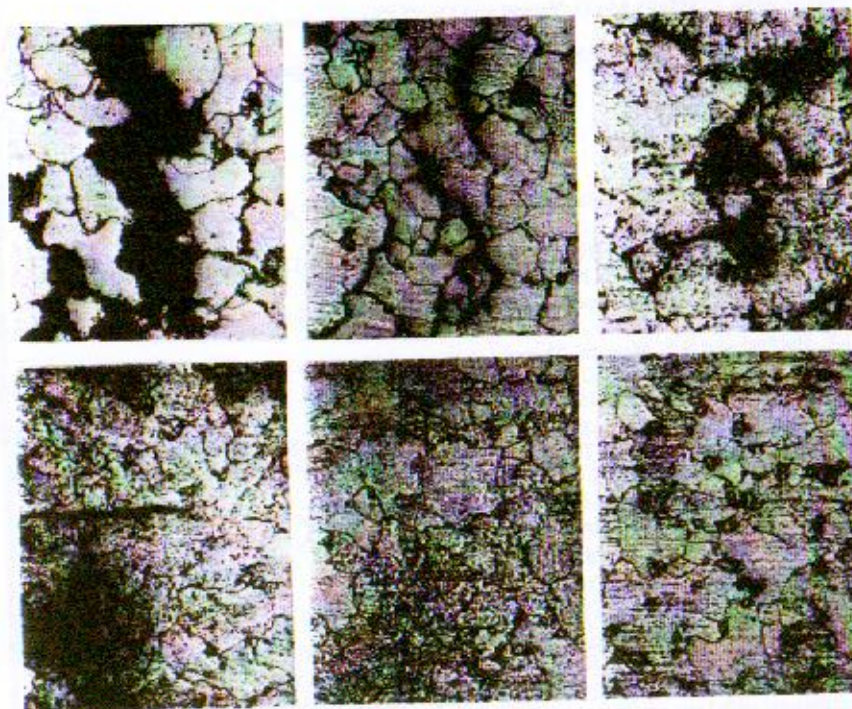
Metallographic analysis. Metallographic specimens, prepared in a common manner, taken from the damaged zone are presented on Figs. 2-7. The basic structure is ferrite, with lot of micro and macro cracks, cavities, extremely large population of different shape carbides, mostly in the grain boundaries, as well as a large number of different size of MnS inclusions, which are propagated through grains and grains boundaries.

Figs. 2-7. Structures of damaged area (500x)

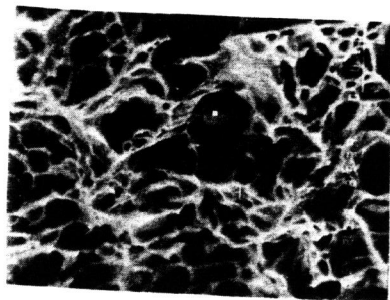
Scanning electron microscopy and EDAX. Fig. 8 shows the fracture features of toughness specimen, taken very nearby the crack. The fracture is ductile, some of the cavities are visible, as well as the inclusion, which is by EDAX analysis of silicate type, Fig. 9. Structure features, obtained by SEM analysis of specimens from damaged area, which are deep etched, are presented in Figs. 10-16.

Fig. 8. Fracture features of toughness specimen

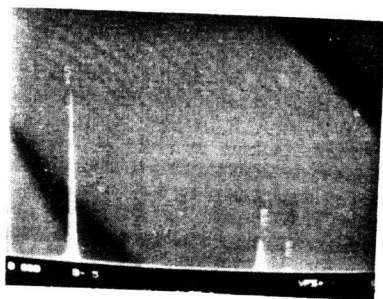
Fig. 9. EDAX of inclusion, silicate type

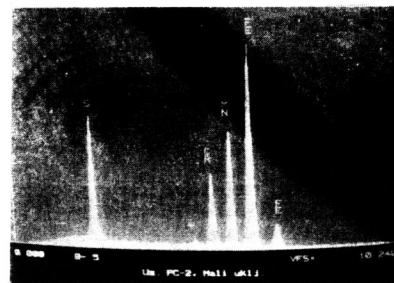
Fig. 14. EDAX from Fig. 13

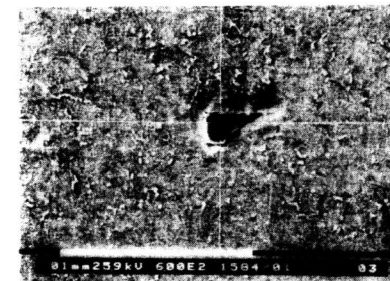
Fig. 15. Silicate inclusion, carbide, cavities, micro cracks

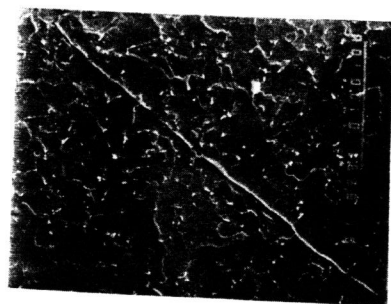
Fig. 10. Elongated MnS inclusion with cavities, many alloyed, different shape, carbides

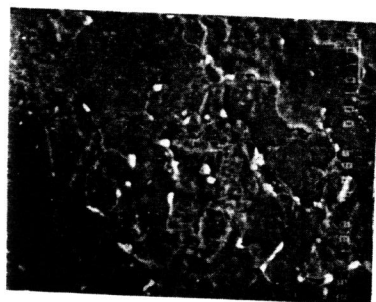
Fig. 11. Secondary microcracks, cavities, alloyed carbides

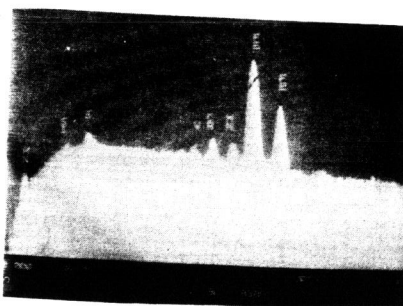
Fig. 12. EDAX from Fig. 11. Alloyed carbide with segregated MnS on its boundaries

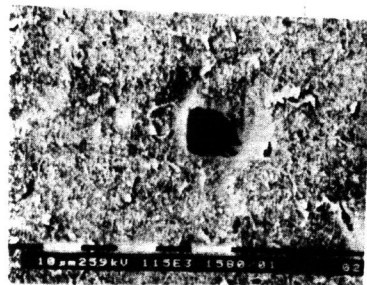
Fig. 13. Alloyed sulfide (MnCr)S, with micro cracks, cavities, carbides

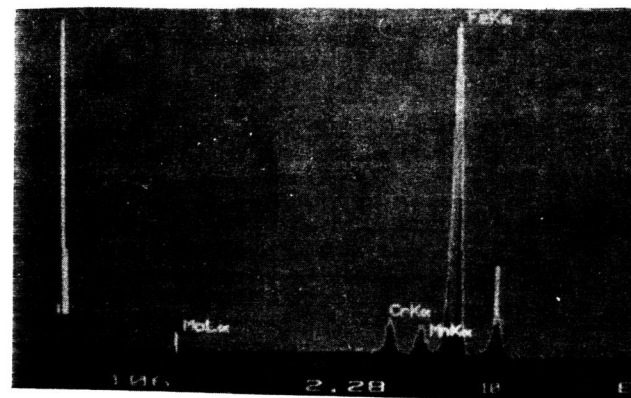
Fig. 16. EDAX of alloyed carbide particles from Fig. 11

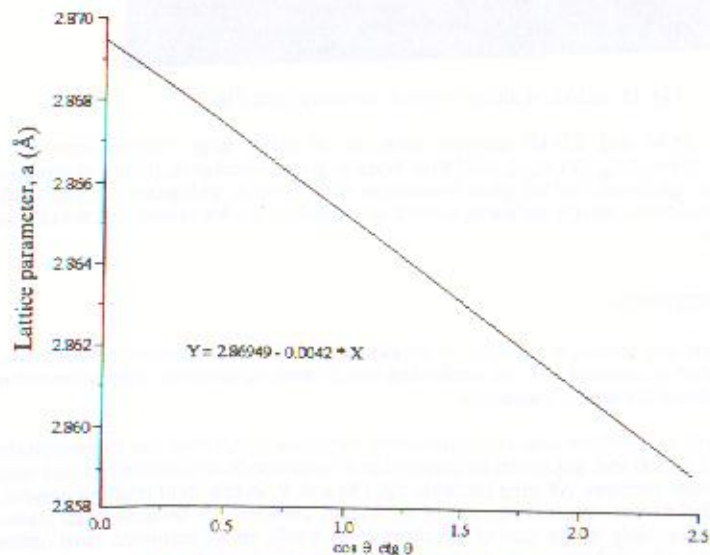
Fig. 17. Determination of true lattice parameter

Determination of crystal lattice parameter of solid solution, indicate unalloyed solid solution, as shown on Fig. 18, which means that measured lattice parameter is very close to the lattice parameter of the pure ferrite. Consequence of that is the decreasing strength characteristic at raised temperatures.
