METALLURGICAL AND TECHNOLOGICAL ASPECTS OF BRITTLE BEHAVIOUR OF TITANIUM ALLOYS

V.U. KLYACKINA and V.M. POLYANSKI

SPA "Composit", Kaliningrad, M.R., Russia

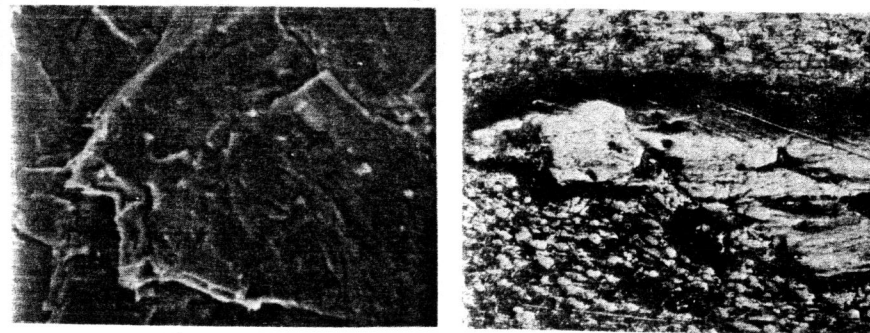
As a rule the ZIFs were of different colour against the background of the main fracture surface. The probable cause of this phenomenon is the unequal reflective properties of observed fracture places. For example on the fracture surface of spherical tank out of alloy BT6, which failed prematurely at the individual test, the ZFI has a coarse faceted relief (Fig.1a). Almost flat facets of this relief are typically of quasicleavage character (Fig.1b).

Fig.1. Microfractograph (a) and the microstructure (b) in ZIF of spherical tank out of alloy BT6.

Additionally there are many cleavage cracks in this zone. Microstructure here contains many light inclusions encircled by

dark pores and ribbonlike constituent. Microanalysis data show that light inclusions has the same contents of aluminium and vanadin as the base alloy but the dark ribbonlike constituent contained as much as 20%V. The sizes of light inclusion and of cleavage facets on fracture surface are about equal. On the microphotography (Fig.1b) cracks begin at the inclusions and continue in base metal. Defects of similar character have been found on fracture surfaces and in microstructure of prematurely failed during individual tests spherical tank and "cover" produced out of alloys BT23 and BT3-1 respectively. In ZFIs here also exist large quasicleavage facets and many cleavage cracks. The microstructure of metal adjacent to the ZFIs is formed of coarse plates and some areas appear as homogeneous α -phase. These features are characteristic for the layers with high concentrations of gaseous impurities. Indeed, the concentration of oxygen in the areas of the defects may reach up to 8-9%.

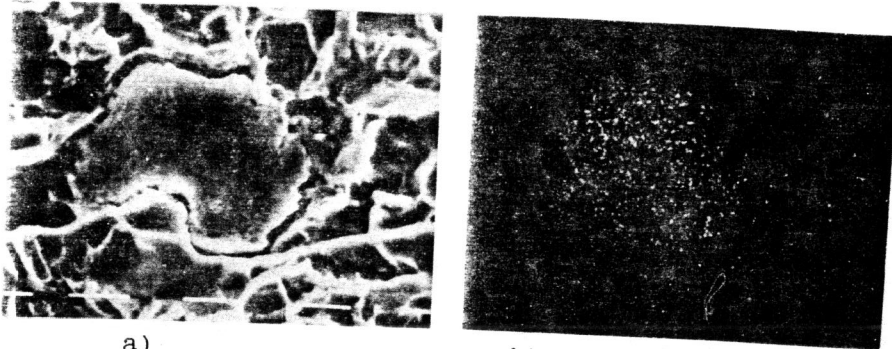
Next fact akin aforementioned failures is the case of low impact toughness in specimens out of alloy BT5-1KT tested at -253°C . The relief of their fracture surfaces was formed out of dimples of different sizes (Fig.2a) and is almost normal for ductile fracture. But in the some areas of surfaces have been detected increased concentrations of silicon, iron (Fig.2b) and tin.

a)
Fig.2. The microfractograph (a) and $\text{Fe K}\alpha$ X-ray image
b)
(b) of the same place of specimen out of alloy BT5-1KT.

Microstructure of the metal, adjacent to the fracture surfaces, contained inclusions of an iron rich phase along grain boundaries. The mean diameter of the inclusions is about 1μ .

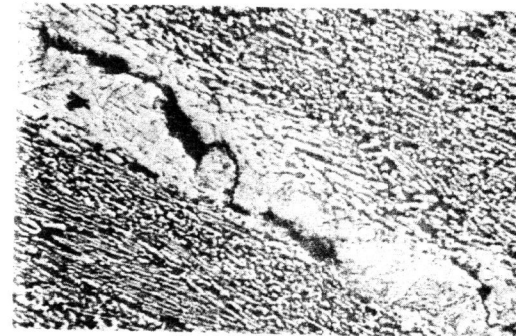
An alternative to presented afore premature failures is one which happened at the technological test of forged flange out of alloy BT3-1. Investigation in SEM in ZFI have been found dimpled relief but with elongated dimples. On polished section square to the fracture surface after etching was seen light structural constituent (Fig.3) of 45mm length. According to the microanalysis data it was very low alloyed ($\sim 98\% \text{Ti}$, $\sim 1\% \text{Al}$).

Its microhardness value was only 273 kpd/mm^2 whereas the same characteristic of base alloy was 360 kpd/mm^2 . The latter corresponds to the property of heat treated alloy BT3-1. In this case the light phase happen to be soft α -phase. Until now have been scrutinized alloys produced by usual ingot metallurgy (I/M). Further are presented results obtained for alloys fabricated by granule metallurgy.

Fig.3. The microstructure of the alloy BT3-1 in ZIF of the detail "flange".

In I/M alloys defects may appear both during smelting and processing, especially by rolling and forging. Typically metallurgical defect is one in flange out of BT3-I. Because of poor mixing of raw materials in a charge there was not achieved uniform distribution of the alloy's components in primary ingot and following heats at all stages of processing. Just in this case preserved large area of the almost unalloyed titanium with the ultimate stress much less than the rest of the alloy has. The case may be called ductile "embrittlement" inasmuch such characteristic as a rupture stress is much lower than admissible one but all microstructural features of the fracture surface are essentially ductile. The defects of the sort are encountered rather often (Borisova et al, 1980).

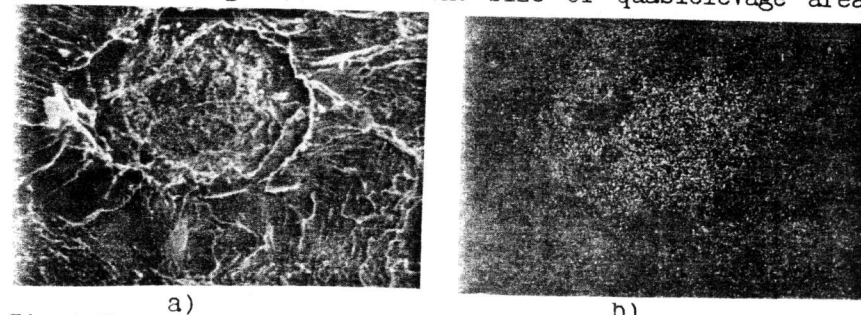
On the fracture surfaces of specimens of embrittled G/M alloys, were met defects which look out like a particles or their imprints on the inspected surfaces. This is true both for model and commercial G/M alloys. The particles imprints are encircled with areas of quasiclavage appearance (Fig.4a). The real inclusions were of different nature: SiO_2 , CaO , Fe , Ni , Cu or granules of another titanium alloy. In quasicleavage areas by microanalysis always were discovered elements contained in the inclusions (Fig.4b). Hence the size of quasicleavage area in

a)
Fig.4. The microfractograph (a) and $\text{NiK}\alpha$ X-ray image
b)
(b) out of G/M BT5-1KT alloy.

each case may be admitted as a measure for diffusional zone's length.

If not admittedly, inclusions get in commercial alloys at different stages of production but always at solid state of granules or their compacts. Diffusion of constituent elements in titanium alloy take place during hot working and heat treatment. High concentrations of such elements within diffusional zone stipulate embrittlement of alloys and premature failures of specimens and machine parts.

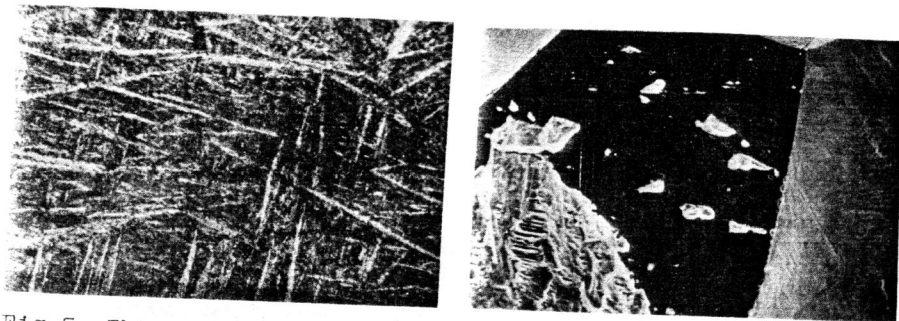
Yet another aspect of brittle and in a sense premature failure occurs in creep tests. If $(\alpha+\beta)$ - alloys are quenched from β -region they acquire coarse grained Widmanstedt microstructure (Fig.5a). After proper ageing the alloys achieve the high strength. In our work has been investigated creep behaviour of $(\alpha+\beta)$ alloys BT14 and BT23 at room temperature. The alloys were quenched from 950°C (β -region) or from $(\alpha+\beta)$ region (910°C -BT14; 800°C -BT23) in cold water and then aged: former-at 620°C , 2h; latter - at 525°C , 10h.

Specimens of alloys quenched from high temperature and aged showed at constant stresses near yield stress very low creep rate and failed after very small elongation. In macroscale the fracture surfaces were approximately perpendicular to the tensile stress. They were formed of rather big quasicleavage facets going along grain boundaries (Fig.5b). The same is true for specimens tested after some sustained loading in tension mode till a rupture.

Fig.5. The microstructure (a) and microfractograph of the specimen out of alloy BT23 (HT: 960°C , 1h + 525°C , 10h) ruptured after creep test.

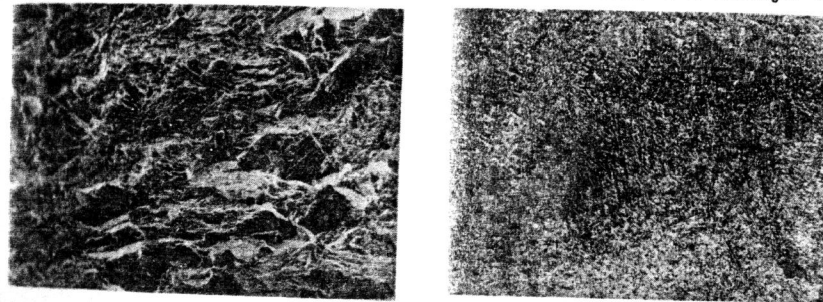
The opposite effects were demonstrated by specimens aged after low temperature quenching. The creep rate in these cases was rather high and the creep deformation of specimens at the time of a failure was approximately equal to the elongation fixed in tensile tests of specimens in the same conditions. The fracture surfaces of these specimens were also faceted but the

transkristalline (Fig.6a) and oriented at about 45° to the tensile axis. The microstructure of the specimens was of basket weave type (Fig.6b).

Fig.6. The microfractograph (a) and the microstructure (b) of the specimen out of alloy BT23 (HT: 800°C 1h + 525°C 10h).
