# DESIGN ANALYSIS AND VALIDATION FOR A BONDED COMPOSITE REPAIR TO PRIMARY AIRCRAFT STRUCTURE

L.R.F. ROSE

*Aeronautical and Maritime Research Laboratory, Melbourne, Australia*

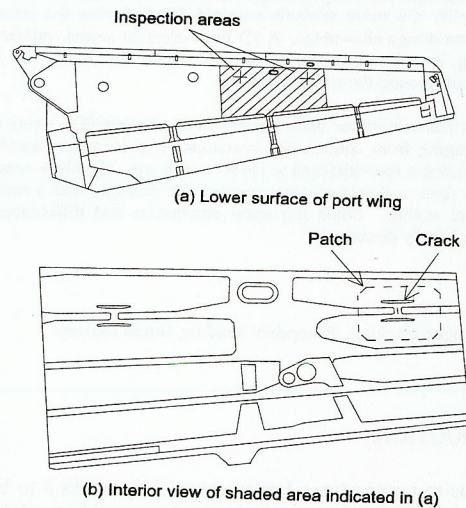
**Figure 1** Location of cracking on the F-111 lower wing-skin, at FASS 281, showing also the outline of the repair patch.

Figure 1 indicates the location of cracking on the lower wing-skin. The shaded areas indicate raised portions which serve as integral stiffeners and as attachment lands for spars. The cracking occurred in an area lying below the forward auxiliary spar, at the

spar station FASS 281.28, where the thickness of the integral stiffener is reduced from approximately 8 mm to the nominal skin thickness (at this location) of approximately 4 mm (with the minimum acceptable thickness being 3.6 mm).

The purpose of this depression in the stiffener is to allow full fuel flow and drainage between adjacent bays of the wing-box fuel tank. Two side-stiffeners are used to compensate for the loss of spanwise stiffness due to this fuel-flow passage, as indicated in Fig. 1. These geometrical features lead to a significant stress concentration factor and to out-of-plane secondary bending at the location of cracking, as discussed in Rose *et al.* (1995).

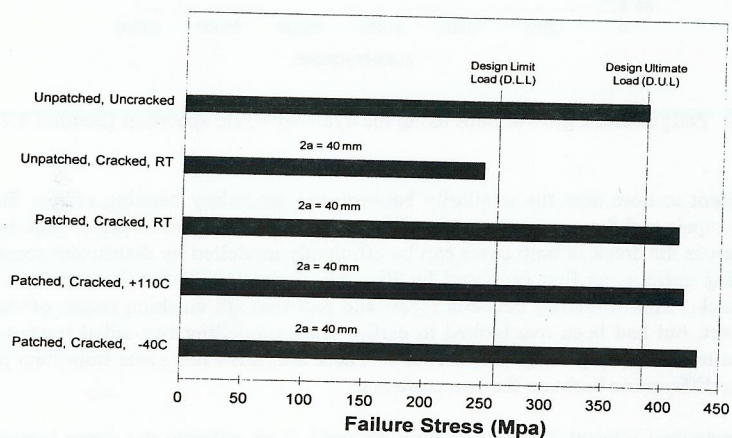
Figure 3: Results of static strength tests on panel specimens.

Figure 3 summarizes the static results on panel specimens. The notable features are the following:

- (i) The residual strength in the presence of a 40 mm crack is degraded to below the Design Limit Load, confirming the fracture mechanics prediction mentioned earlier (Section 1).
- (ii) Application of a bonded patch restores the residual strength to above the Design Ultimate Load capability. Indeed, it can be seen that the repaired strength exceeds the strength of an uncracked panel, even at the extremes of test temperature.
- (iii) The failure mode at room temperature (RT) and at low temperature (-40°C) involved simultaneous crack growth and fibre failure across the crack. This is consistent with the stress analysis results indicating a through-thickness stress concentration in the patch immediately over the crack.

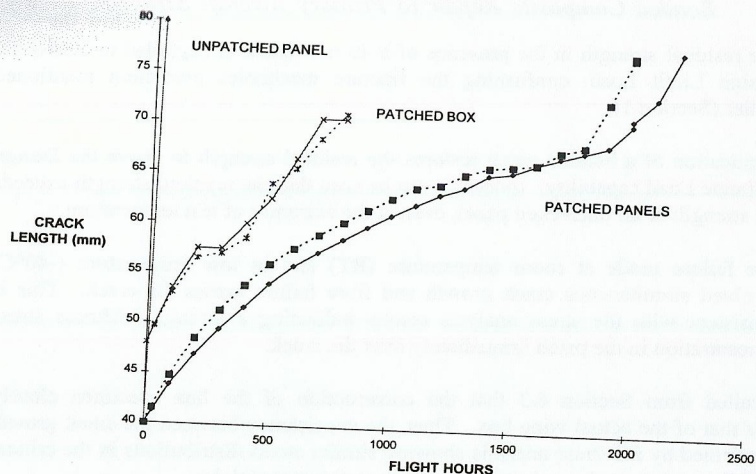
Figures 4 and 5 show the results obtained using the two load spectra described in Section 4.2. The important features are:

- (i) the residual life without a repair is very short;
- (ii) the crack growth rates after repair are very consistent, both between specimens of the same type as well as between the two types of specimen, taking account of the different initial crack lengths.

Figure 4: Fatigue crack growth rates using the blocked spectrum (Section 4.2).

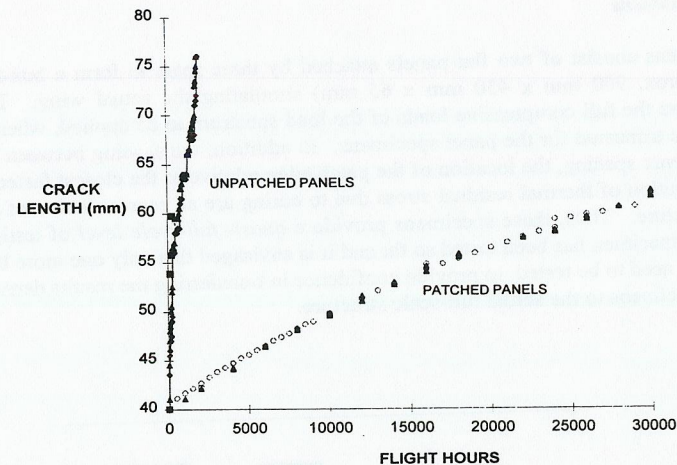
Figure 5: Fatigue crack growth rates using the cycle-by-cycle spectrum (Section 4.2).
