Analysis of fatigue mechanism in locked coil wire ropes by means of fractography

Jarmila Woodtli, Christian Hellwig

Swiss Federal Laboratories for Materials Testing and Research, 8600 Dübendorf, Switzerland

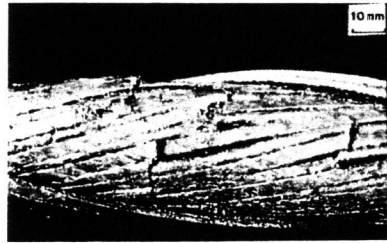
In all ropes investigated the cracks and breaks within the second layer were clustered together (s. Fig.2). Two configurations dominated: either in a circumferential direction (around the cross-section) or in a helical direction (along the contact line of the superimposed wire of the first layer).

Fig 2. Partly dismantled rope. View of the second layer with clustered cracks.

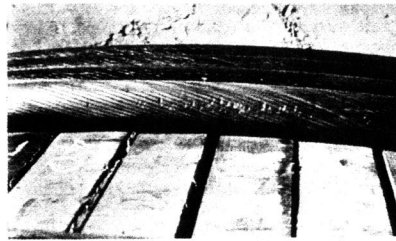
The indentations made by a file did not influence the service life of the wires significantly. On contrary, the indentations made by hammer or roller caused a severe reduction of the fatigue life. Some wires showed only 30% of the original service life. No significant differences could be observed between indentations made by a hammer and those made by a roller. Nevertheless, the reduction of fatigue life was more profound with indentation made on an unloaded rope. Of great importance was the location of the indentation with respect to the pulley: the indentation towards the pulley side suffered r fatigue damage earlier than that on the opposite side.

Fig 3. Damage due to hammering on the surface of the locked coil wire rope.

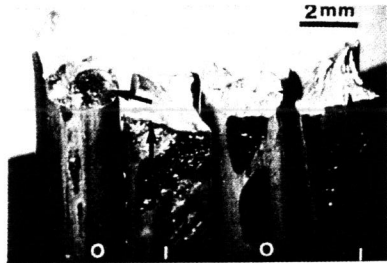
With few exceptions, the breaks appeared within the intensive wear zones. Typical for the 1 1/2x locked coil wire ropes were crack origins in the "I" wires on the surface facing the first layer, whereas the "O" wires showed crack origins mostly on the interface with the adjacent "I" wire (Fig. 4). The contact zones between "I" and "O" wires showed the typical structure of fluctuating compressive loading (s. Fig. 5). The hammered-like surface topography can be attributed to contact fretting with small lateral amplitude. On the other hand the contact areas with the "I" wires and "Z" wires e.g. between the 1st and 2nd layer showed distinct wear traces as typical feature of abrasive wear, as revealed in Fig. 6.

Fig. 4 Breaks in the 2nd layer. Arrows indicate crack origins.

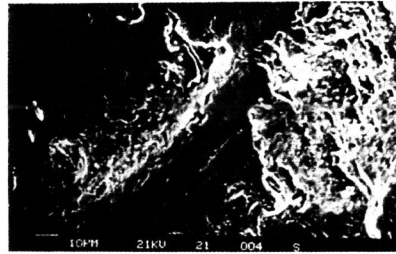
On the other hand, the fatigue nucleation in the "O" wires shows typical features of **fluctuating compression** loading with small lateral displacements. The hammered-like surface and transformation of the microstructure along slip planes into white etching areas in sub-surface zones (adiabatic shear bands) are typical for oscillating Hertzian stress with high vertical compressive component.

Fig.5 "O"-wire. Microscopic surface structure typical for fluctuating compressive loading.

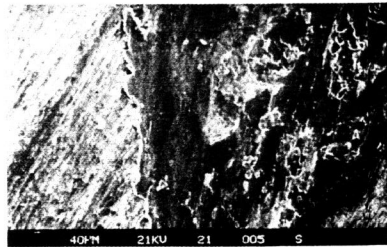
Fig. 6 "I"-wire. Microscopic surface structure typical for abrasive wear.

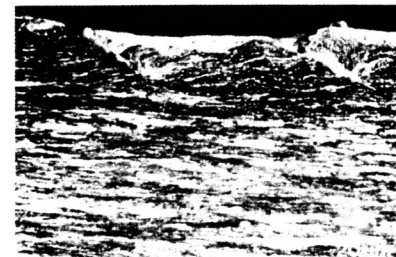
Fig. 7 "O"-wire: White etching areas, adiabatic shear bands. Longitudinal section.

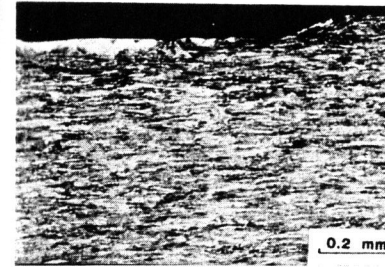
A detailed metallographic investigation was carried out on numerous longitudinal sections which were taken both from the prime fracture regions and neighbouring contact areas. An examination of these sections revealed formation of white etching areas in the subsurface region prior to fatigue cracks. Within the contact zones of the "O" wires the formation of white etching areas predominantly appeared along the shear planes as shown in Fig.7. The crack origin sites in the "I" and "Z" wires from the second layer showed a severely worn surface as a result of frictional wear which was also accompanied by the creation of white etching areas. The typically rounded shape of the layer of white etching areas in an "I" wire is shown in Fig. 8.

Fig. 8 "I"-wire: White etching areas within abrasive scar. Longitudinal section.

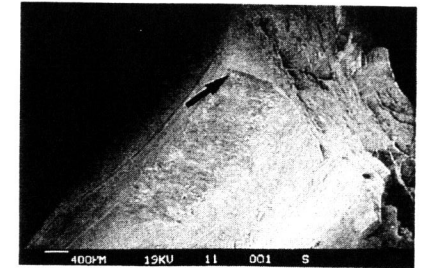
The fractographic investigation of the fatigue fractures in the Z-wires showed, that the crack initiation took place predominantly sideways to the damaged zones at the contact with the neighbouring wire in the same layer. In these zones displaced material from the indentation was pressed against the neighbouring wire. In some wires the crack initiation took place at the interface with the wire from the second layer which was altered by the impact. As Fig. 9 reveals, there was always a remarkable fretting scar which was promoted by the material displacement caused by the plastic flow near the indentation area. The indentations made by a file did not cause any material displacement by plastic flow. Therefore no reduction of service life was caused by these indentations.

Fig. 9 SEM-micrograph of a broken wire with fretting scar at the side of the indentation. Crack origin at fretting scar (arrowed).

To avoid the intensive fretting in the vicinity of the damaged zones, the displaced material was totally removed by grinding prior to the fatigue test. Since the thickness of the grinding disc was greater than the space between the wires, the restored wires suffered a reduction in cross-section. Such reduction in combination with local notch (grinding slot) caused a reduction in fatigue life. A deeper grinding slot led to a reduced service life due to early crack initiation by enhanced local stress.

Another palliative approach was the use of regular local relubrication within the area, where the lubricant was squeezed out. This measure was very successful since the initiation of fatigue was significantly delayed.
