Investigation of Corrosion Assisted Crack Growth in an Intermediate Size Pressure Vessel at Elevated Water Temperatures

Kusssmaul, K., D. Blind, R. Gillot, and W. Burr, MPA Stuttgart

3rd International Conference on Biaxial / Multiaxial Fatigue, April 3 - 6, 1989, Stuttgart, FRG

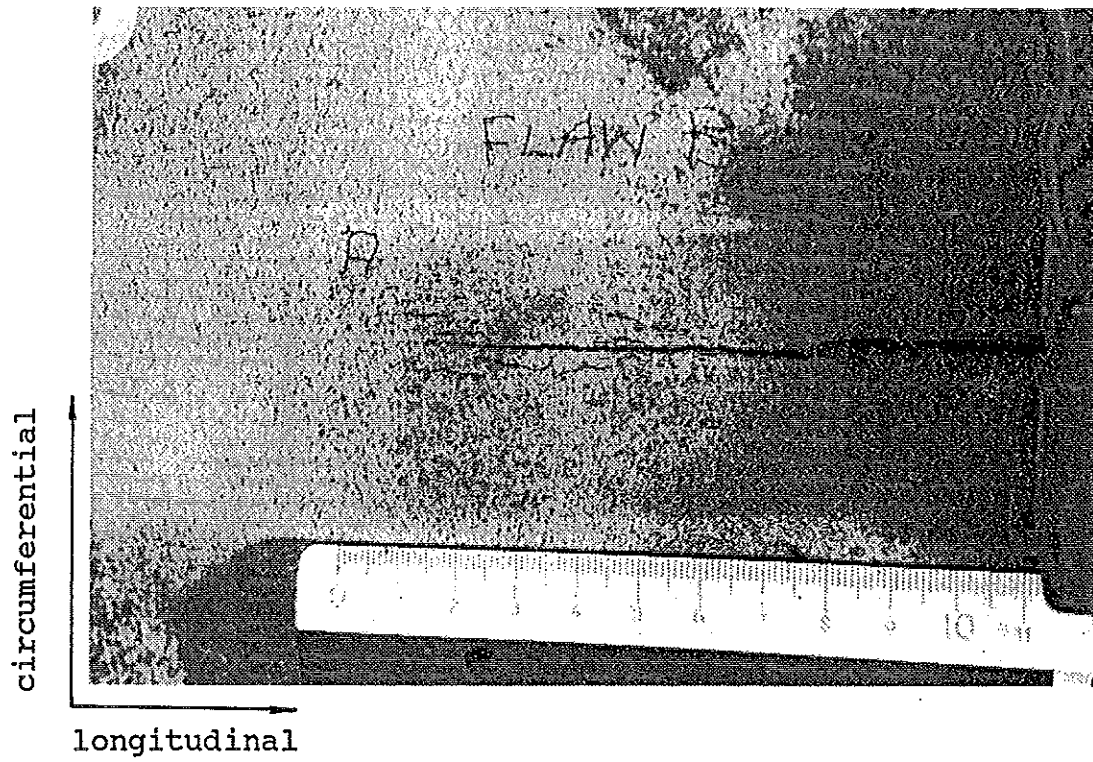
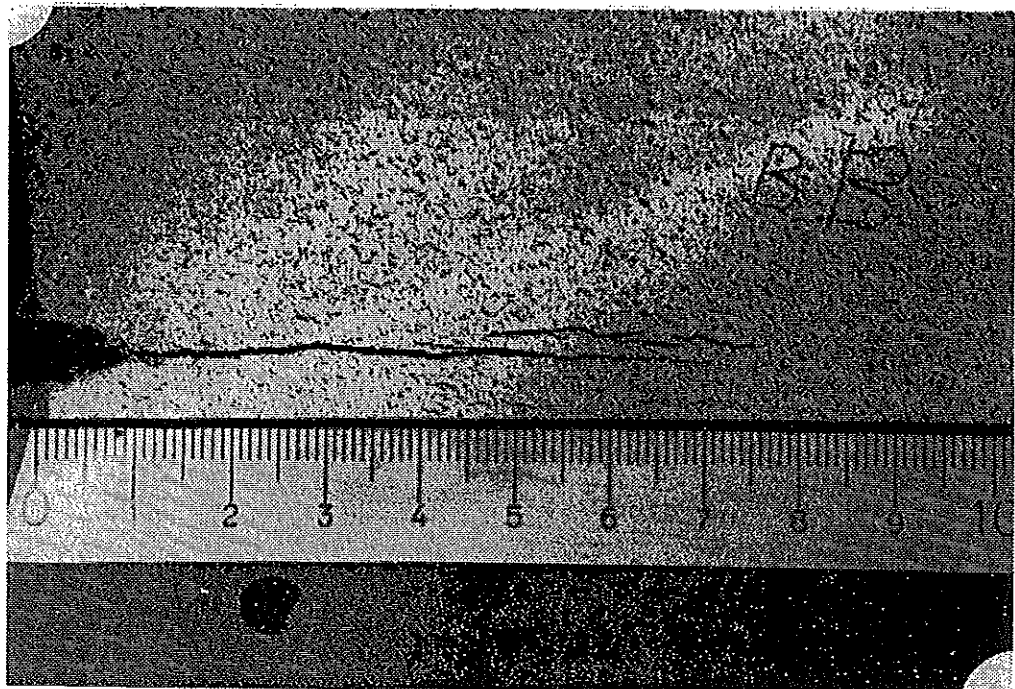
Fig. 3 shows flaw B at the end of the test after 28.348 load cycles /4/. The flaw grew approximately 65 mm on each side in longitudinal direction. Several secondary cracks parallel to the main crack path can be seen in the second half of the crack propagation, this corresponds to the test temperature of 288°C. In addition, the effect of corrosion is evident by the large number of cavities on the inner surface of the vessel.

According to Fig. 3, the crack propagation in longitudinal direction occurred on a straight path. This is also true for the propagation in the radial direction, Fig. 6. Especially at the location of hydrotests there is a tendency for small secondary cracks, which in most cases branched off the main crack path in an angle of 20 to 30° and in no case exceeded a length of 0,4 mm. It is of special interest that the branching started symme-

Fig. 3: Crack growth of longitudinal flaw B after 28.348 load cycles
(end of test)
top: left side of flaw B, bottom: right side of flaw B

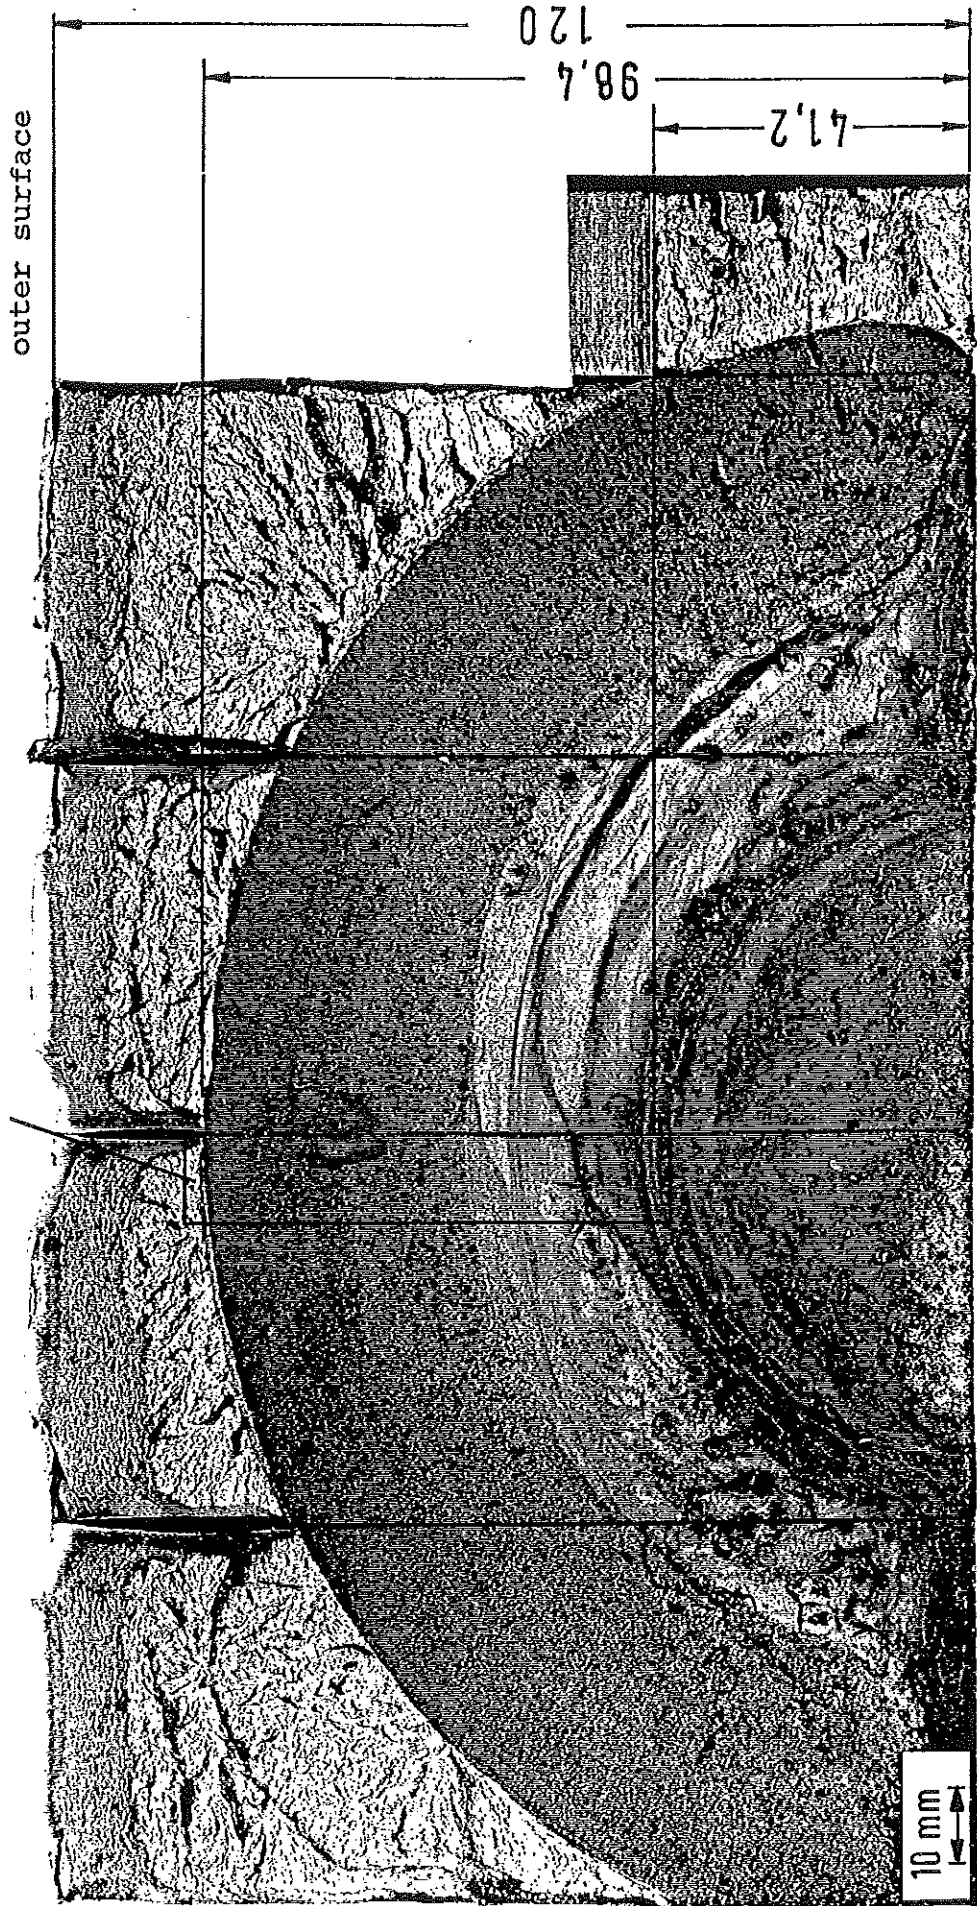
After the test, flaw B was saw-cut into several sections and opened, Fig. 4. Starting from the center of the flaw the first two semi-elliptical crack fronts are the tip of the machined and prefatigued notch, resp. The adjacent bright portion of the fracture surface is the result of the cyclic loading at 60°C, the loading at 288°C caused the crack growth demonstrated by the outer, dark grey section.

Fig. 4: Fracture surface of longitudinal flaw B after 28.348 load cycles (end of test)

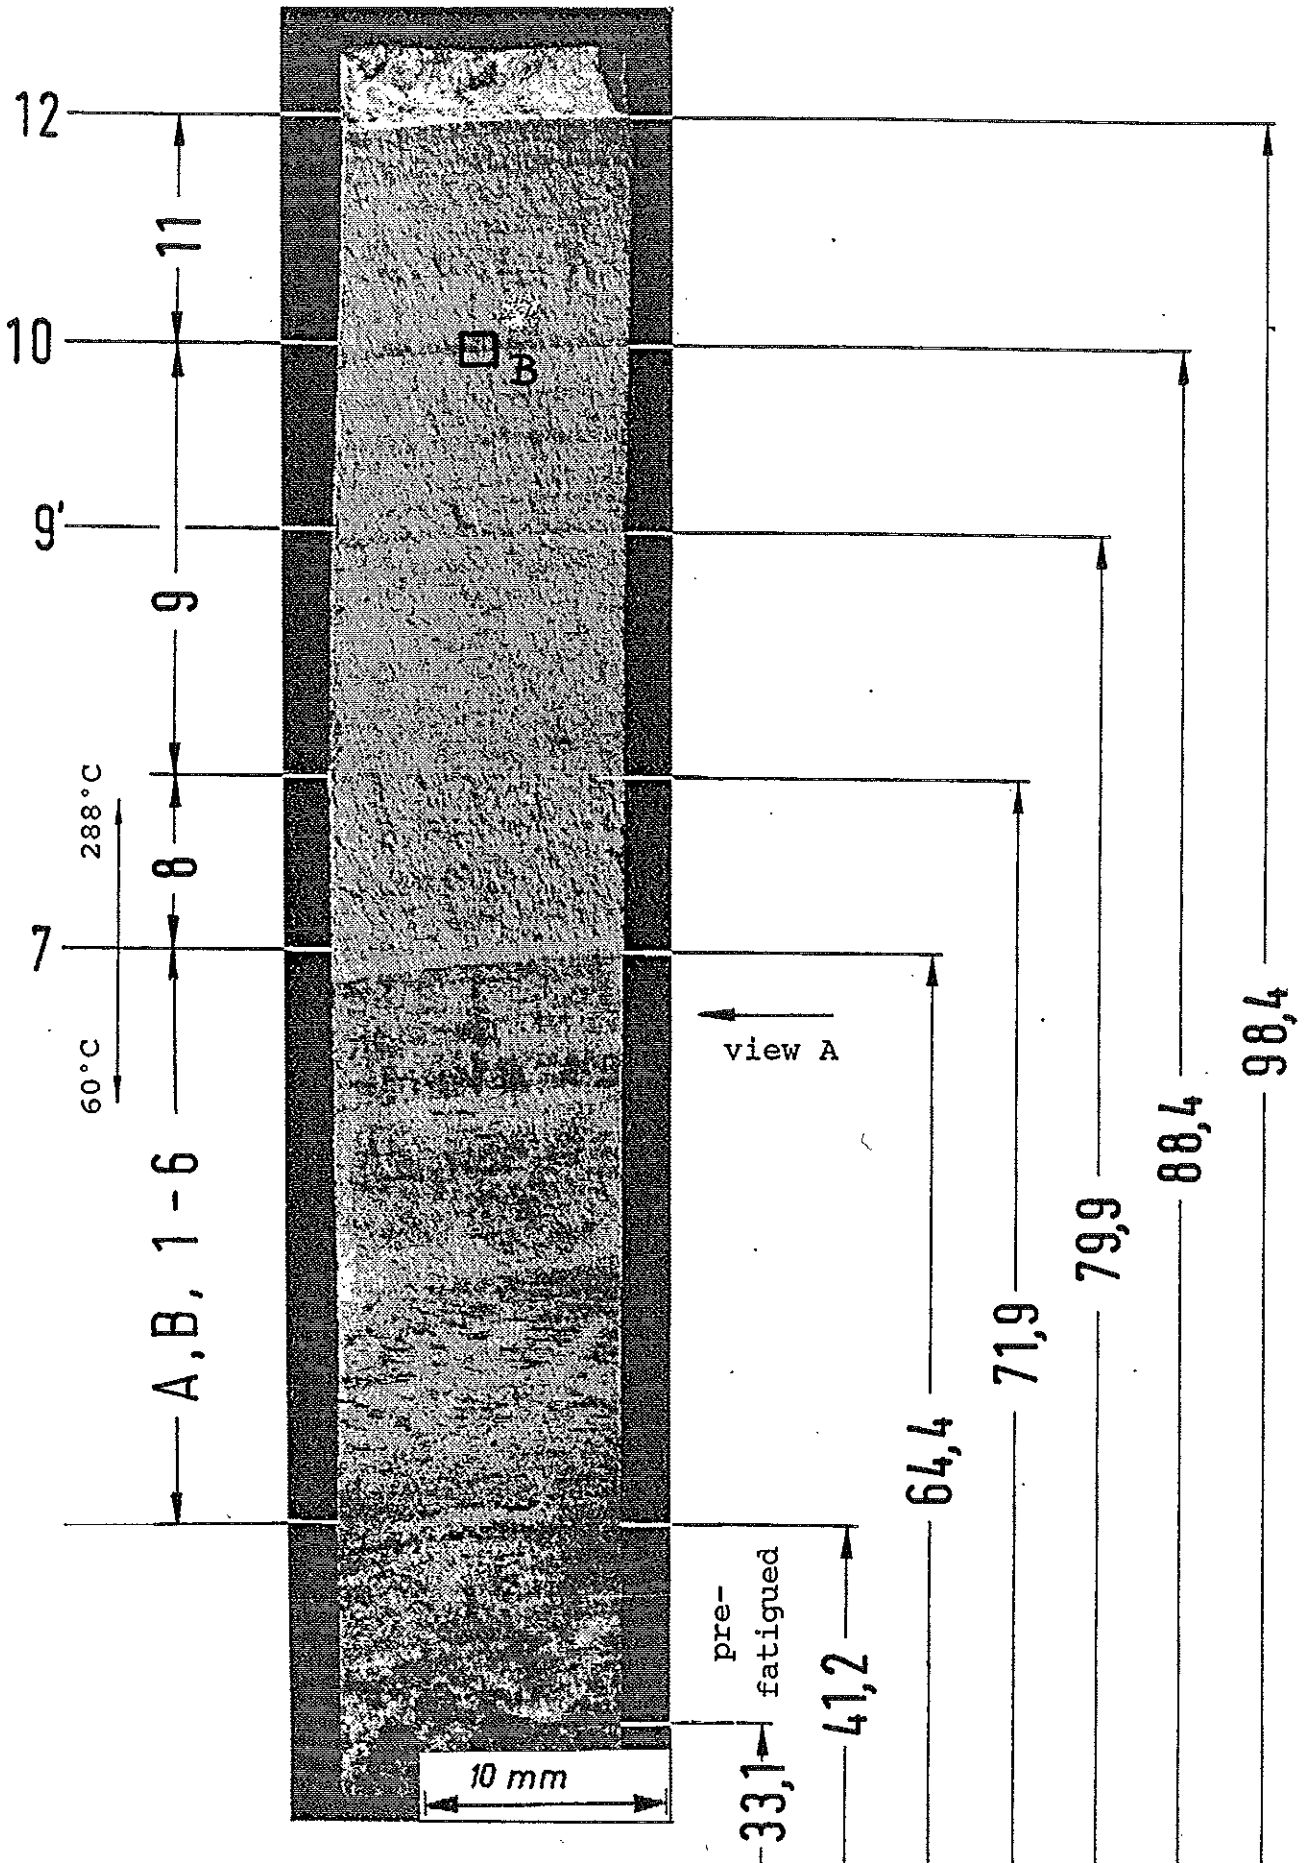
Section A of Fig. 4 is shown in detail in Fig. 5. The different load steps according to Fig. 2 are separated by clearly defined lines which were caused by stable crack growth during the hydrotests. With these marked crack fronts a reliable correlation between the different load steps and the crack propagation is possible.

piled in Table 1. One can see that at the end of the tests at 60°C (step 6) the calculated crack depth is 19% longer than the measured one according to Fig. 5. For the load steps B through 5 a reliable correlation between crack length and load cycles is not possible due to corrosion effects on the fracture surface.

Fig. 5: Section A of Fig. 4, total crack propagation

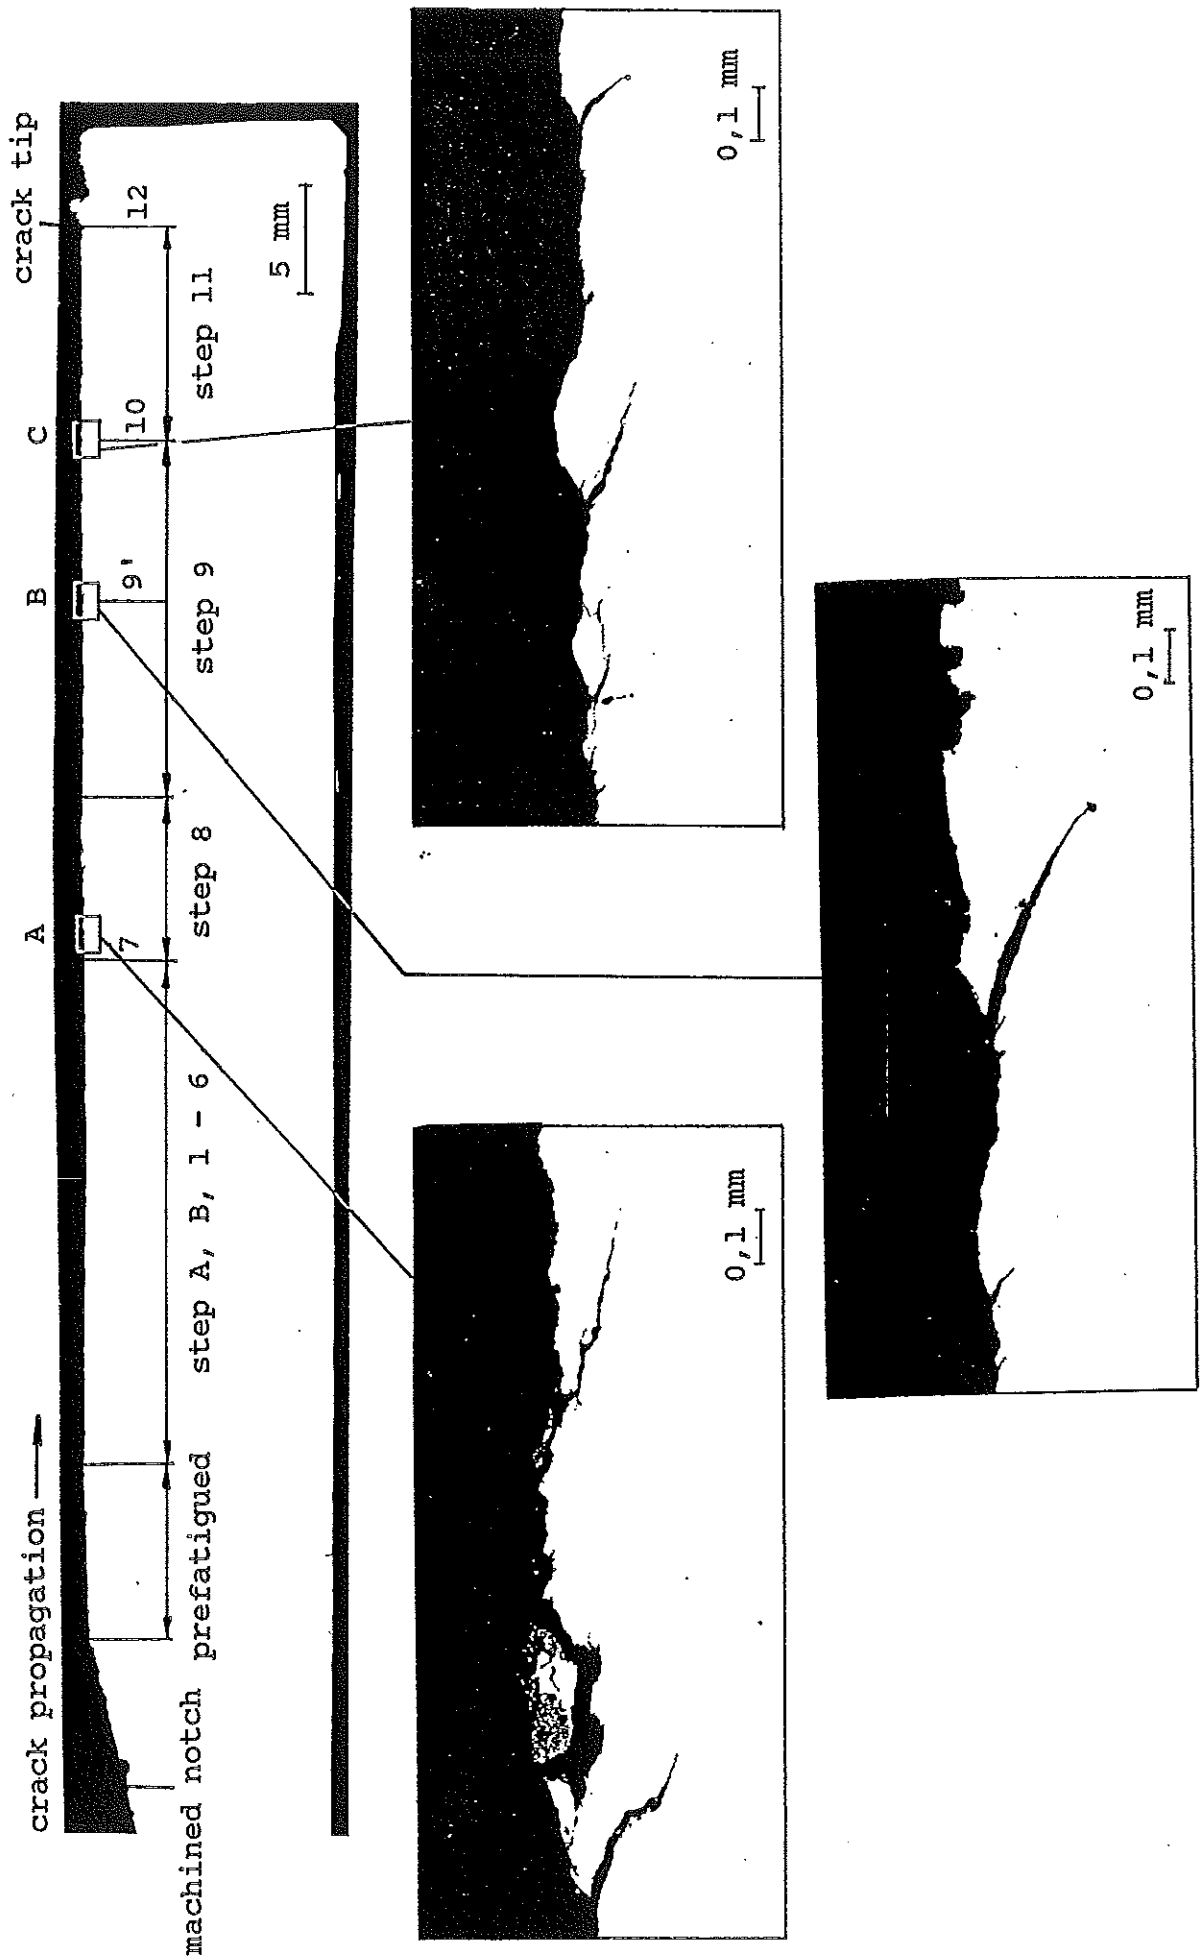
trically to both sides of the main crack, and that in most cases one, in some cases both cracks turned back to the centerline after a few tenths of a millimeter. At the fracture surface corresponding to a test temperature of 60°C no secondary cracks were found in any of the three flaws. The general direction of the main crack path is not influenced by these cracks.

Fig. 6: Crack propagation of longitudinal flaw B, view A of Fig. 5

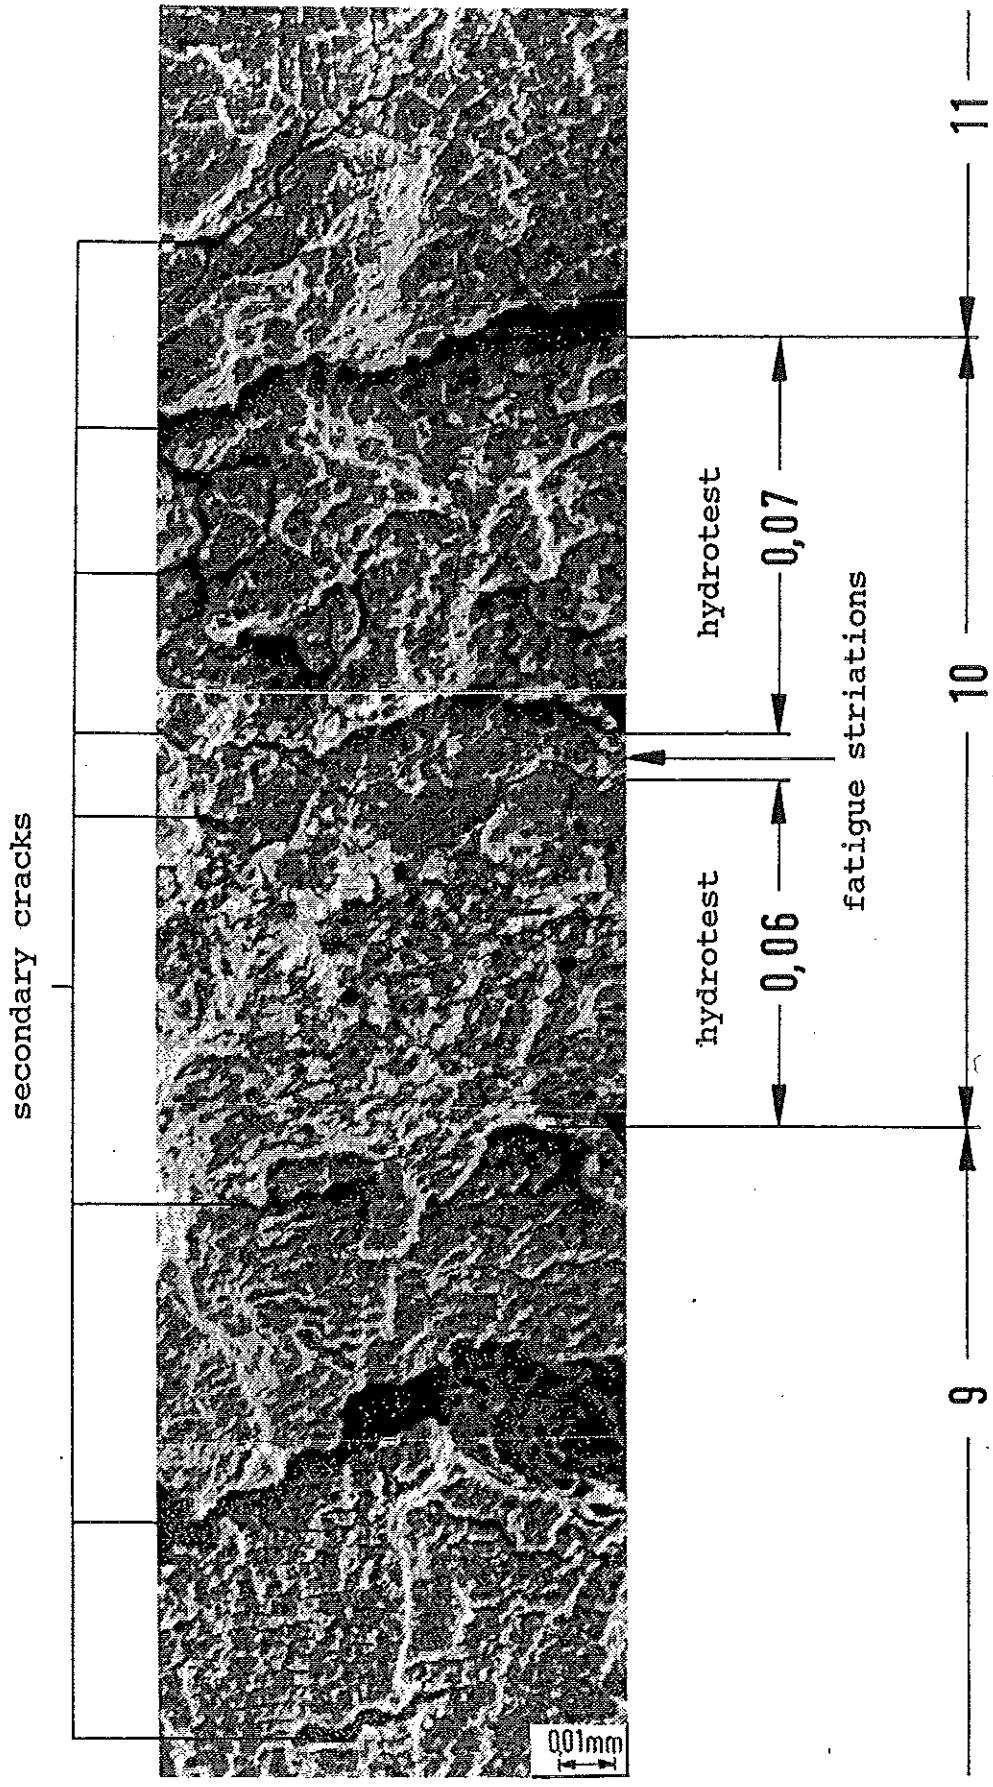
Fig. 7 shows a close-up view of the fracture surface at the end of load step 9 (288°C), the two hydrotests 10 (60°C), and the first cycles of step 11 (288°C). One clearly can see fatigue striations caused by the cyclic loading during steps 9 and 11. The two hydrotests, separated by ten load cycles, can be identified by a stable crack growth of 0,06 and 0,07 mm, resp. The secondary cracks on the fracture surface correspond to section C of Fig. 6.

Fig. 7: Section B of Fig. 5, crack growth during cyclic loading and hydrotests

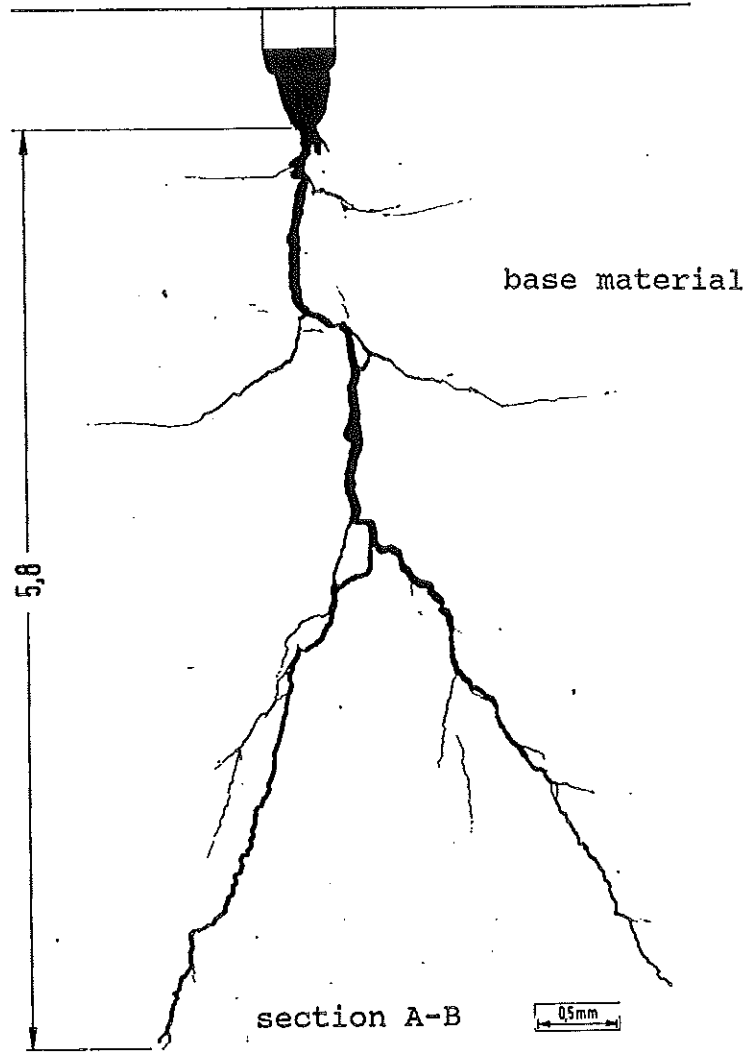
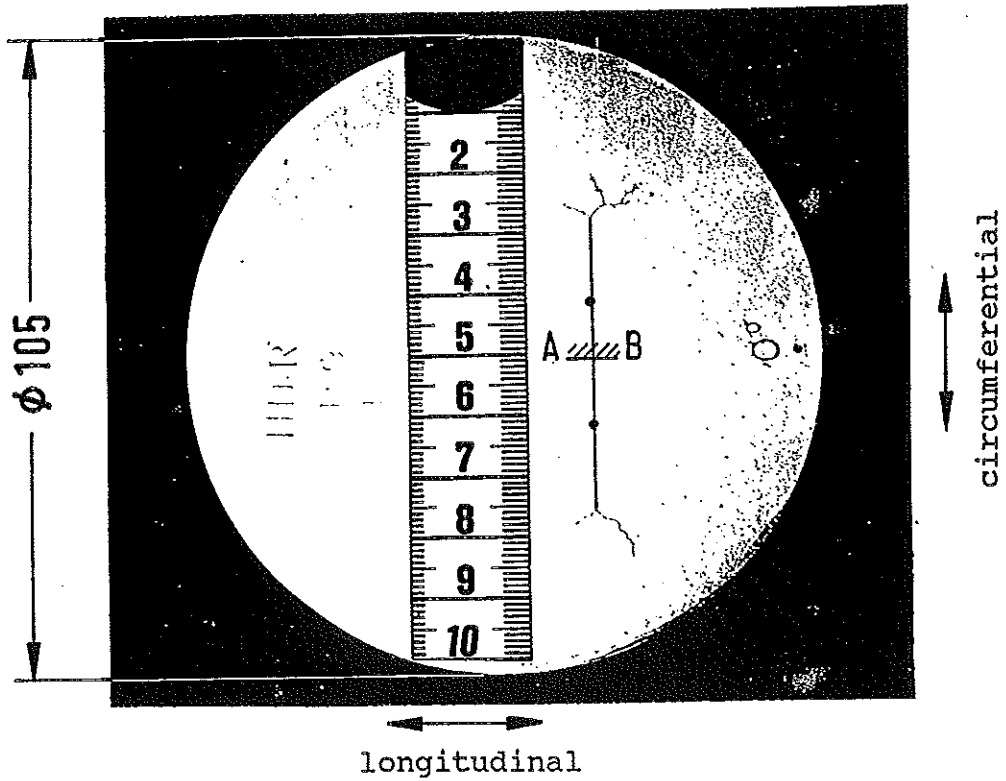
Crack branching in a more pronounced form was found in the cylindrical wall of the pressure vessel of the decommissioned HDR plant /5/ (superheated steam reactor near Frankfurt/Main), Fig. 8. This investigation was part of the THEZ-series (thermal shock of the cylindrical vessel wall) of the HDR Safety Program /6/, where loading by cyclic thermal shock was applied. The circumferential crack started from a 9 mm deep blunt notch and was grown by 6500 load cycles in three test blocks. During the two stops in between the vessel was statically loaded at different pressure levels and temperatures for 100 h and 140 h, resp. In this case, the high temperature water also had an elevated oxygen content.

Fig. 8: Trepan B9 of the decommissioned HDR-plant, inner surface of the cylindrical pressure vessel wall

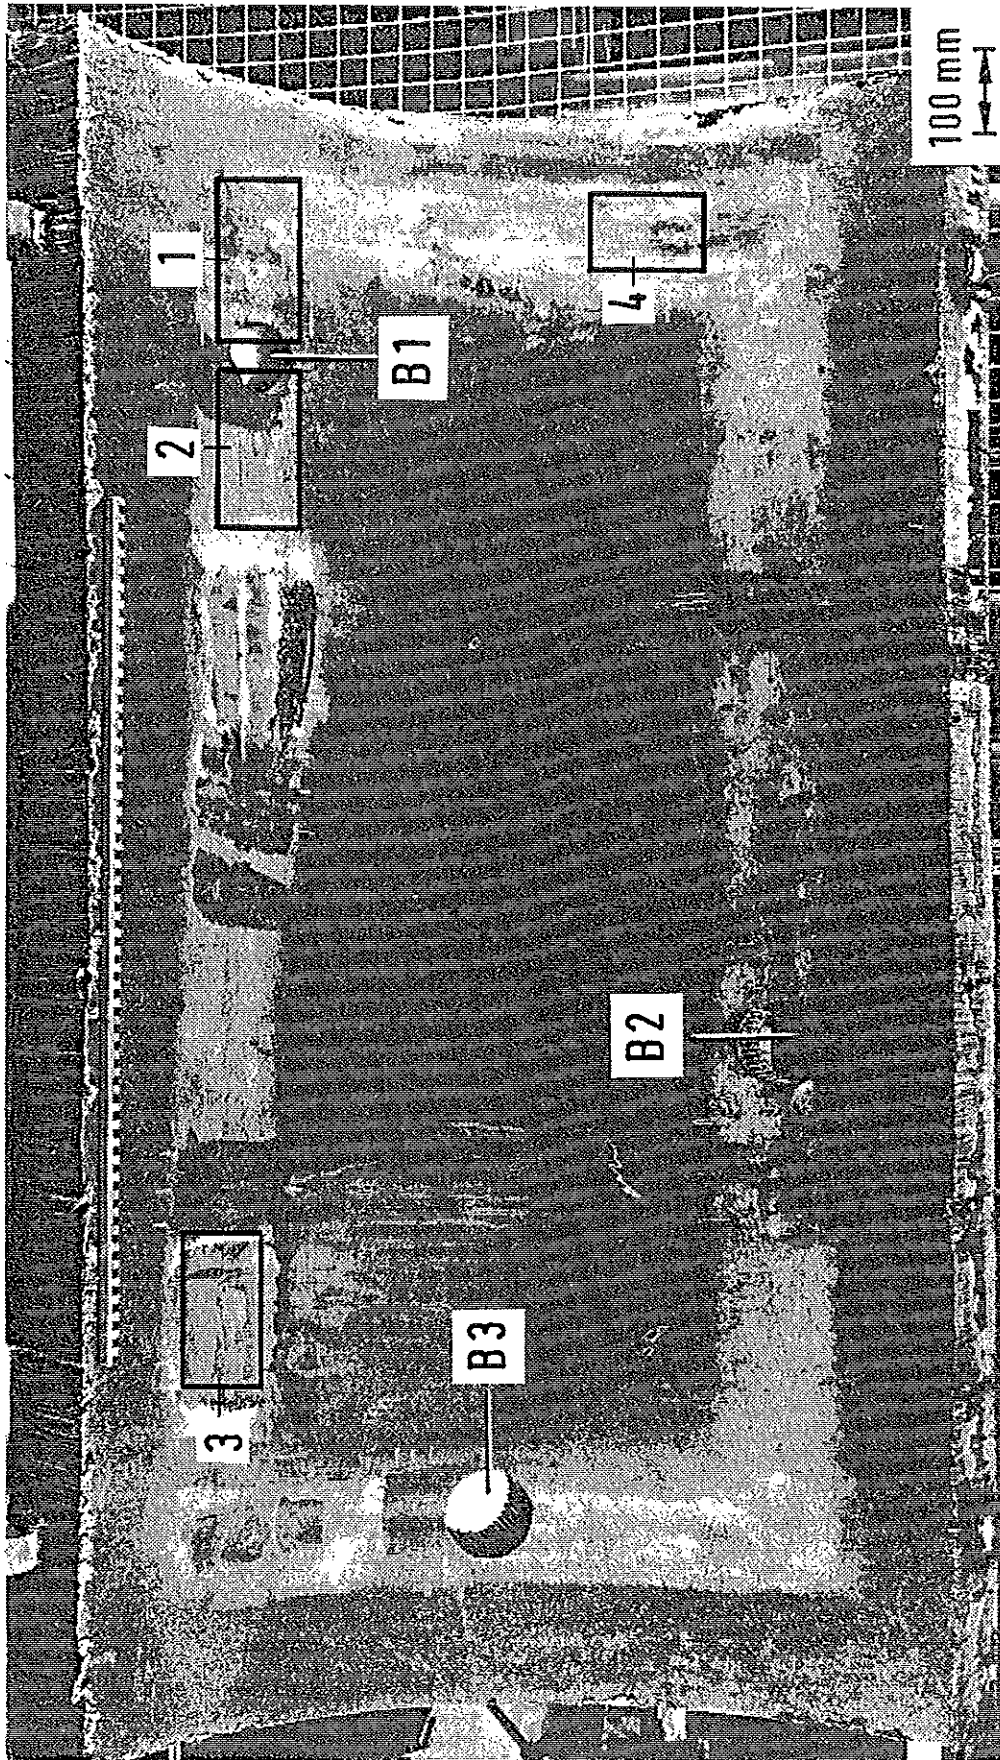
After 23.340 load cycles at 60°C and 288°C and 7 hydrotests at 60°C (Fig. 2, step 1 through 12) the patch S3 was removed from the vessel by torch-cutting. The inner surface after a final nondestructive examination (NDE) is shown in Fig. 9. The bright rectangle from the magnetic particle testing marks the location of the longitudinal and circumferential welds. Three trepans (B1 through B3, diameter 100 mm) were taken from the welds at locations where the deepest cracks were expected.

Fig. 9: Inner surface of patch S3, material 20 MnMoNi 5 5, location of the trepans B1 through B3 and the areas 1 through 4

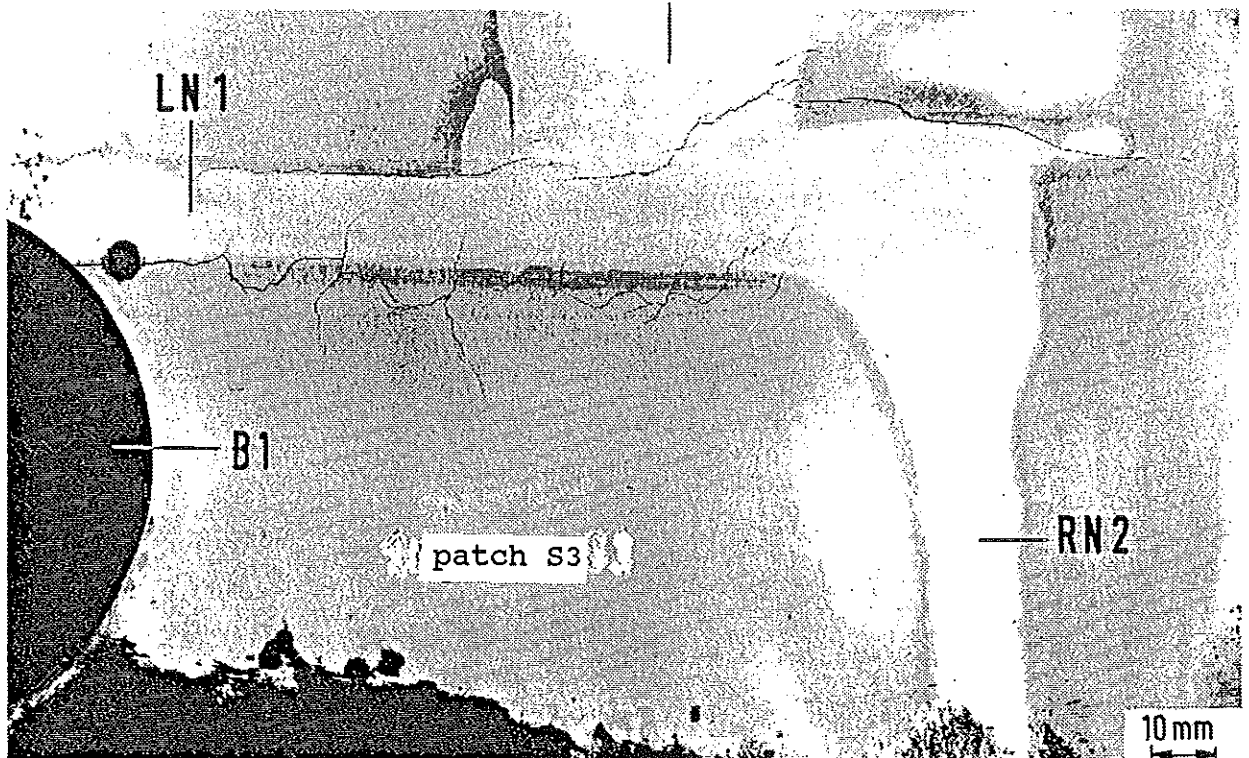
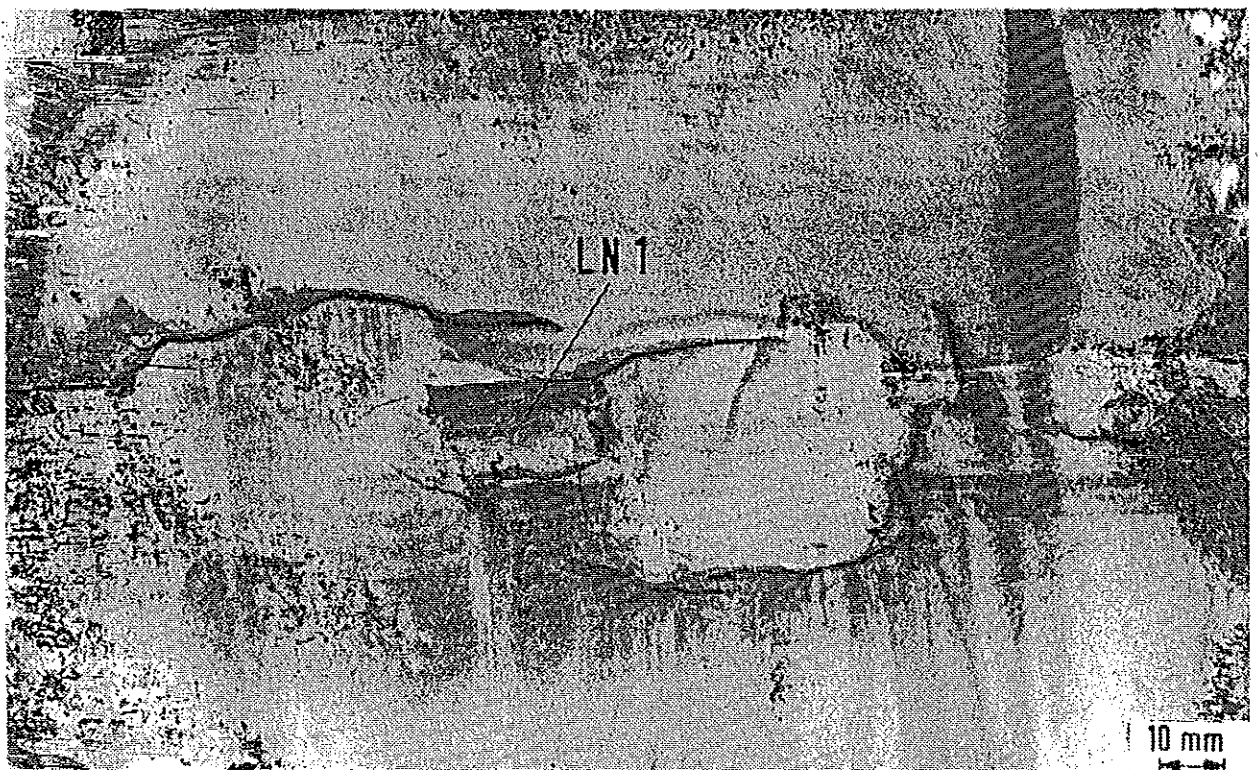
Two sections of the cracked root of the longitudinal weld LN 1 are shown in Fig. 10. In both cases, numerous cracks on either side of the root can be seen. While the preferential orientation is in the longitudinal direction, there are some cracks with a circumferential orientation. The bottom picture of Fig. 10 depicts an area of a repair weld with cracks at the transition from the weld to the base material.

Fig. 10: Fracture appearance in the root of longitudinal weld LN 1,
top: section 1 of Fig. 9
bottom: section 3 of Fig. 9

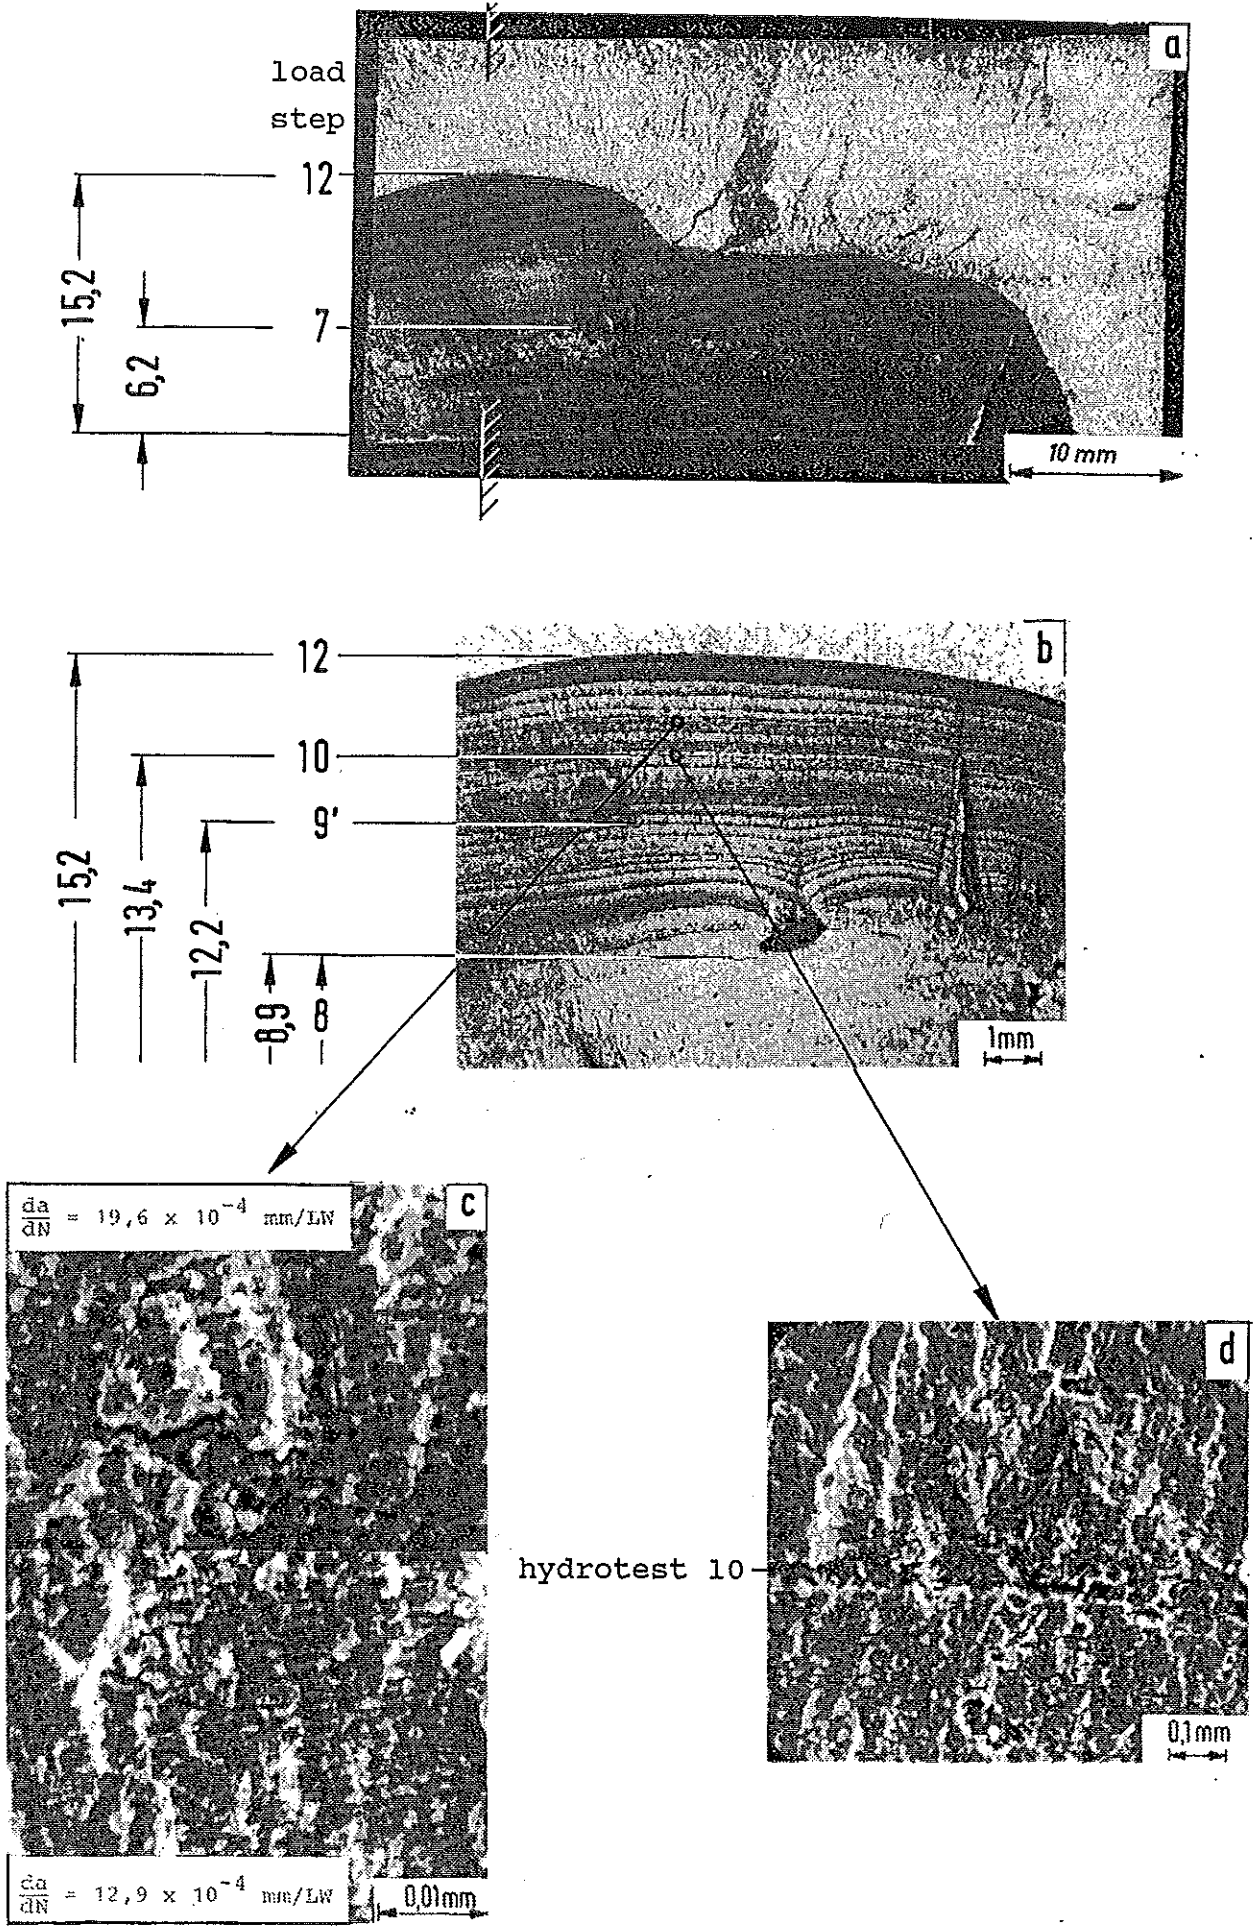
In order to further investigate the morphology of the fracture surface, the cracks of the three trepans were opened. Comparable to the appearance in the three flaws, the various load steps can be correlated to clearly visible stripes on the fracture surface, Fig. 11. The different lines in Fig. 11b correspond to crack growth caused by cyclic loading on one test day, Fig. 11c, or to hydrotests, Fig. 11d. Due to an extremely corroded fracture surface no statements can be made for the load steps 1 through 8 with a total crack propagation of 8,9 mm.

Fig. 11: Longitudinal crack in trepan B2 of Fig. 9

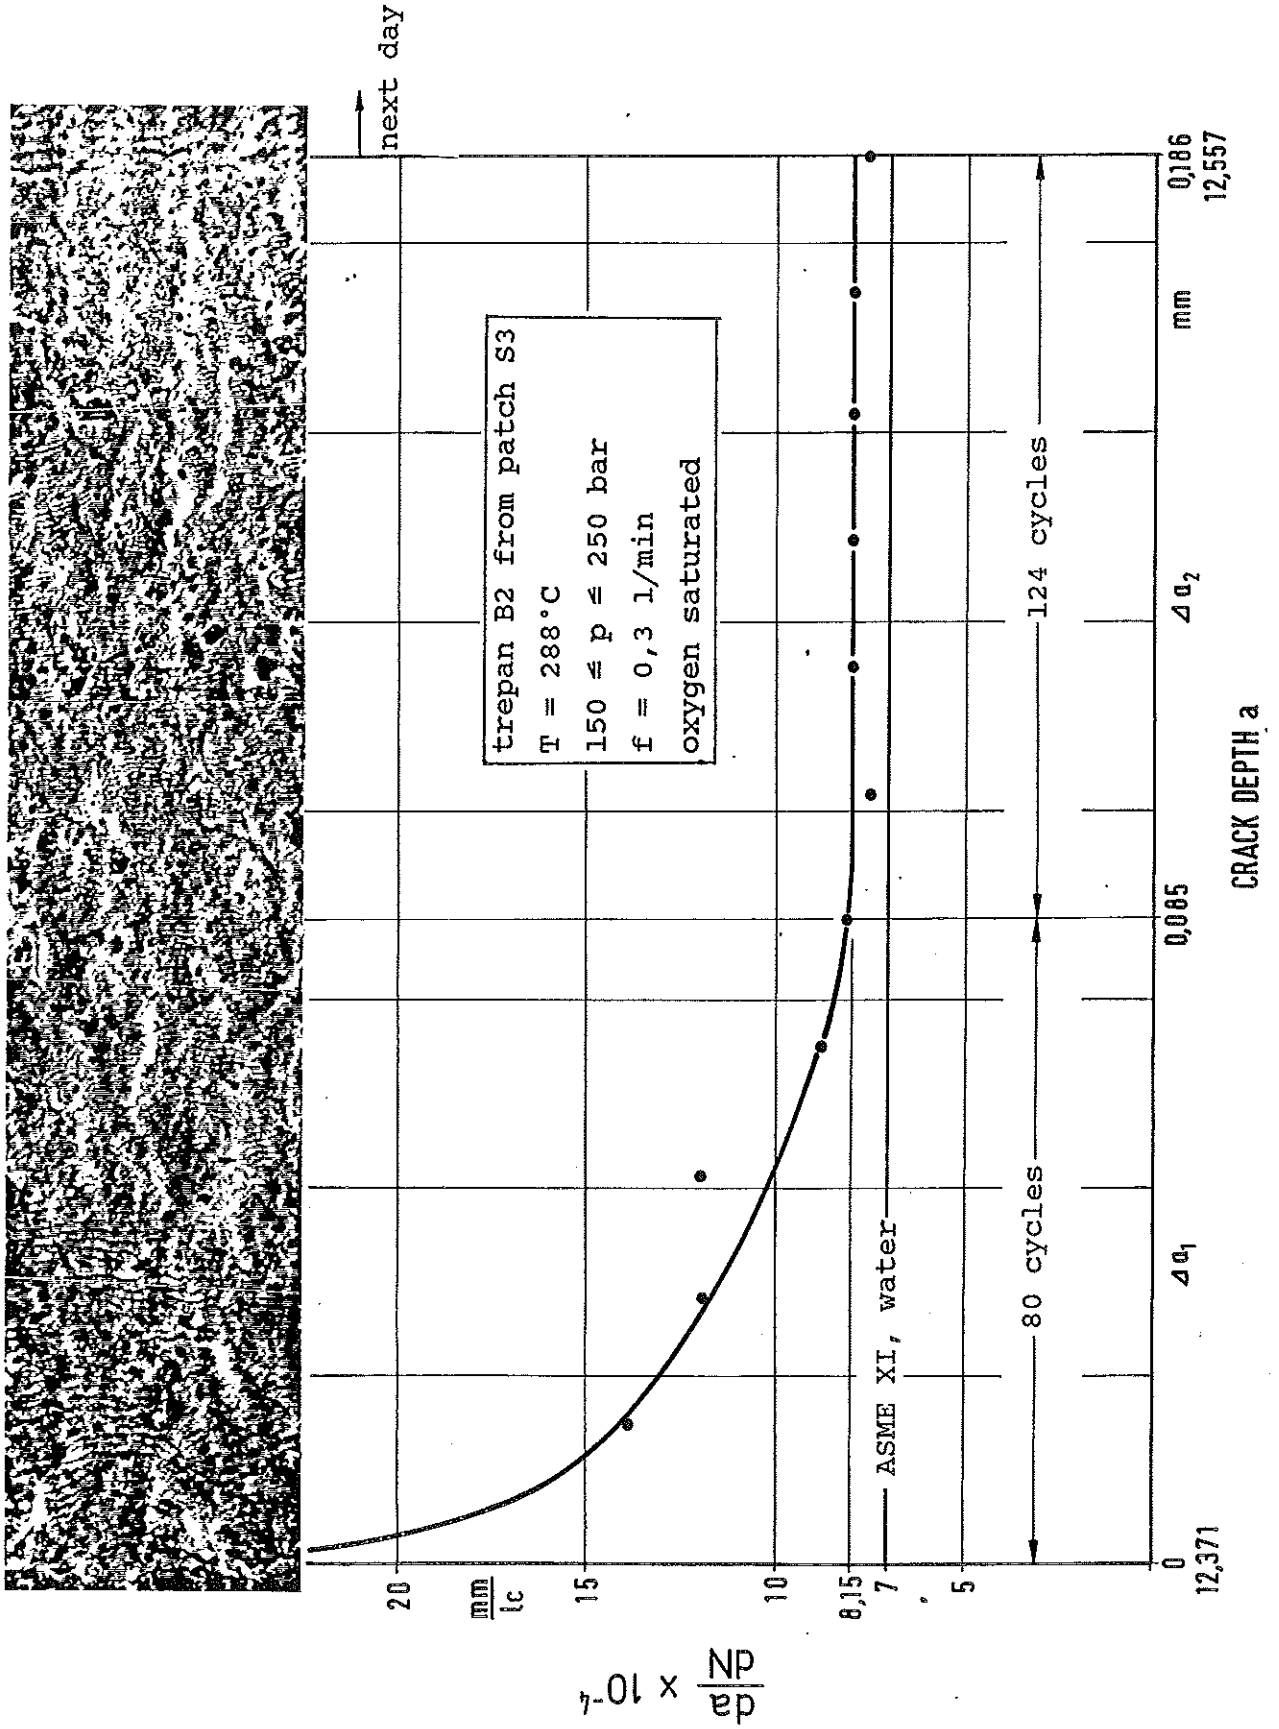
Fig. 12 shows a close-up view of one of the stripes of step 9 (Fig. 11b). This section of the fracture surface corresponds to a total crack growth of 0,186 mm, caused by 204 load cycles between 150 and 250 bar at 288°C. This test sequence was conducted after a stop of 18 days with temperatures between 10°C and 288°C.

loading is, more than twice as high as in the second half of the day. The plateau reached after 80 load cycles is slightly above the value derived from the K_I -calculation and the da/dN -curve for water according to ASME, Sect. XI /7, 8/. Tests to determine the da/dN -values for the particular vessel conditions (vessel material, water chemistry) were not conducted. After an overnight stop of 8 hours at 150 bar and 288°C, da/dN is high again during the first cycles of the following day, see right end portion of Fig. 12.

Fig. 12: Cyclic crack growth during one test day after a stop of 18 days. load step 9
