Investigation of Corrosion Assisted Crack Growth in an Intermediate Size Pressure Vessel at Elevated Water Temperatures

Kusssmaul, K., D. Blind, R. Gillot, and W. Burr, MPA Stuttgart

3rd International Conference on Biaxial / Multiaxial Fatigue, April 3 - 6, 1989, Stuttgart, FRG

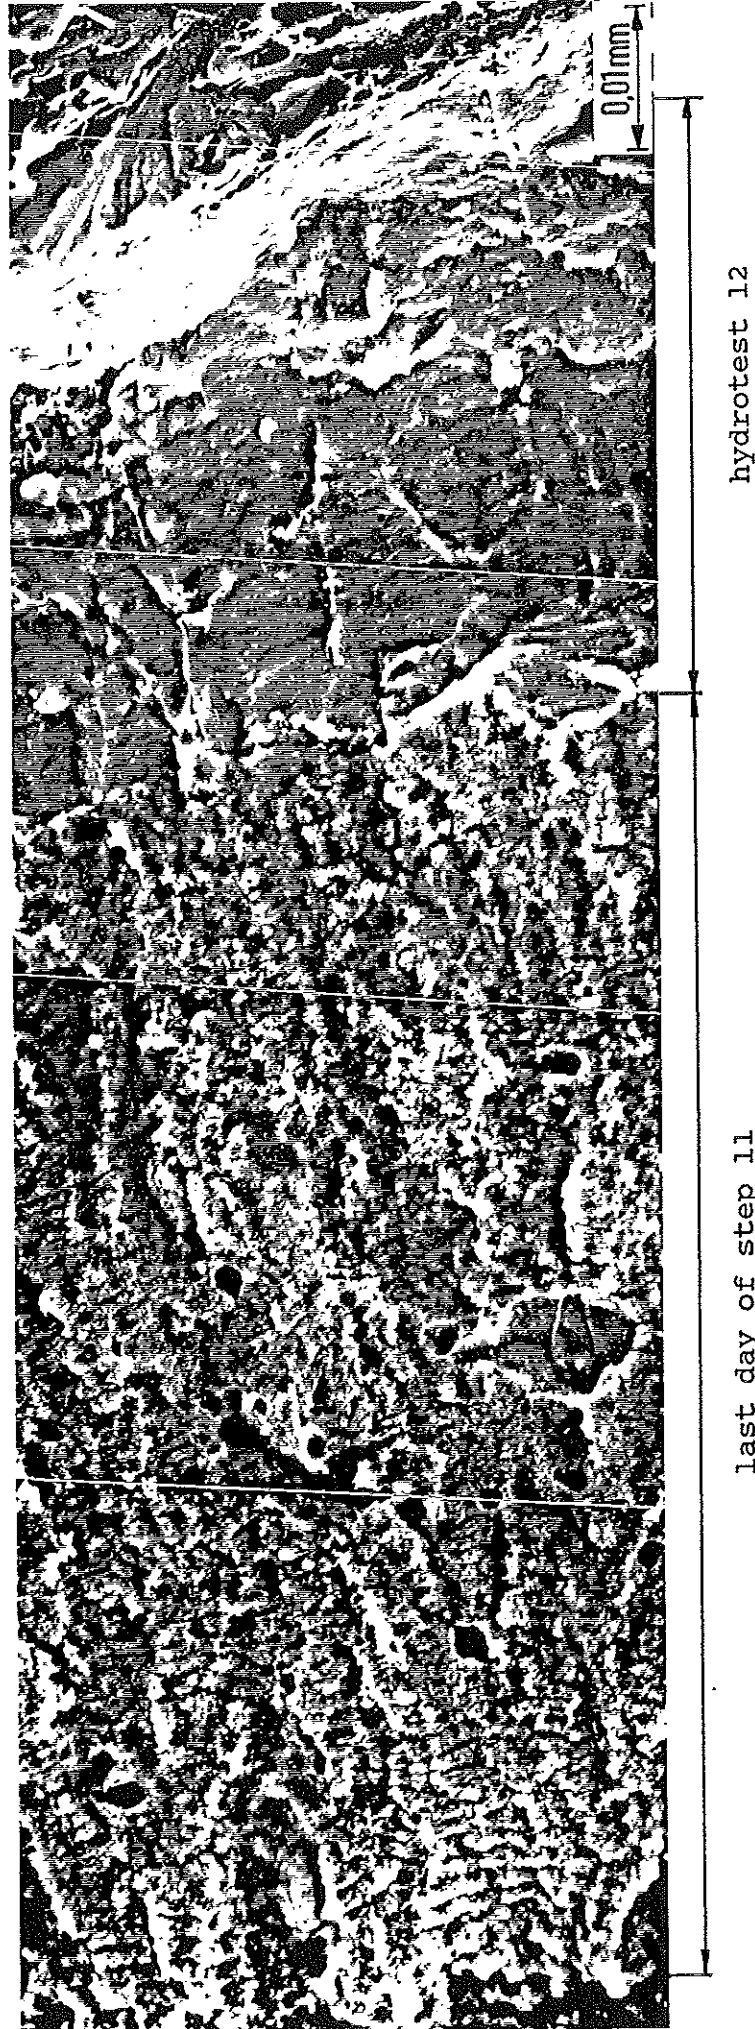
After removing the corrosion layers from the fracture surface, striations only could be found at the crack tip, Fig. 14. They were caused by load cycles of the last test days of step 11, ranging between 100 and 250 bar at 288°C. Calculations for finite length circumferential part-through cracks in vessels /9/ assuming an average crack depth of 20 mm and a total crack length of 700 mm (according to the width of the patch) yield a stress intensity factor of $\Delta K = 13 \text{ MPa m}^{1/2}$. According to /8/ this corresponds to a crack growth rate of $2,5 \cdot 10^{-4} \text{ mm/load cycle}$ which is one fourth of the measured value at test begin.

With an increasing number of load cycles, da/dN in Fig. 14 decreases to lower values. This behaviour is similar to the one described in Fig. 12. Due to the rough fracture surface of the circumferential cracks a more detailed evaluation can not be made. It seems to be evident, however, that the overall crack behaviour of longitudinal and circumferential cracks is similar.

Fig. 14: Crack growth by cyclic loading at 288°C and hydrotest at 60°C, section A of Fig. 13
