# Influence of Galvanizing Process on Fatigue Resistance of Microalloyed Steels

**ABSTRACT.** This paper presents the fatigue life behaviour of galvanized rear axles made of microalloyed steel. The main objective of this study is to predict the influence of the zinc protection layers on the steel fatigue life. The results show that the galvanized rear axles exhibited a lower fatigue limit as compared with the non galvanized ones. This was attributed to the cracking in the galvanized layer caused by the presence of zinc penetrating beneath the sheet surface.

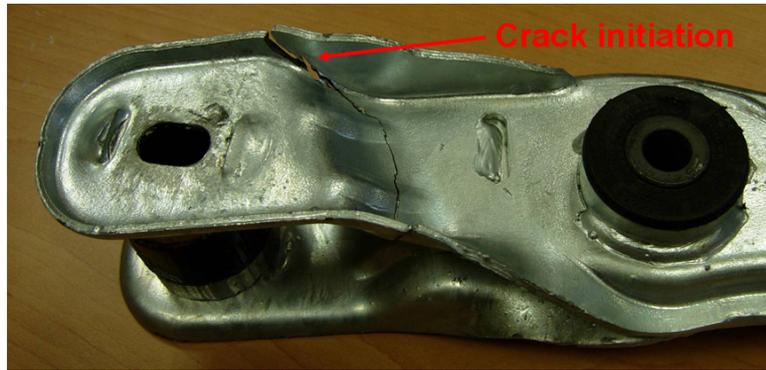
The failure locations is positioned in bending region of the component, as indicated in Fig. 3. Fatigue cycles life was about of 120.000 cycles. The maximum number of cycles was fixed at 200.000.

After test, the component was macroscopically observed in order to highlight crack initiation site. All the tested components have shown that cracks originate in the bending zone, as shown Fig. 3. A specimen was taken from this region in order to investigate the fracture surface by SEM analysis. Micrograph is reported in figure 4 where the zinc soaked into the steel working as cracking initiation is clearly visible.

Figure 3: Failure location observed during the fatigue tests.

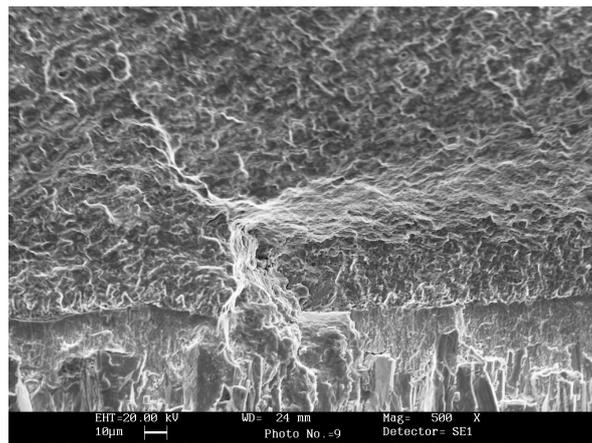
Figure 4: SEM micrograph of crack initiation.

Also, the fatigue cracks, in the rear axle, seems to be due to the presence of zinc penetrated into the steel, as shown in Fig. 4. Therefore, the initial surface state is responsible for the opening of cracks during the fatigue test.

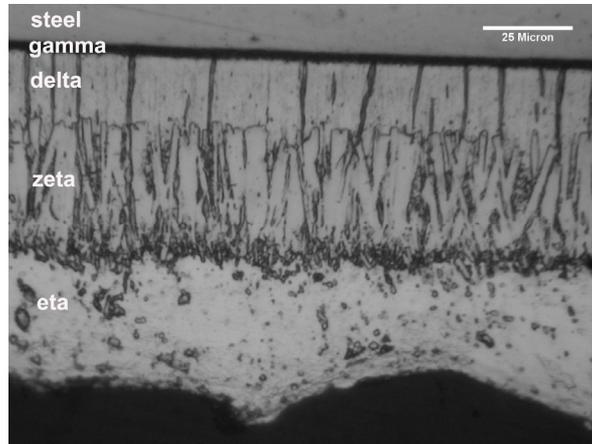
Fig. 5 shows the three intermetallic sub-layers forming the hot-dip galvanized coating between  $\eta$  (made of pure zinc) and the steel. The coating thickness was measured and varied from 90 to 130 micron. The microstructure of the steel is completely ferritic as shown in Fig. 6.

Figure 5: Optical micrograph of the hot-dip galvanized coating on the steel substrate.

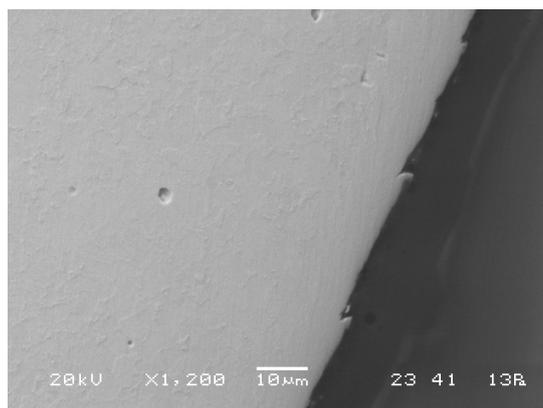
SEM analysis of longitudinal section of not-coated specimens shows pre-existing cracks whose direction is parallel to the loading direction, see Fig. 9.

Figure 9: SEM micrograph of the not galvanized steel in the longitudinal direction.

The SEM observations in Fig. 9 of the not galvanized smooth specimens revealed the presence of micro-cracks on the steel surface. During the galvanizing process, these damages increases steel reactivity because iron atoms in these areas are in a high-energy state and can readily dissolve in the molten zinc alloy, resulting, locally, in abnormally high iron solubility. As a results the reaction between zinc and iron can not be inhibited (by the Al-Fe layer) and local growth of the intermetallic compounds is observed directly on the steel surface. This phenomenon is called outburst and is undesirable because it has negative effect on zinc coating properties.

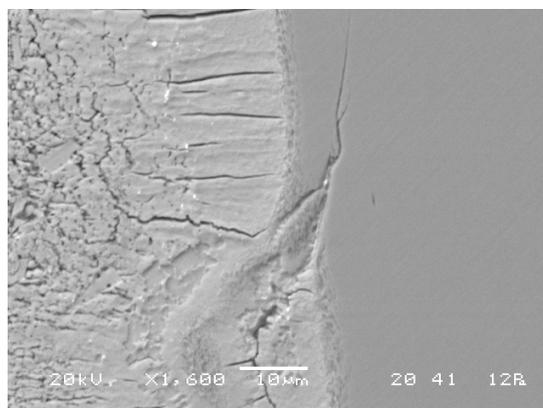
Figure 10: SEM micrograph of the galvanized steel after fatigue in the longitudinal direction: cracks propagate from zinc layer to steel.

SEM analysis of coated specimens on cross section parallel to the loading direction suggest that galvanization is able to open the above-mentioned cracks already present in bare steel specimens. Fig. 10 shows the penetration of zinc layer in such cracks that induces opening. The penetration of zinc is highlighted by a SEM-EDX microanalysis mapping performed on crack area, as shown in Fig. 11.

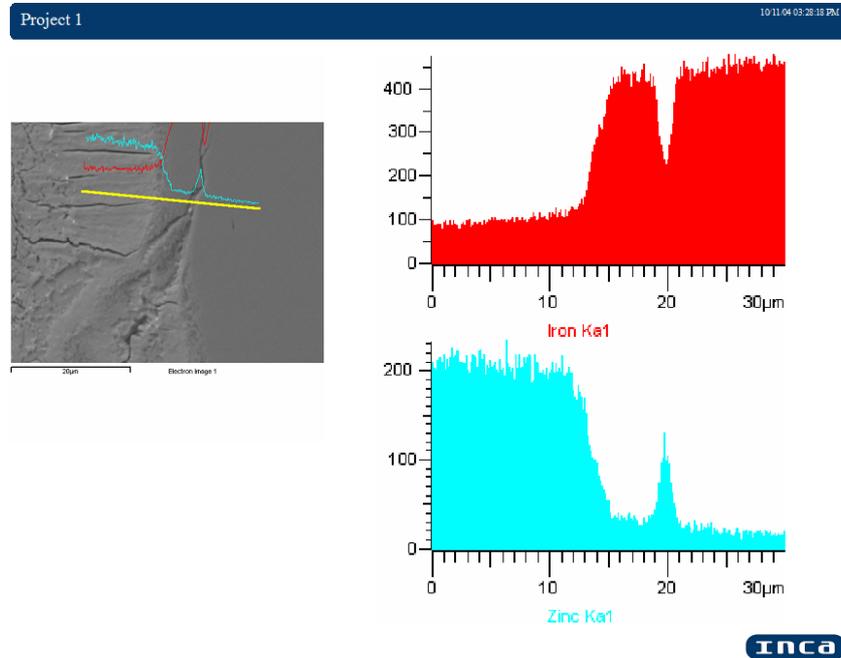
Figure 11: EDX microanalysis of the galvanized steel after fatigue in the longitudinal direction showing zinc propagation into the steel substrate.

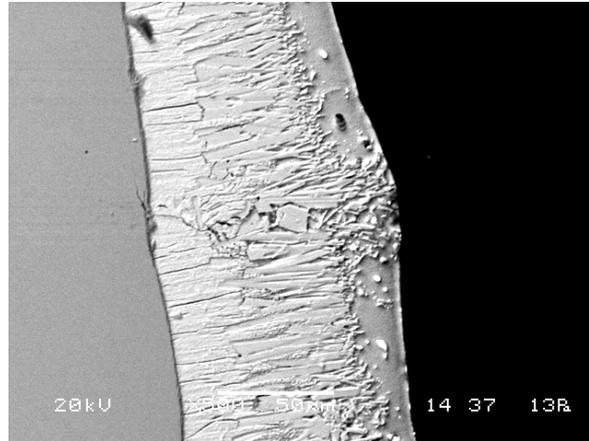
In Fig. 12, the typical appearance of an outburst with non uniform growth of the delta phase is shown. Furthermore, in Fig. 12, it is evident the generation of the outburst at the presence of surface defects. Thus, as shown in Figs. 11-12, the presence of outbursts is related to the presence of micro-cracks on the steel surface, and originates the penetration of the brittle zinc intermetallic compounds into the steel substrate. During the fatigue tests, these micro-cracks operate as initiation site and the presence of iron-zinc brittle compounds allows them to propagate very rapidly leading to a lower fatigue limit.

Figure 12: Example of outburst.

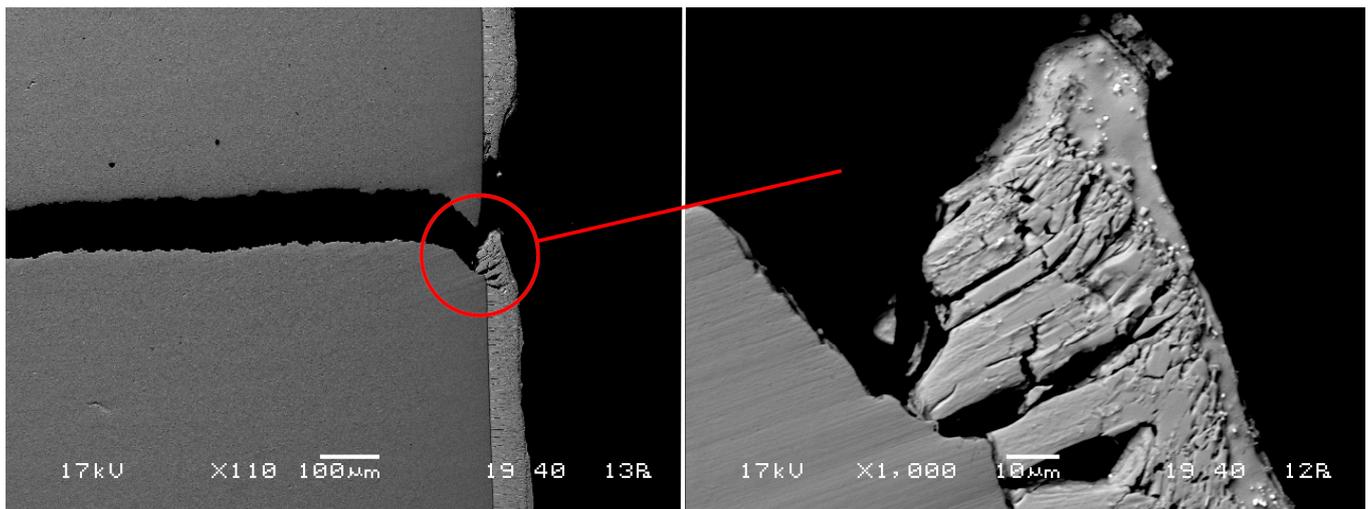
In Fig. 13, the initiation site of the fatigue crack is reported for a broken galvanized specimen. It is evident, in fact, that the crack starts in correspondence of an outburst.

Figure 13: Example of fatigue cracks starting from an outburst.
