Some Experiences with Crack Path Issues

L. P. Pook¹

¹ University College London

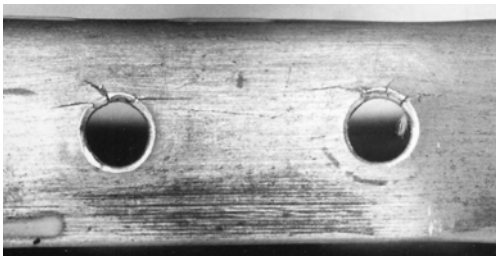
Figure 1. Cracks in undercarriage bay bracket.

The relationship between mode of fatigue loading and paths taken by fatigue cracks has been of interest for a long time [7, 8]. This information can be useful in failure analysis and Figure 1 shows an example from 1961. It is a bracket from an aircraft undercarriage bay which showed unexpected cracking at rivet holes. The bracket was a formed 18 swg (1.2 mm thick) aluminium alloy angle, $10 \times 0.8 \times 0.8$ in ($254 \times 20.3 \times 20.3$ mm). The figure shows a general view of typical cracks observed after the bracket was removed from the bay. Examination of the fracture surfaces of the cracks showed that fatigue cracks had originated at both surfaces of the bracket at the rivet hole corners and then propagated inwards on elliptical crack fronts, with the two cracks intersecting at or near the centre line of the sheet. Figure 2 shows the fracture surface of a typical crack. This indicates that failure was caused by out of plane alternating bending fatigue loads, which were not anticipated by the designer. Examination of the fracture surfaces at high magnification showed the presence of striations and hence confirmed that cracking was

due to fatigue. This is an example of the useful crack path information which can be obtained from simple examination of a failed component with the naked eye.

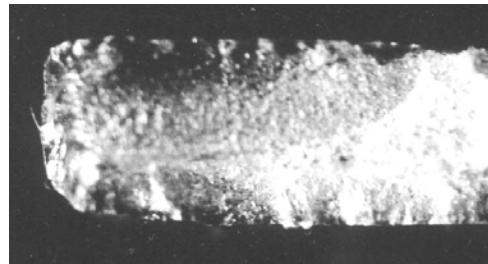
Figure 2. Surface of crack in an undercarriage bay bracket.

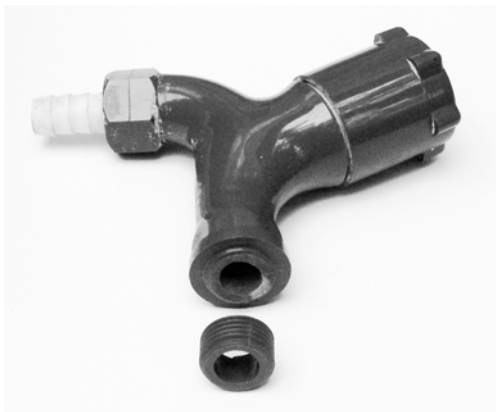
Figure 7. Plastic domestic tap.

In 1991 a plastic domestic tap in the author's utility room was observed to be leaking where it was screwed into a fitting on the supply pipe. The tap had a fitting for a hose pipe, and appeared to be a replacement for the original brass tap. When an attempt was made to unscrew the tap it failed completely. The two parts of the broken tap are shown in Figure 7 and a close up of the fracture surface in Figure 8. The dark area is fatigue and the light area the final static failure. The age of the tap at the time of failure is unknown, but as one fatigue cycle is applied each time a tap is turned on and off it is likely that thousands of cycles had been applied. Safety critical pressure containing components are often designed to leak-before-break [6] in order to avoid catastrophic failure. It is fortunate that the tap did so otherwise the utility room would probably have

been flooded. The failed tap was replaced with a brass tap, and it was observed that the detail design in the vicinity of the threads was exactly the same. The replacement tap is still in use. The episode is an example of the danger of using a different material for a component without making appropriate changes to detail design.

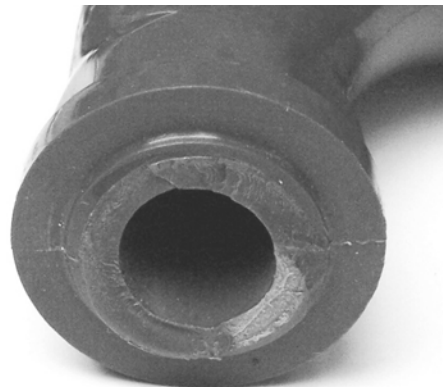
Figure 8. Crack surface of plastic domestic tap.

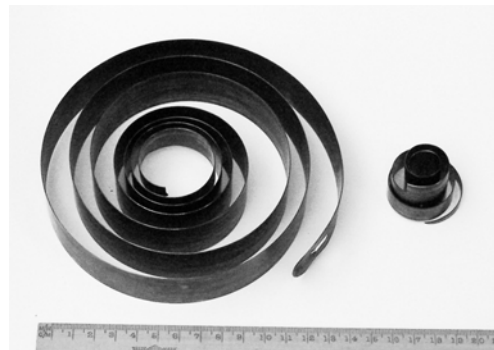
Before the days of quartz clocks, spring driven wall clocks were widely used in public buildings. The example shown in Figure 9 was originally used in a school, but since 1968 it has been in use in the author's kitchen. In 1994 the mainspring failed while the clock was being wound. Examination showed that this was the final failure following fatigue crack growth. A general view of the failed mainspring is shown in Figure 10. Fatigue has been a problem in clock mainsprings for centuries, and traditionally they are designed using rules of thumb based on experience [16], rather than by detailed analysis. The total fatigue life is not known, but the clock is wound weekly so it must be thousands of cycles.

Figure 9. Wall clock by John Davidson, Coatbridge. Figure 10. Failed wall clock mainspring.

A clock mainspring is loaded in bending, with loading and unloading moving along the spring as it is wound and unwinds. When a mainspring breaks in fatigue the crack is usually straight across the spring, with crack growth predominantly through the thickness. However, in this particular mainspring crack path behaviour is unusually complicated, and details are shown in Figure 11. A fatigue crack initiated at a corner at one edge of the 27 mm wide mainspring. Initially, crack growth was across the spring (downwards in the picture) but after about 9 mm of growth the crack turned sharply towards the outer end of the spring (right in the picture), and then grew in a spiral fashion towards the other edge of the spring until the final failure took place. During this crack growth two secondary cracks initiated, and then joined so that a small triangular piece of spring became detached. The joined secondary crack then grew in a

spiral fashion towards the centre of the spring, but did not contribute to the final failure. This is an example of a nuisance fatigue failure which did not have serious consequences. Such failures are not normally investigated at all. The offending component is simply replaced. In this particular case the replacement mainspring is still intact after 12 years.

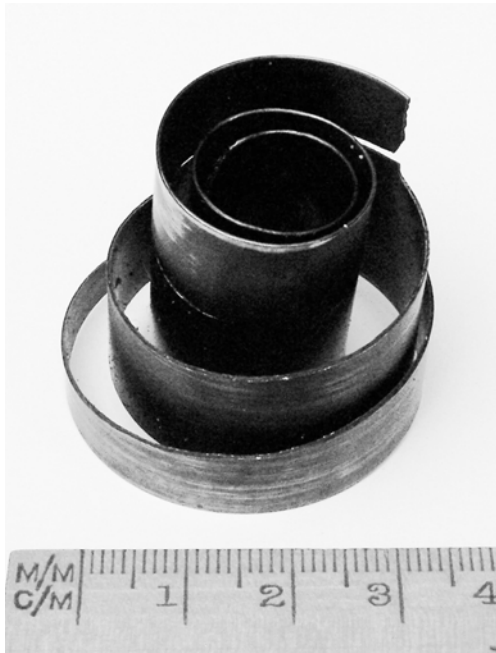
Figure 11. Centre portion of failed wall clock mainspring.

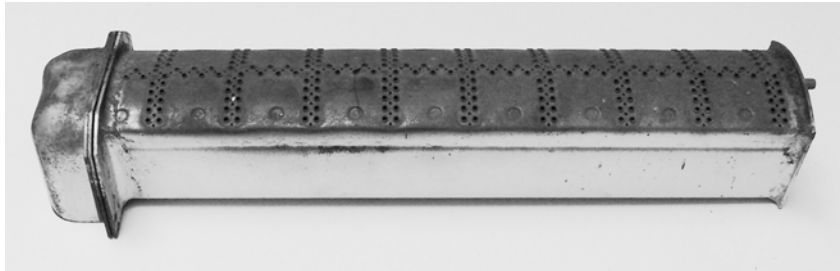
During routine maintenance in 2002 one of the two burners in the gas fired domestic central heating boiler installed in the author's house was found to be cracked due to thermal fatigue. A general view of the burner is shown in Figure 16, and the crack is shown in Figure 17. The boiler was about 12 years old so, assuming it fired about 10 times per day, about 44,000 thermal fatigue cycles had been applied. The burner consists of a steel box with a series of small and large holes on top to distribute the gas to the flame above the box. The larger holes have reinforced perimeters. An internal wire mesh, just visible in Figure 17, helps to distribute the gas evenly. Cracking appears to have initiated at three places on the perimeter of a smaller hole, grown into two larger holes with a small triangular piece becoming detached, and then two cracks grew across most of the width of the box, resulting in improper combustion. The designer did not appear to have appreciated the point that stress concentration factors are largely independent of hole size. The reinforcement had prevented crack initiation at the large

Figure 16. Burner from domestic central heating boiler.

holes but its absence had allowed cracking at a small hole. This is another example of a nuisance fatigue failure. Annual inspection was recommended by the boiler manufacturer. This ensured that the cracking was detected before it became dangerous, and the burner was replaced..

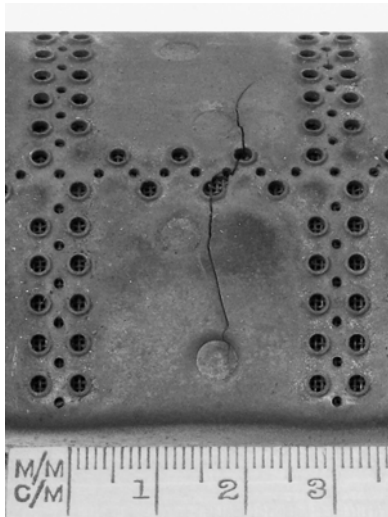
Figure 17. Crack in burner from domestic central heating boiler.

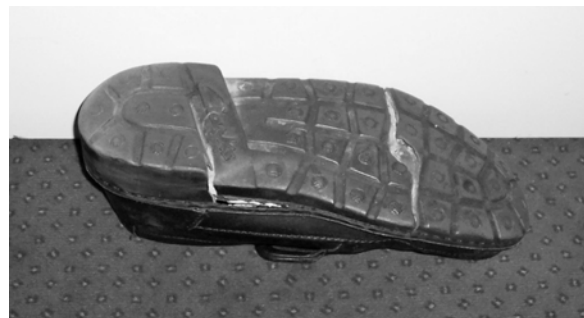
Figure 18. Cracks in sole of walking shoe.

In 2005 the author found that the plastic soles of pair of walking shoes had become badly cracked and one no longer fitted properly. This more severely damaged shoe is shown in Figure 18. The sole of a shoe is subjected to repeated bending. Going uphill a sole is also subjected to repeated tension as the rearward force applied by the wearer's heel is transferred to the ground. This particular pair of shoes had covered several hundred kilometres, which is equivalent to around 3×10^5 cycles. In the shoe shown two separate cracks had initiated in grooves near the toe, grown past each other and then curved together, in a well known crack path behaviour [19], so that a piece of sole

became detached. The heel had also cracked and, in what appears to have been the final event that reduced the stiffness of the shoe so much that it became unusable, the sole separated from the upper at the end of this crack. The use of a plastic, instead of rubber, for the soles has reduced the rate of wear but led to fatigue failure. This is another example where a change of material has resulted in fatigue cracking.
