# Fatigue Crack Paths in Shafts Subjected to Bending and Torsion

T. Lassen<sup>1</sup> and A. Spagnoli<sup>2</sup>

**ABSTRACT.** *In the present article an in-service fatigue failure of a large propeller shaft is analyzed and discussed. Observed crack growth path and fatigue life are compared with fracture mechanics calculations for various loading modes to determine the most likely fatigue damage mechanism. It was found that the fatigue crack leading to failure of the shaft emanated from a flaw on the surface. The initial flaw had a depth in the range of 0.5-1.0 mm. The subsequent crack shapes were revealed from crack front beach marks. Larger cracks had approximately a semi-elliptical shape with an average aspect ratio near 0.8. Although the design stresses in the shaft were fluctuating shear stresses due to torsion, unforeseen rotating bending stresses may have occurred due to misalignment of the shaft bearings. Based on the observation of the crack front shapes, it was shown that the fatigue failure of the shaft was driven by a multiaxial stress situation dominated by rotating bending stresses at an early stage.*

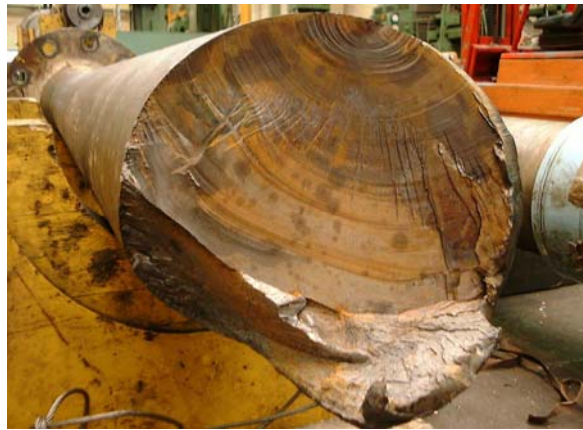
The fracture occurred in the intermediate part, between bearing and flange, of the propeller shaft in the shuttle tanker. The crack had started from a flaw on the surface of the shaft. The fatigue fracture surface was characterized by its smooth appearance with almost no plastic strain. As is shown in Fig. 1, beach marks, indicating the position of the crack front at various stages during propagation, have a typical semi-elliptical shape. The final rupture was ductile with a crack size close to 250 mm. This is about 70% of the shaft diameter  $D$  ( $D = 360$  mm).

Figure 1 - Fatigue fracture surface and final fracture.

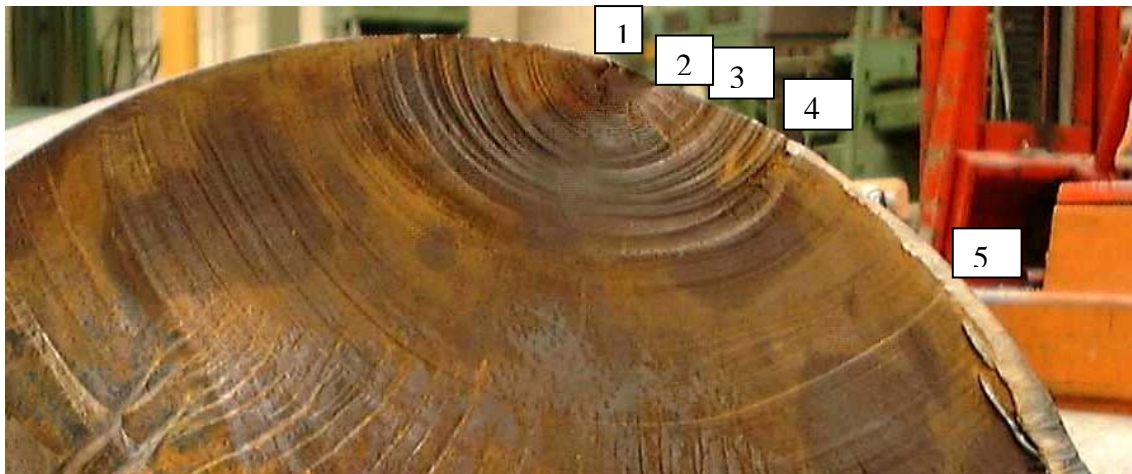
The geometry of five chosen crack fronts was studied in detail, see Fig. 2. Each crack front is designated by a number and for crack no 2-5 the associated label has its bottom left hand corner located where the actual crack front intersects with the free surface of the shaft. The shape data of the cracks according to the notation of Fig. 3a are given in Table 1. The smallest crack designated no 1 is difficult to trace and the geometry is

somewhat uncertain. It has a smaller aspect ratio than the others and is most likely formed by the coalescence of two circular shaped cracks. All the other cracks are semi-elliptical with a rather high aspect ratio  $a/b$ . It can also be seen from Fig. 2 that all the crack fronts have an intersection angle with the free surface close to  $90^\circ$ . The fatigue fracture plane is normal to the shaft axis for cracks no 1 and 2. After the crack depth passes 9.2 mm (crack no 2,  $a/2R=0.026$ ,  $a/b=0.75$ ) the fatigue fracture plane shifts towards an angle of  $60^\circ$  with respect to the shaft axis. The parameter  $\alpha$  listed in Table 1 will be defined in the ensuing text related to Fig. 3b.

The present shaft has a crack plane perpendicular to the shaft axis from the start up to a crack depth of approximately 9 mm. After this crack depth is passed, the crack plane orientation changes to 60° with respect to the shaft axis. Hence, it is likely that the main driving force for the fatigue growth in the early stage has been rotating bending.

Figure 2 - Chosen crack fronts for shape definition.

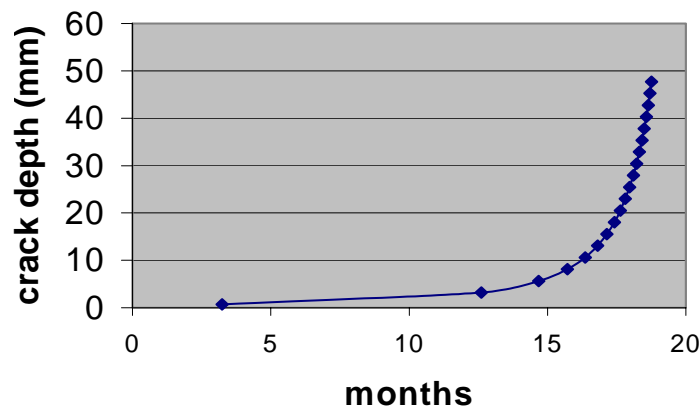
As a first approach, by integrating the Paris law between  $a_i=0.5$  mm and  $a_f=90$  mm ( $a_f$  is equal to 25% of the shaft diameter) and equating the result to the experienced fatigue life of 20 months, we work out an effective stress range due to rotating bending. Therefore such a range causes the same damage as the real time-dependent stress history. If we assume a shaft rotation of 127 rpm (corresponding to a loading frequency of 2.1 Hz) we have approximately  $1.1 \times 10^8$  cycles in the experienced fatigue life of 20 months and, hence, the effective stress range results to be  $\Delta\sigma=49$  MPa. As can be observed from the crack growth history in Fig. 4, the 85% of the fatigue lifetime is spent before reaching a crack depth of 10 mm.

Figure 4 - Crack growth history for  $a_i=0.5$  mm and  $\Delta\sigma=49$  MPa.
