Crack Path in Turbine Blades for Transition from Very- to High-Cycle-Fatigue Regime

A. A. Shanyavskiy¹

¹ State Centre for Civil Aviation Safety Flights, Moscow, Russia, shananta@stream.ru

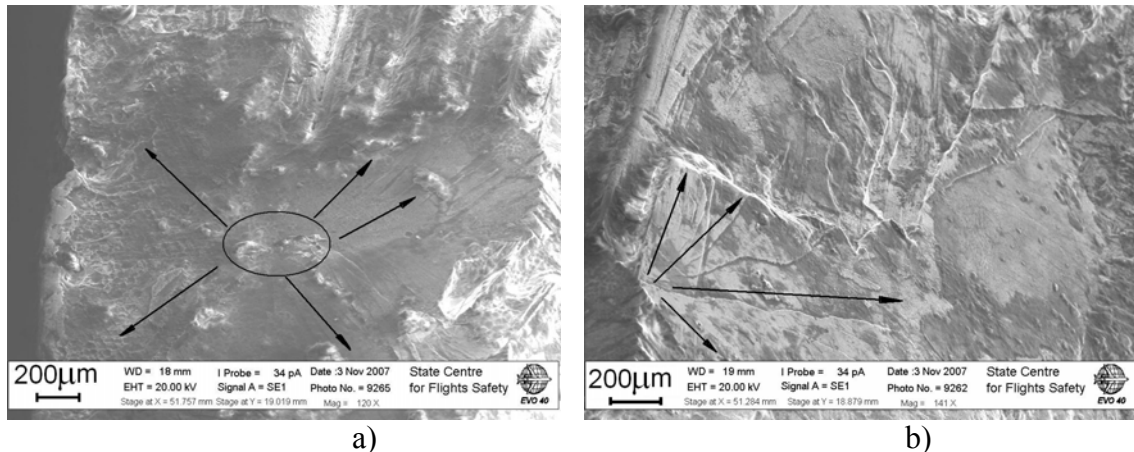
Fatigue crack occurred in two zones at some distance from the suction side surface (SSS). The initial area of origin, dominated crack propagation is located nearly in the middle SSS, Fig.1.

Figure 1. Fracture surface relief (a) near the origin area situated under the suction side surface, and (b) fracture surface peculiarities formed in the progress (indicated by arrows) of initial fracture facet generation. The boundary of the origin has indicated by dotted line.

Unfortunately, due to initial blade surface etching, its fracture has been turned to be partially etched. Consequently, the fracture in its portion directly adjoining to the SSS has been covered with material etching products, and this makes it impossible to trace crack initiation peculiarities taking place just below the surface. Nevertheless, steps that have observed to diverge in fan-shaped directions from the fracture origin allow to consider them in such manner that the crack initiation occurred subsurface at the distance of about 0.9mm below it.

Then crack propagation proceeded within the range of the facet reflecting material fracture along one of crystallographic planes by dominating shear or mode II of the crack opening. New crack initiation has occurred at the boundary of this facet from several sources, one of which has concentrated focus, Fig.1b.

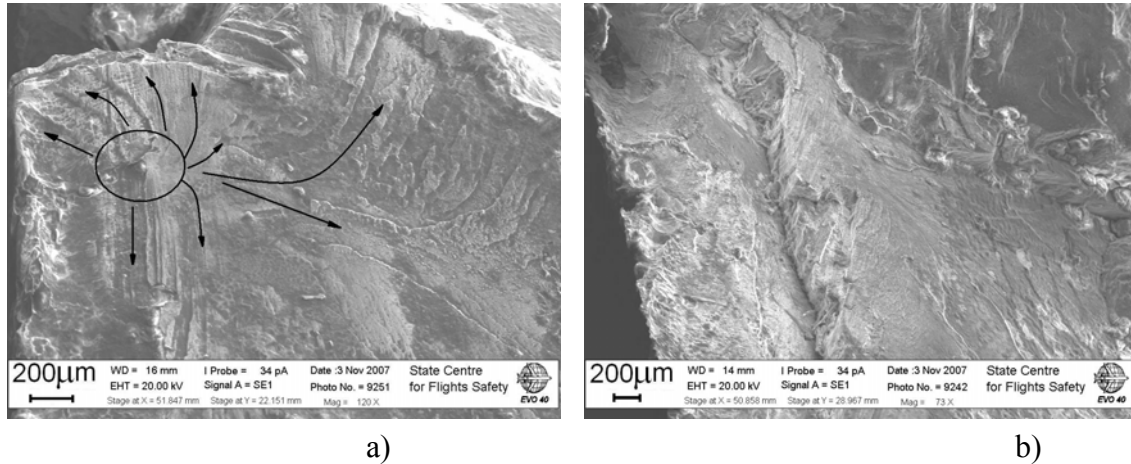
The second fracture origin positioned at some depth under SSS is located at a considerable distance from the primary origin. Its initiation has occurred subsurface at a depth of approximately 0.6mm below the SSS, Fig.2.

at some depth from SSS. Both are concealed from observation by that material segment which had not been destroyed when the crack No.1 was opened. There is a scarcely expressed system of slipping blocks along the fracture facets reflecting material fracture through dominated mechanism of shearing, Fig.2b.

Figure 2. General view (a) of fracture relief in the secondary origin (indicated by circle) of fatigue fracture under the blade suction side surface and (b) extended segments of quasi-cleavage of dendrite body on various fracture segments.

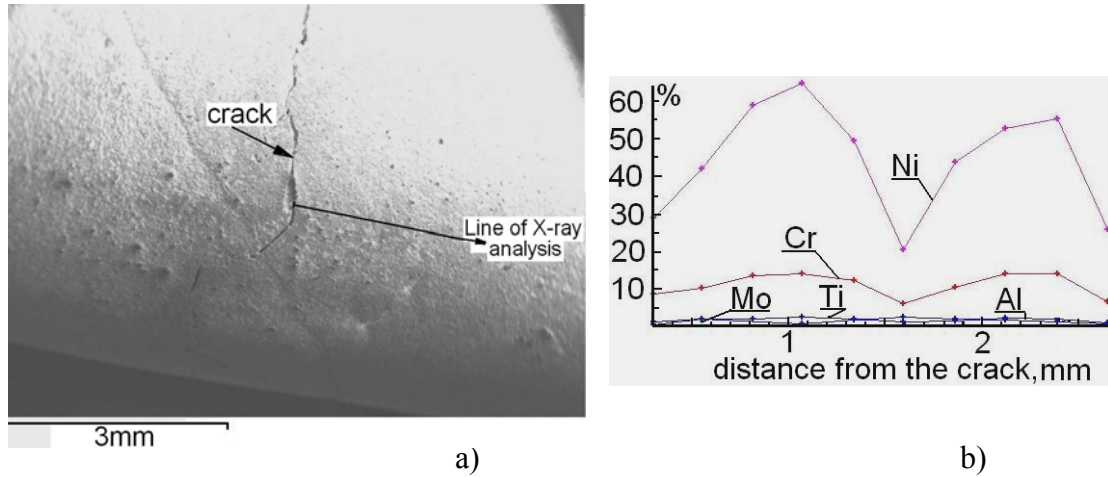
Study of the etched blade surface in the region of the crack No.2 has showed as follows. The surface is uniform without any signs showing presence of material precipitations or deposits, which could be geometrically discernible on etched surface, Fig.3. Crack boundaries include segments of hardly expressed zones with opening its edges, and simultaneously with these, there are drastic geometric changes in other segments at the blade edge. No additional material cracking has revealed near the main crack path along the blade edge on both the suction side and the pressure side.

Local X-ray spectral analysis performed point-by-point at a distance from the crack path has showed that no fundamental differences in distribution of basic elements are there (see Fig.3b). Governing laws of changing in both ratio and percentage of chemical elements are typical for the composition of this material. Available variations, e.g. some decrease, and then increase of nickel content at a distance from the crack explains by the fact that strengthening particles dominate near the grain (dendrite) boundaries.

Figure 3. View of the crack path (a) located at the blade edge in the segment of the most pronounced variation of its track, and (b) weight distribution of basic elements over its length to the right hand of the crack (shown by arrow).

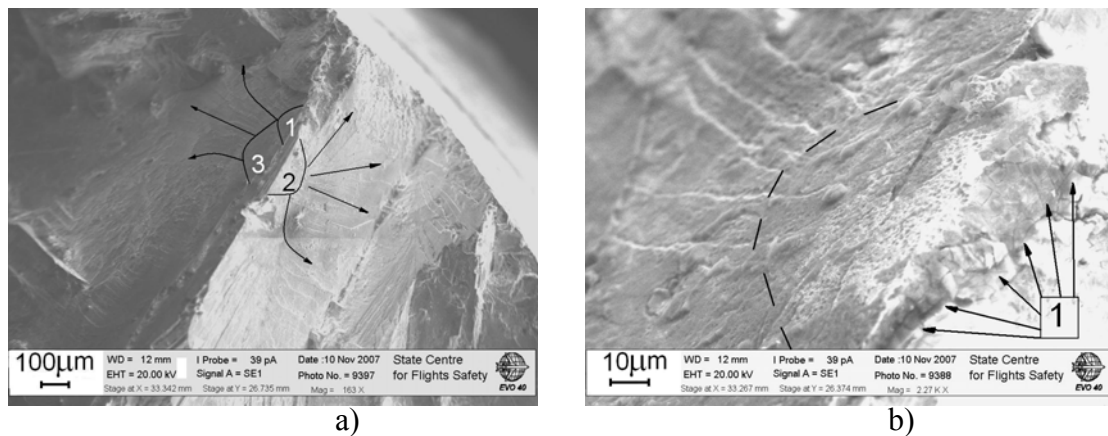
After implementing the above-mentioned investigations crack edges have been opened to study character of its origination and growth. It has found that fatigue crack initiation zone has clearly positioned in space according to two slipping planes, which correspond to two conjugated dendrites, Fig.4. Both planes are positioned in the space so that rupture source zone is moved away to a significant distance from the fracture plane which correspondes to main-line crack development at a distance from these source-bound rupture plane.

Figure 4. Overview (a) of the fatigue crack initiation zone with indication of three failure origins (“1”-“3”) and (b) first of the origin area with a cascade of brittle inclusions (shown by arrows) placed in its focus.

the blade surface. Originally segments “1” and “3” were generated as it shown schematically (see Fig.4); and then initiation and propagation of the crack from the source “2” has occurred.

Fracture relief analysis in the zone of crack origination has showed that an agglomerate of brittle inclusions, Fig.4b, generates it. It follows therefore that fatigue crack initiation has occurred as a result of high stress concentration caused by the zone where brittle inclusions have been accumulated.

Lowering probability for aggregation of brittle inclusions in the blade material near its edge results in increased durability and can exclude crack initiation in the blade airfoil.

This recommendation has introduced in the new manufacturing procedure for blades and new tests by the same programm have shown increased fatigue limit on 20% and crack initiation on the second loading phase at the blade surface in the airfoil base only.

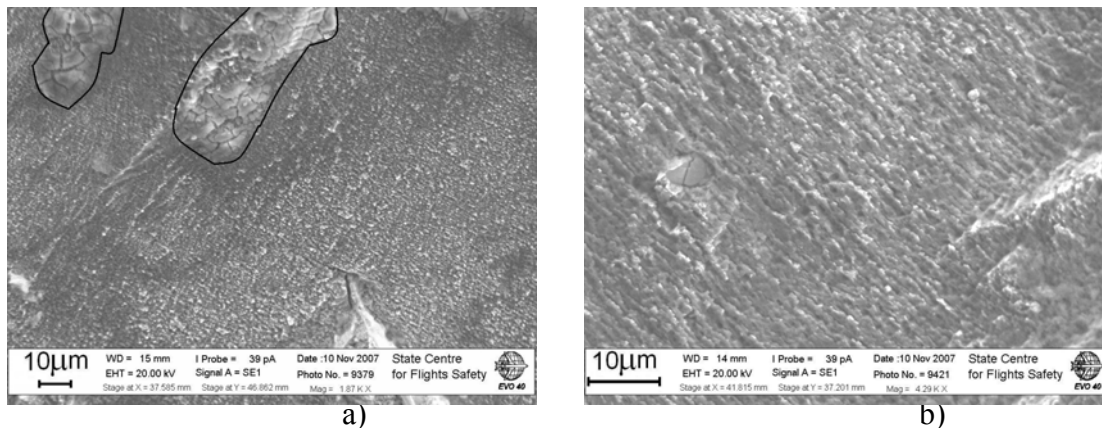
Relief elements analogous to those described as applied to fracture relief because of crack growth under the material tension at the blade airfoil base, revealed in the direction of crack propagation, Fig.5.

Figure 5. Fracture relief (a) positioned in the crack growth direction with a cascade of opened brittle inclusions (indicated by dotted lines) and (b) blocks of slip bands under magnified view.

The fact has engaged our attention that aggregates of brittle inclusions have got into the fracture located in the crack growth direction (see Fig.5). The X-ray analysis has shown that a high content of sulfur and oxygen is there in inclusions zones. The fracture zone itself contains no sulphur with natural fracture surface oxidation. The brittle inclusions and their aggregates observed at a significant distance from the crack origins and over the course of the crack development support the fact that fatigue crack initiation subsurface has just occurred from an aggregate of those inclusions, which are inherent for this material.
