CRACK PATH OF IN-SERVICE FAILED TITANIUM COMPRESSOR DISKS IN HIGH- AND LOW-CYCLE-FATIGUE REGIME

A.A.Shanyavskiy¹, Yu.A.Potapenko¹

¹ State Centre for Civil Aviation Safety Flights, Moscow, Russia, shananta@stream.ru

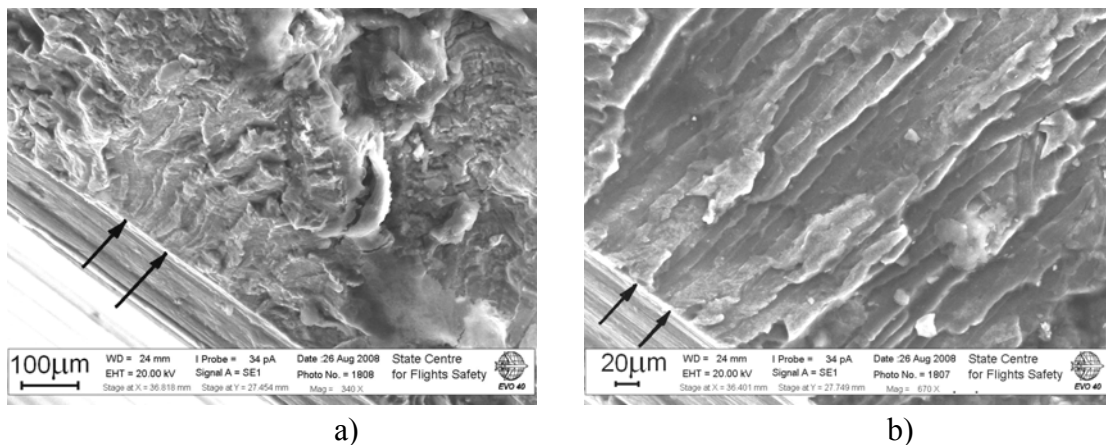
It has established that in all cases studied the initial zone of the fracture origin represents of the facet with specific relief, Fig. 1. There is relief, commonly desined “streamlet-like”, and lined surface of the facet. In all cases, the revealed surface pattern of the facet reflects the material fracture in HCF regime. They distinctly seen because of intersections of slip bands under sliding process that are typical characteristics of titanium alloys fracture in the HCF regime.

Figure 1. Overview of the fracture surface pattern near origins (shown by arrows) of disks of engine D-30 taken an operating time (a) 11489 hours, (b) 11881 hours.

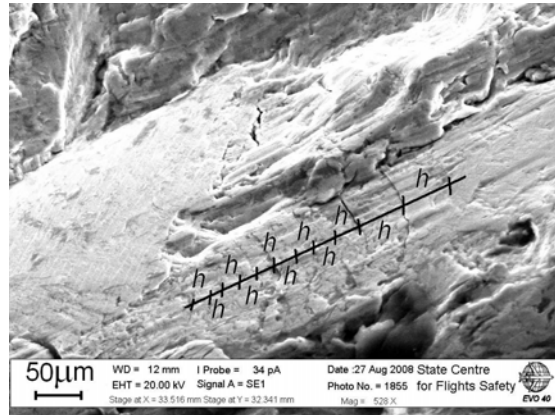
The principle difference in the fracture surface relief for all investigated disks is not present. The most extending zone of the initial facet developed in HCF regime has revealed in the disk with operating time 10753 hours. Here it was possible to see several meso-beach-marks (MBM) reflecting borders for crack propagation during one flight cycle indicated as “FC”, Fig.2. The most MBM quantity revealed on the initial facet has made 30 pieces that corresponds to 30 FC, according to the developed methodology [2] of cracks growth period estimation in titanium compressors disks.

Figure 2. Blocks of meso-beach-marks of the spacing “h” in the damaged because of tearing area of the fracture origin of the disk with an operating time 10753 hours.

Attempts to estimate cracks growth duration in different disks have been undertaken based on measurements of fatigue striations spacing. However, localness of zones with blocks of fatigue striations and their unequivocal orientation concerning to initial fracture zone have not allowed to lead an estimation of cracks growth duration. The dominating fracture surface faceted pattern testifies because of action on the rim-outshot of loads from blade vibrations. In fact, duration of vibration loads cannot be estimate for one flight. Therefore, there are many facts to believe, that duration of cracks development through the section at the basis of the rim-outshot makes no more than several tens flights. This conclusion has agreement with the earlier investigated failures [2] of rim-outshots of disks engines D18 and D36. Investigations have shown that crack growth period in the specified disks has made less than 90 flights.

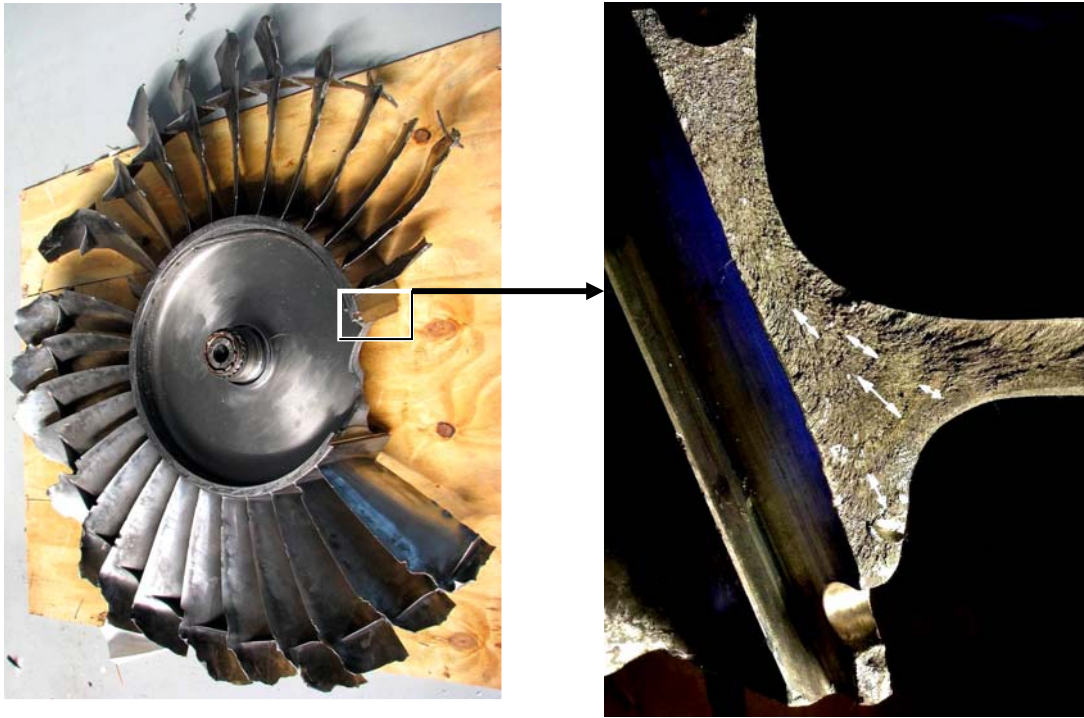
The considered disk failure of the first stage of the LPC took place because of separation of disk rim portion with five blades. The beginning of the disk fatigue fracture has realized in area of the corner of the rim-outshot base, Fig.3. The fracture occurred on the intermediate surface between the rim-outshot surface and the groove surface for the blade. On the fracture surface there were good-looking macro-beach-marks (MABM) of the fatigue failure (see Fig. 3b).

Figure 3. Overviews (a) of the failed disk of the first stage of LPC of engine D-30KU-154 and (b) its fracture surface. Arrows specify distances between macro-beach-marks of fatigue failure.

There are bases to believe what exactly the mode of engine D-30Ku revolutions up leads to MAMB formation. Such statement follows from the realized failure of the disk. It has taken place at run on aircraft by the runway before take off that is connected to transition to more intensive mode of disk operation. The distance between MABMs reflects of the disk fatigue failure during one FC. However, there was not expressed dependence of the distance between MABMs on the crack length. The analysis of the last of 23 flights duration for the aircraft has shown that the engine operation duration had the period from 1.1 until 6 hours. The crack in-flight increment is the more for the disk longer time under loading. Last several flights had not regularities in duration from one flight to another that is why in the fracture surface at last stage of the crack growth there is not revealed natural increase of distance between MABMs in the direction of the crack growth (see Fig. 3). Summarizing estimations of crack growth duration in the disk, it is seen about 27 FC based on actual flights duration by the given aircraft.

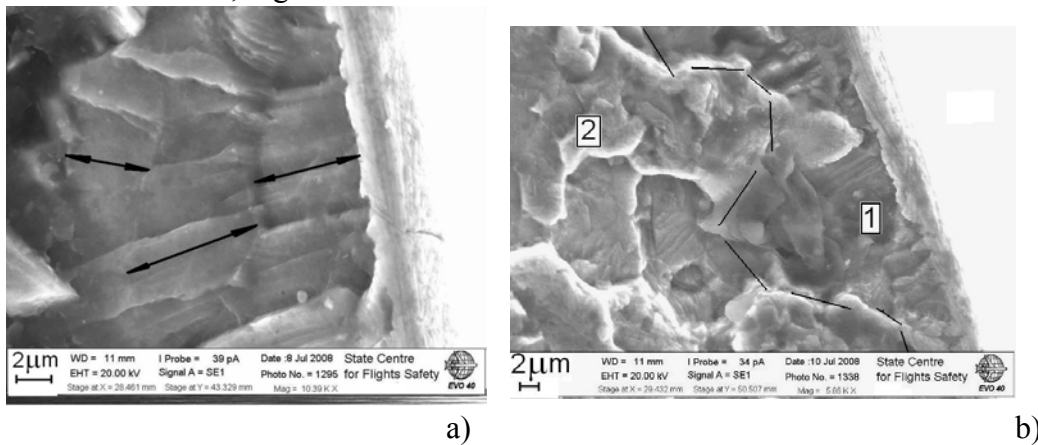
The initial fracture surface zone of the disk is along an external surface of the groove for the blade dovetail, Fig. 4.

Figure 4. The fragment (a) of the disk fracture surface at the surface of the groove for blade with "streamlet-like" relief and meso-beach-marks, and (b) fracture area of transition from the "streamlet-like" relief "1" to faceted pattern (2). Arrows specify distances between MBMs.

The specified zone has been generated because of formation of several origins. The fracture surface analysis has shown that the main fatigue fracture has passed by this initial site. Therefore, it is necessary to consider this center as initial fracture with the crack propagation in small depth, but this initial crack has not defined general disk fracture. The fracture zone on the considered area has generated in result of transgranular, quasi-brittle material fracture by the sliding planes. The fracture surface patten is “streamlet-like” reflecting high frequency of material cyclic loading and its cracking in the HCF regime at durability more than 10^7 cycles.

On the considered areas which depth is within the limits of 50 microns, are revealed, also, MBMs of the fatigue fracture surface, characterizing borders for crack increment in one FC between them. On the observable fracture surface morphology it is seen such 4 MBMs, and there are blocks of fatigue striations, which spacing makes about 0.1 microns (see Fig. 4) are observed on the fracture surface after the “streamlet-like” relief. Fatigue striations orientation shows that they are created from the vibrating loading generated from the blade, or the disk fluctuations, as well as an initial zone.

On separate areas, along the initial fracture zone at the surface of the disk groove for blade, there have revealed drastically transition to transgranular cleavage of globules without the block of fatigue striations, Fig. 4b.

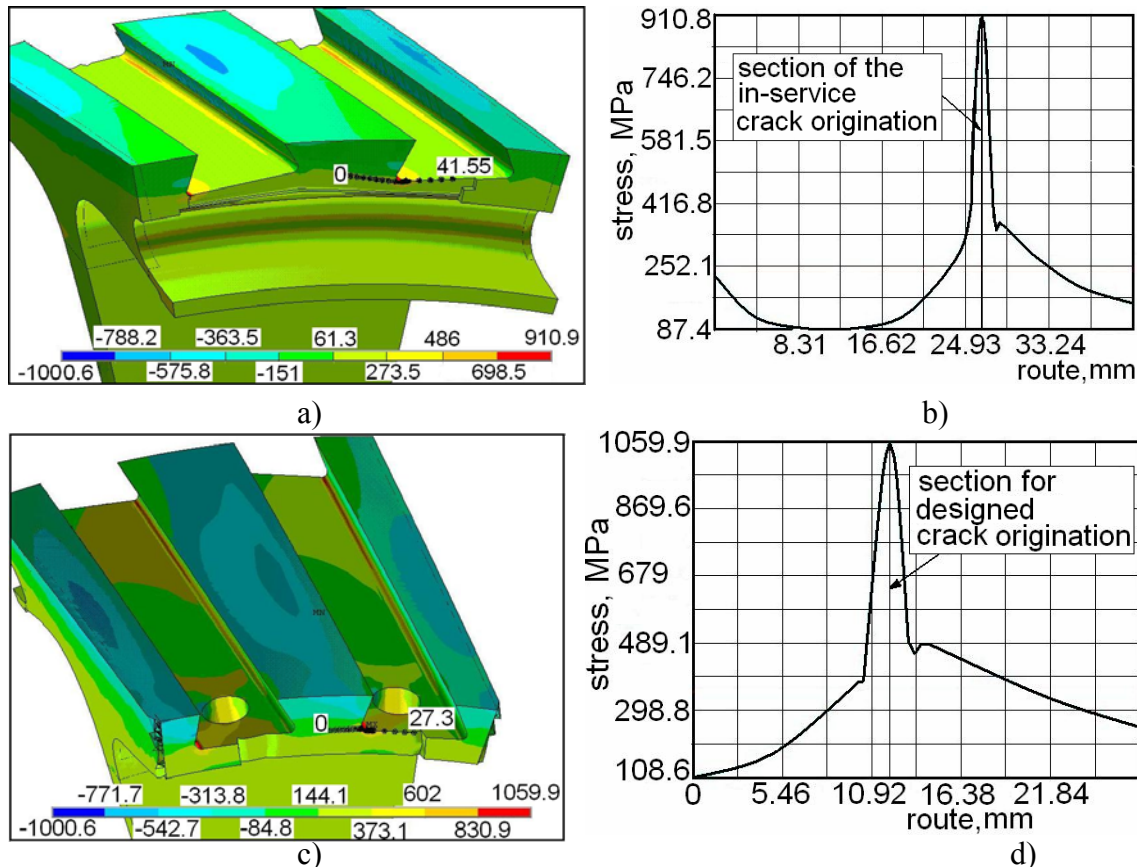
Stess-state distributions of the disk was analysed to comparer stress levels in different areas of the rim parts [4]. It has discovered that the maximum stress level along the disk circle takes place in area of the rim where air stream goes in, Fig.5. In fact, the area of the in-service crack initiation, where air stream goes out of the rim has on 50 MPa less stress level than area with maximum stress-state has that illustrated Fig.5c, d. The same situation takes place for the nominal stresses in the compered areas.

The discovered stress-state of the disk shows that the crack initiation placed in area with less stress-state for LCF regime than has area, which used for estimation of in-service disk durability during its design. It is evidently contradiction between stress-state and durability estimation for the disk failure in LCF regime, it should be crack initiation in another area, with realized in sevice failure.

Figure 5. Overview of the stress distribution in rim area with indicating stress level for the rim side (a) where air stream goes in and (c) out and (b), (d) stress dependence on the route in the direction shown in (a), (c) for the same rim area respectively.
