Crack Path for In-service Subsurface Fatigued Turbine Blades

A. A. Shanyavskiy¹

¹ State Centre for Flights Safety, 141426, Moscow region, Chimkinskiy State, Airport Sheremetievo-1, PO Box 54, Russia, shana@flightsafety.msk.ru, shananta@stream.ru

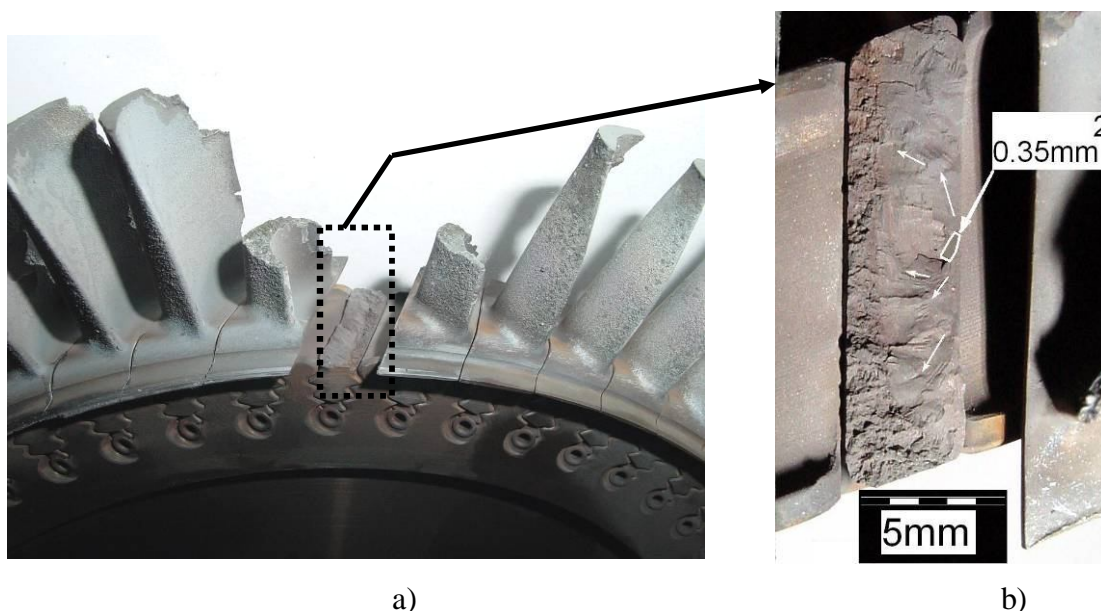
For in-service engines of M-601 there were seen rare cases of TRB in-flight fatigue failures with subsurface crack origination (Figure 1). The fatigued blades of various engines had flown in the range of (370-1670) hours at the moment of their failure ispite of design-service-goal not less than 10000 hours. That is why first thinking about cause of the TRB failures was addressed to creeping process for the crack subsurface origination because of bad state of manufactured superalloy GS6K. This consideration was used to improve technology for TRB but rear failures had appearing again with the same evidence of subsurface fatigue crack origination.

Figure 1. Overview (a) of the turbine disks with area of first failed and other damaged blades and (b) macroscopic view of this blade fracture surface with indication in square of the crack origination (white arrows show directions of crack propagation).

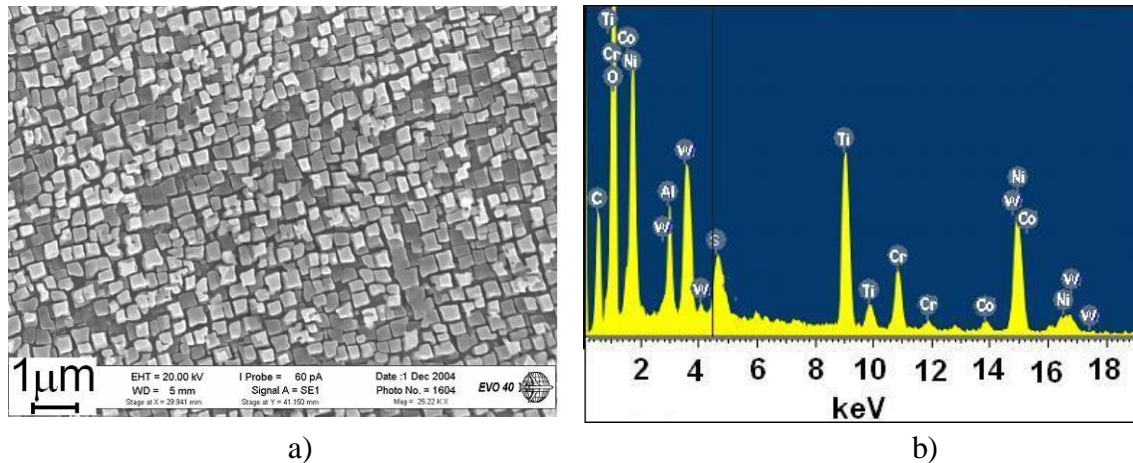
Figure 2. Typical (a) microstructure of GS6K alloy with indication of gamma prime phase (γ') shapes, and (b) example of chemical elements distribution in area of crack origination.

Microstructure of all discussed TRB, fatigued in service, has been attested with scanning electron microscope under magnification not less than 10000 times and it was shown that in each case studied the variation in shape of γ' -phase was not principle from shown in Fig.2. The distribution of grain size and the mean grain size were in the same range that recommended by the introduced manufacturing procedure for TRB.

Material average chemical composition has been compared with their local distribution based on the X-ray analyses in scanning electron microscope with using special device of INCA-instrument, see Fig. 2b. Results of the analyses have shown that by the main chemical elements there not principal difference in their distribution as recommended for investigated superalloy GS6K.

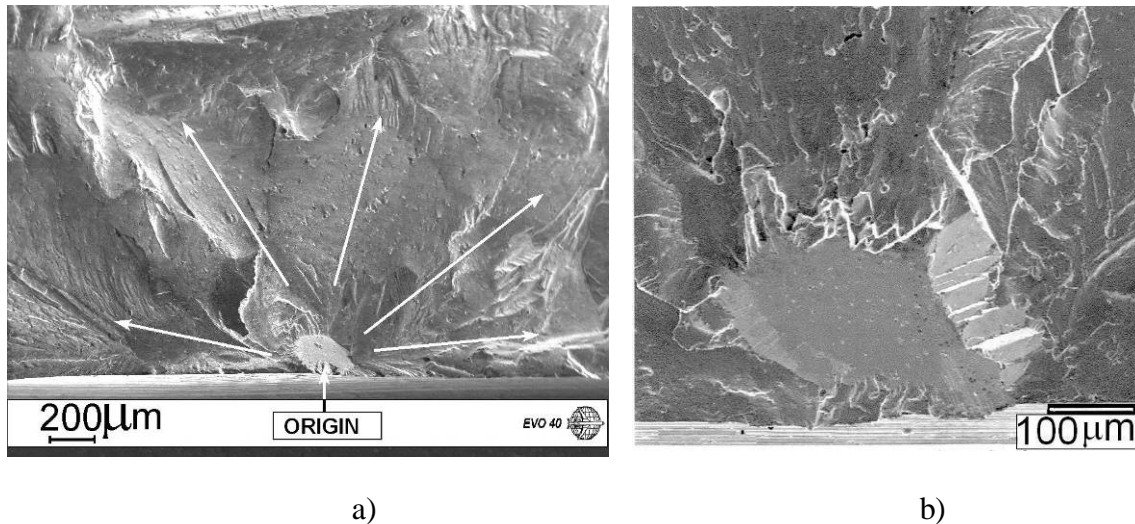
Fractographic analyses of in-service failed TRB have shown that the crack origination in all cases took place not far from the blade surface, Fig. 3.

Figure 3. Areas of fatigue crack origination in TRB after in service time (a) 1493 hours or 1084 flights and (b) 370 hours or 264 flights.

First flat facet (FFF) is the main fracture surface pattern for all blades which reflect first step of TRB fatigue cracking independently on the in-service number of flights or operating hours. Cracks have origination in one of the points by the border of the grain or through grain without formation point of origin. Two grains had quasi-brittle cracking with strongly expressed border which divided subsurface and surfacesly TRB fatigue cracking. That is why below will be considered more precisely only features for in-service failed TRB which had flown 1493 hours.

In the invested case, parameters of the Eq. (1) are $HV=430$, and $\sqrt{\text{area}} = (235 \mu\text{m}$ and $350 \mu\text{m})$ for TRB areas shown in Fig. 3. Calculated values of the equivalent stress are near to 317 MPa and 345 MPa respectively for TRb with in-service time 1669 и 370 hours. In the case of $k_p=1.0$ stress level for TRB is in the range of (210-230) MPa being not far from the calculation result based on the database taken from the paper [7].

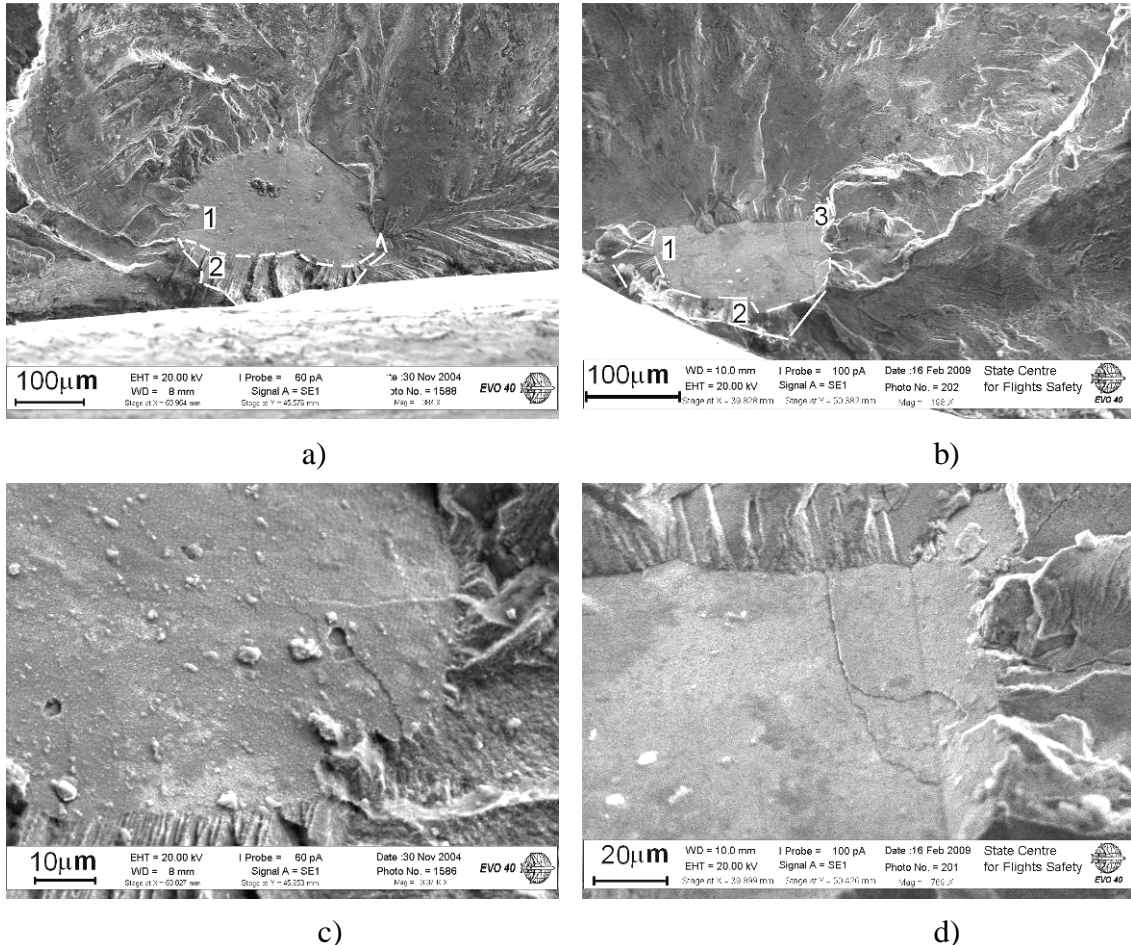
Features of the fracture surface in FFF for TRB have been compared with subsurface pattern of fracture origin areas of EP741 NP alloy specimens fatigued in the stress transition range from VHCF regime to High-Cycle-Fatigue (HCF) regime, Fig. 4. It is clear that compared features of the FFF are the same in both cases. The subsurface FFF has strongly expressed border because of transition from one to another mechanism of material cracking. The similarity in fracture surface features for all FFF reflects the unified mechanism of subsurface metals cracking. It was discussed earlier applicably to Ti-, Al- and Ni-based alloys [3]–[5]. The mode-III mechanism of twisting under compression is the way of the crack subsurface origination for metals in VHCF regime. The FFF subsurface formation starts because of material cyclical weakness in a local volume under compression with twisting due to residual stresses and, simultaneously, diffusion in the weakened volume rest gases or other chemical elements.

FFF on the discussed TRB fracture surface has regular lines but on the specimen FFF there not seen this pattern (see Fig. 4c and 4d). This is not sistematic behaviour for blades fracture surface formation.

Figure 4. View areas of subsurface FFF in the in-service failed (a), (c) turbine blade and (b), (d) in-test fatigued specimen of EP741 NP superalloy formed respectively after in service time 1493 hours or 1084 flights and 9×10^5 cycles with stress level 960 MPa and $R=0.05$. Numbers “1”, “2”, “3” indicate cracked grains. Photos (c) and (d) are magnified view of (a) and (b) respectively.

In many cases FFF were with the same smooth surface that is shown in Fig. 4d. The regular lines reflect plastic relaxation acts due to persistence slip bands moving after the FFF formation. For instance, these patterns were seen for fatigued Ti-based alloy with subsurface cracking on the one fracture surface but had not seen on another one [5].

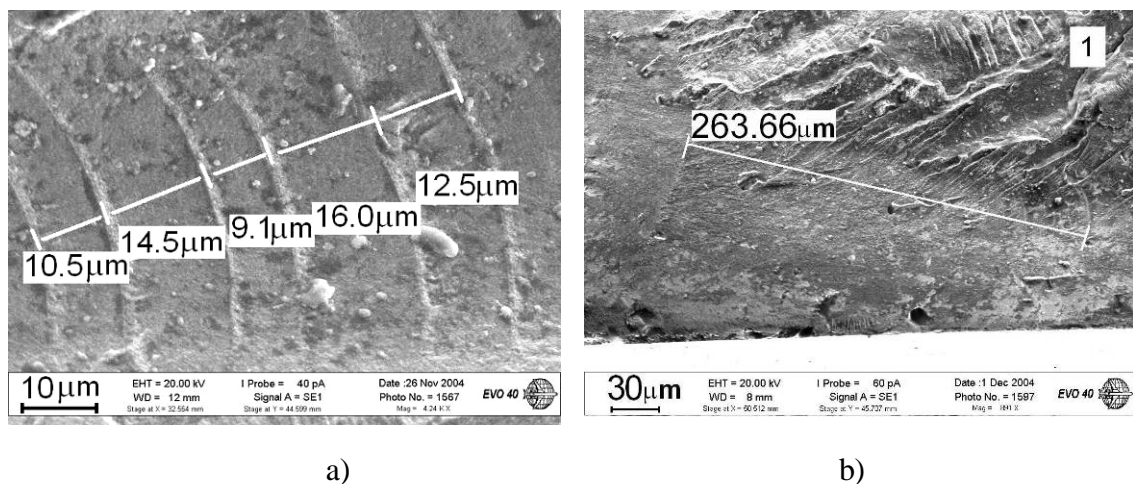
The well-known pattern as meso-beach marks were performed on the TRB fracture surface because of material simultaneously cracking under mode I and II, Figure 5.

Figure 5. Two types of meso-beach-marks have been indicated as (a) – MBM1, and (b) – MBM2, having difference in spacings.

There were discovered two types of meso-beach-marks (MBM): (1) MBM1 with small spacing; (2) MBM2 with larger spacing which included itself some number of MBM1 with small spacing. The MBM formation process had so regular manner that the MBM2 in a number of 8-12 could be systematically seen as one block for one MBM1 (see Figure 5). The block of MBM1 reflects the blade material reaction on the cyclic loads variation during fatigue crack propagation in one flight [1].

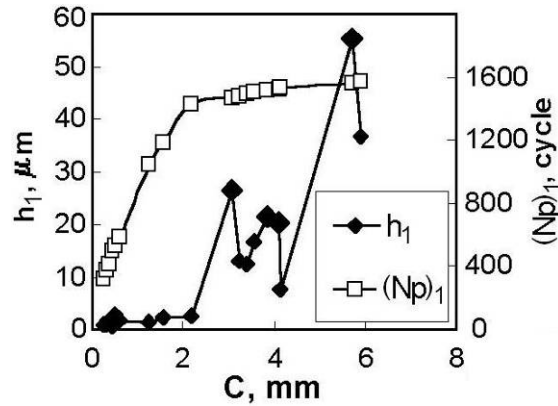
As a result of the measurement MBM1 spacing and calculations number of cycles, $(N_p)_1$, the unified dependence of the MBM1 spacing and $(N_p)_1$ on the one of the semi-crack-length along the TRB surface was discovered, Fig. 6.

Figure 6. MBM1 spacing h_1 and number of cycles $(N_p)_1$ versus crack length “c” in the direction of crack propagation from origin on the maximum distance to fast fracture.

The ratio N_p/N_f between crack growth period and lifetime to failure for TRB was $[160/1084] \times 100\% = 14.7\%$. Consequently, in the VHCF regime there is the ratio N_p/N_f being approximately the same that in the HCF regime after subsurface cracking has transition to through crack propagation.
