# An experimental investigation on crack paths and fatigue behaviour of riveted lap joints in aircraft fuselage

A. Skorupa<sup>1</sup>, M. Skorupa<sup>1</sup>, T. Machniewicz<sup>1</sup>, A. Korbel<sup>1</sup>

**ABSTRACT.** *Effects of variables related to design and production of riveted lap joints representative of longitudinal sheet connections for a pressurized transport aircraft fuselage were experimentally investigated. The specimens from an aircraft Al alloy D16 Alclad sheets of three different thicknesses (1.9, 1.2 and 0.8 mm) were assembled under load control using round head rivets and rivets with the compensator from a P24 Al alloy. For the joints from 1.9 mm thick sheets fatigue tests indicated a dependency of the crack initiation site and crack path on the squeeze force level and on the rivet type. At the same time, increasing the squeeze force led to improved fatigue properties of the joints, specimens assembled using the rivets with the compensator showing fatigue lives consistently longer than joints with the round head rivets. All observed trends have been explained based on hole expansion and load transfer measurements. For thin sheets connected using the round

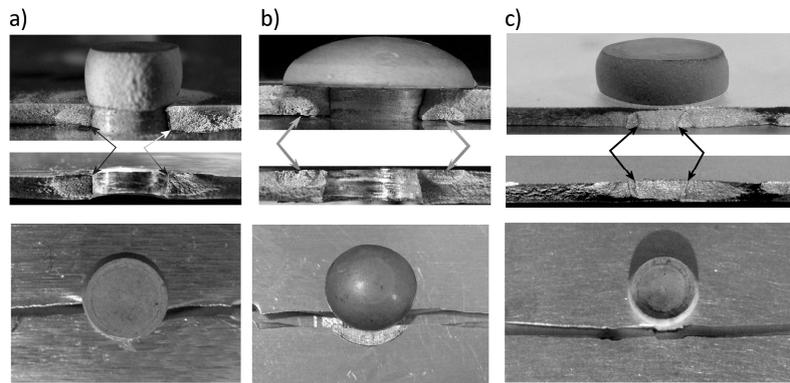
An illustration of the results from Table 2 are fractographic observation results shown in Fig. 4. It is seen that fatigue cracks always initiate on the faying surface in one of end rivet rows, which results from the influence of secondary bending [1]. For a limited squeeze force, the cracks initiate at the edge of the rivet hole and propagate in the net cross section, Fig. 4a. A more intense squeezing of the rivet leads to crack initiation outside the hole, but propagation through the hole, usually shifted above the net cross section, Fig. 4b. For a relatively high squeeze force fatigue cracks nucleation occurs above the hole, near the edge of the clamping area beneath the rivet head, and the crack propagates outside the hole, Fig. 4c. The latter behaviour is partly contributed by fretting [5].

$D/d$	Fatigue life* kcycles	Crack initiation site; Crack shape	Crack path
1.3	81.6	Under driven head; Quarter elliptical	Net cross section
1.4	160.0	Under driven head; Quarter elliptical	Above net section, through rivet hole
1.5	235.5	Under manufactured head; Quarter/semi-elliptical	
1.6	298.2	Under manufactured head; Semi-elliptical	Outside rivet hole

Figure 4. Effect of squeeze force on fatigue crack initiation and path. Explanation in text.

It is seen in Table 2 that the specimens with  $D/d$  of 1.5 and 1.6 always failed in the sheet adjacent to the rivet manufactured head, while in the case of  $D/d \leq 1.4$  the crack nucleation and failure occurred in the sheet under the driven head. The above behaviour can be explained based on rivet hole expansion measurements shown in Fig. 5 and load transfer measurements shown in Fig. 6. In Fig. 5a, hole expansion is defined as  $he = (d_e - d_o) / d_o$ , where  $d_e$  is the expanded hole diameter. As shown in Fig. 5a, for  $D/d$  of 1.5 and, especially, 1.6,  $he$  in the sheet next to the rivet driven head considerably exceeds that in the sheet next to the manufactured head. At the same time, Fig. 6 demonstrates that loads transferred by the end rivet rows are almost equal. Consequently failure occurs in the sheet with smaller hole expansion, i.e. under the manufactured head. For  $D/d \leq 1.4$   $he$  in both sheets is relatively small and only slightly larger under the driven head (Fig. 5a). In that case, the negative influence of a much higher transfer load in the sheet adjacent to the driven head (Fig. 6) dominates and determines the failure location. A more uniform load transmission distribution for  $D/d$  of 1.5 compared to  $D/d$  of 1.3 shown in Fig. 6 stems from lower flexibility of rivets installed with a higher squeeze force [1].

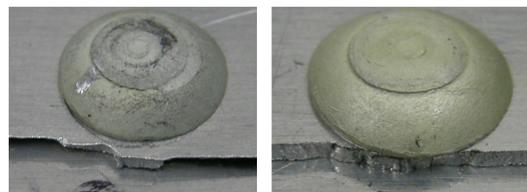
Applying the rivets with the compensator to connect thin sheets brings no benefits compared to the round head rivets because, due to a specific shape of the manufactured head bottom surface (cf. Fig. 3b), significant local imperfections of the sheet beneath that rivet head precipitate failure. For the above reason, fatigue cracks develop in the sheet under the manufactured head and can grow outside the rivet hole, Fig. 8.

Figure 8. Typical failure mode for specimens from thin sheets and rivets with the compensator:  $t=0.8$  mm,  $D/d=1.4$ ,  $S_{\max}=120$  MPa.
