FRACTURE MECHANICS AND METALLOGRAPHIC ANALYSIS OF THE
DEFECTS IN A GENERATOR ROTOR AFTER 190000 HOURS OF SERVICE

A generator rotor was scrapped after 190,000 hours of service and 255 cold start-ups, due to the high number of large defects detected by in-service boresonic inspection. Metallographic and fractographic analyses of defects and mechanical tests in the defect-free regions were performed. The results were used to evaluate according to LEFM theory the possibility of the largest defects to grow under the fatigue loads induced by start-ups. A negligible growth was calculated even for the largest defect; only some local linkage of original shrinkage cavities could have taken place. The outcomes of this study encourage similar analyses to be performed on flawed components, in order to assess the feasibility of further operation.

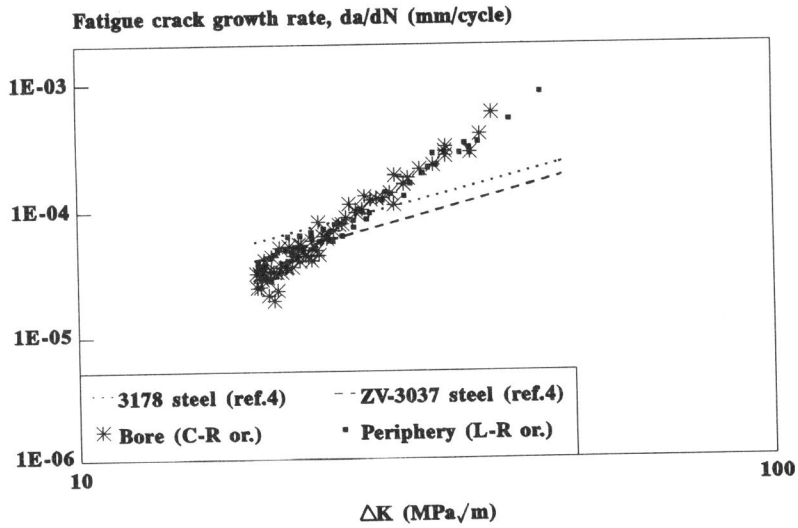
Fatigue Crack Growth (FCG) tests were performed at R.T. on 1"-thick Compact Tension specimens, sampled from regions reasonably free from inclusion clusters and shrinkage cavities, using R-ratio=0.1, test frequency of 20 Hz and the Potential Drop technique to monitor crack propagation. FCG data in the range ΔK > 25 MPa√m revealed higher crack propagation rates with respect to data obtained in similar tests on steels of this class (4), Figure 2. The Paris curve was

1. The material is in a rather brittle condition, but this is not due to service. The fatigue crack growth data experimentally obtained in tests on specimens sampled from the defect-free regions are significantly larger than similar materials' data.

Figure 2 Comparison between trend of FCG data measured on the generator rotor in the Paris' regime and those reported in ref. (3) [R-ratio = 0.1].

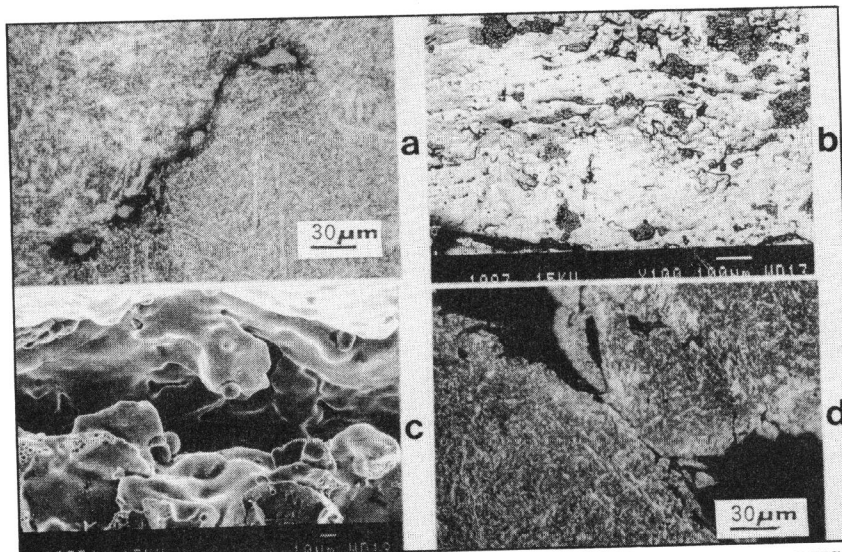
From microscopy observations of the regions where previous boresonic inspections had revealed the presence of defects, it was possible to conclude that those indications, that might be suspected to be cracks and must be treated as cracks in the integrity analysis of the component, were actually inclusion clusters (mainly MnS, Figures 3a and 3b) and shrinkage cavities (Figure 3c) formed during ingot solidification. Fractographical evidence of fatigue crack extensions (i.e. striations) was found only in very local areas, suggesting that fatigue loading was likely to cause interlinkage of already existing defects (Figure 3d), in regions where high ΔK values were present due to local stress intensification caused by particular geometrical asperities of the defects. This cracking phenomena did not propagate into the defect-free material (note that FCG data in Figure 2 refer to defect-free material), where indeed no evidence of transgranular fatigue cracking was ever observed.

3. The defects were found to be inclusion clusters and shrinkage cavities, i.e. existing prior to service.
4. Subcritical crack growth due to fatigue mechanisms was observed to occur only in local areas, as an interlinkage between adjacent defects.

Figure 3 a) MnS inclusions (Optical Microscope); b) MnS inclusions (SEM-BKS-COMPO); c) Shrinkage cavities (SEM); d) Example of linkage (Opt. Micr.).
