FAILURE ANALYSIS OF A GENERATOR ROTOR WITH A DEEP
CRACK: FRACTOGRAPHY AND FRACTURE MECHANICS APPROACH

V. Bicego*, E. Lucon*, C. Rinaldi* and R. Crudeli†

A generator rotor was retired from service due to a large transverse crack. It was clarified that the crack started at a surface defect placed at the root of a tooth, critical under the anomalous high flexural stresses induced by particular problems typically occurring at the beginning of rotor life. During the following years, the crack grew mainly during transients and not during operation; that was the reason why the crack could not be detected by on-line vibration monitoring for most of the time.

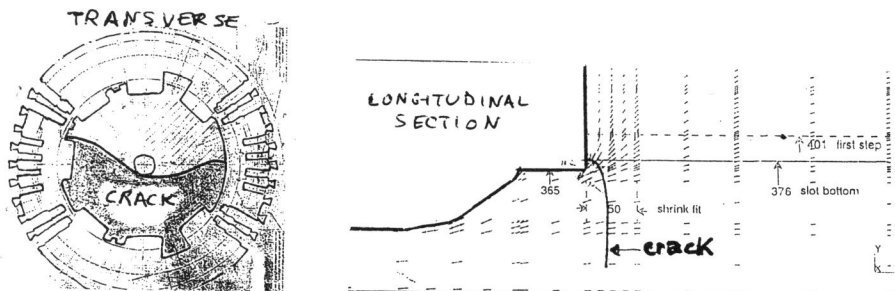
This paper deals with an activity of failure analysis performed by CISE and ENEL on a generator rotor, which was retired from service after approximately 131000 operating hours and 400 start-ups, due to a remarkable increase in the amplitude of vibrations during rotation. A campaign of in-situ ultrasonic inspections, carried out with winding installed, revealed the presence of a large crack inside the component, located close to the driven end-face; such findings were confirmed by the results of an analytical simulation study of the dynamic behaviour of the rotor, accounting for a hypothetical defect. After dismantling the coils, a large transverse crack became actually visible, extending on the external surface of the rotor for more than 180°. A large transverse section, containing the defect, was cut from the rotor and subjected to additional non-destructive inspections (US and magnetic particle inspection); on the basis of such indications, further machining was performed, in order to obtain the thinnest possible slick containing the whole crack, which extended through approximately 60% of the cross sectional area. The slick was broken open by high-cycle fatigue in CISE Materials Laboratory, by means of a servo-hydraulic test machine with 250 ton capacity and using low loads in order to avoid serious disturbances to the original crack tip. A sketch of the rotor transverse section with the crack is shown in Fig. 1.

Fig. 1 Sketch of the crack in the rotor

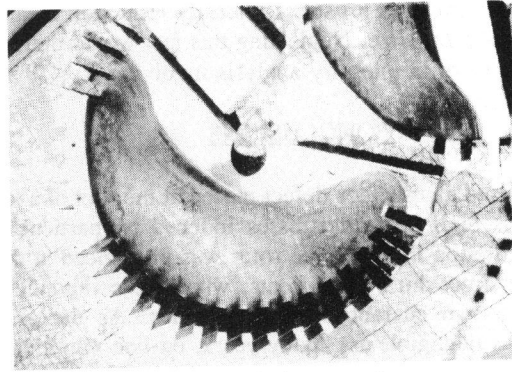
The general aspect of the fracture surface is shown in Fig.1. The elliptical shape of the beach marks indicates clearly that the crack started at the root of the first tooth near to the magnetic pole. At the starting site, a big forging defect is emerging at the root of the tooth (Fig.2). Fractographic analyses in a scanning electron microscope and metallography on a section demonstrated the defect to be a lap, about 3 mm long at the surface along the tooth root and almost 20 millimeters in depth. The sketch in Fig. 3 shows the two projections of the defect on the circumferential and transverse plane of the rotor (in both cases a semielliptical shape was chosen to approximate the actual shape).

The crack propagation phase is clearly due to high cycle fatigue induced by flexural longitudinal loads, typical of both service conditions and vibrations at critical frequencies during transients. A good correlation was found between the history of the rotor and the sequence of the beach marks (B.M.) on the fracture surface, until the previously described first beach mark near the crack origin. In particular a crack stop along half of the crack front was recognized

Fig. 2 Fracture surface of the fatigue crack

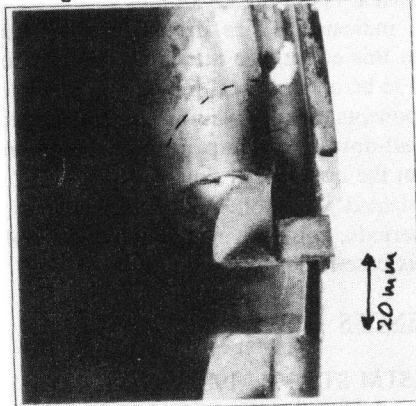
From the lap a circumferential crack originated (possibly due to radial load cycles associated to start-ups); but the crack after some millimeters changed its direction gradually towards a transverse plane, indicating that since the beginning flexural longitudinal loads gave a contribution.

Fig. 3 Defect emerging at the tooth root and the first beach mark

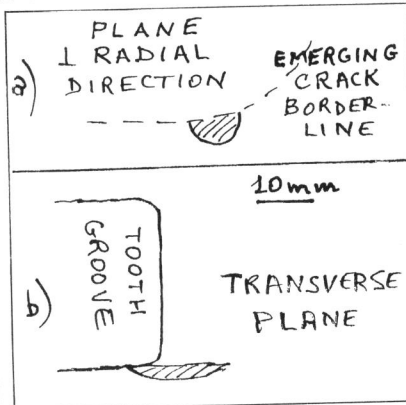
The ΔK values at the initial defect were estimated using the stress values obtained in radial and in longitudinal direction by finite element calculations made by the constructor. Under such loads, the Newman-Raju (1) formulas for semielliptical surface defects were applied to the two projected defects of Fig.3, obtaining $\Delta K = 18 \text{ MPa}\sqrt{\text{m}}$ for radial stresses applied to the circumferential projection of the defect (Fig.3a) and $\Delta K = 1.8 \text{ MPa}\sqrt{\text{m}}$ for longitudinal stresses in normal operating conditions. At the beginning of its working life, during some of the first start-ups, some problems of oil film instability (due to particular design of main bearings) induced anomalous resonant vibrations at 1,000 rpm, for several minutes; from vibration monitoring and calculations, a load peak of $\sigma_{\text{max}} = 120 \text{ MPa}$ was evaluated for these fatigue cycles at $R = -1$. In this condition, $\Delta K = 10 \text{ MPa}\sqrt{\text{m}}$ was calculated at the projection defect of Fig. 3b. As described in the following section, these ΔK values were compared with threshold ΔK values and the defect resulted to be critical for fatigue crack growth. The number of cycles estimated from on-line vibration monitoring during that anomalous behaviour was large enough (about 45000 cycles) to allow consistent crack propagation. Actually the first beach mark, corresponding to the beginning of normal operation is at 15 mm on one side, 50 mm on the opposite, 30 mm in radial direction (all these are distances from the defect location).

Fig. 4 Defect projections: a) circumf. plane; b) transverse plane.

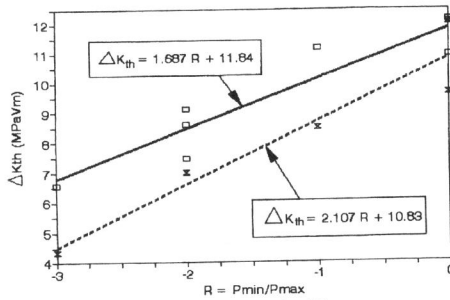
A reduction of the critical defect size and an increase of crack growth kinetics in the first propagation stage is given by the violation of the Principle of Correspondence of the Fracture Mechanics theory, under partly compression fatigue. There is some evidence in literature (3) that under compressive fatigue loading the fracture mechanics parameter ΔK loses its general capability of uniquely correlating crack growth rates, and the crack growth rate becomes dependent, for fixed values of ΔK , R and crack size a , on the value of σ_{\max} (or σ_{\min}); or equivalently, for fixed values of ΔK , R and σ_{\max} , on the value of a . The values of ΔK_{th} measured in specimens with varying amounts of compressive stresses and final crack lengths indicate such a dependence, as shown in Fig.6. Consequently, once a defect has been detected by NDT, the evaluation whether it will be frozen or not, must take into account the decrease of ΔK_{th} values at decreasing defect sizes. As a general example for a NDT-revealed defect, 3 mm in size, semicircular, under fatigue with $R = -1$, the threshold condition can be roughly estimated from the two equations (the latter obtained by best-fitting test results):

Fig. 5 ΔK_{th} vs stress ratio R

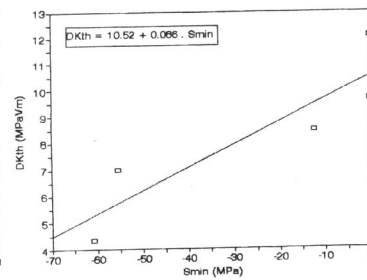
the solution being: $\sigma_{\max} = 68$ MPa and $\Delta K_{th} = 4.7$ MPa \sqrt{m} . (It must be remarked that a maximum longitudinal stress of about 60 MPa can be evaluated at the tooth root, due to rotation cycles of this rotor at resonance frequencies during transients). In the traditional approach, not considering this violation of the correspondence principle of Fracture Mechanics at $R < 0$, one would simply use the threshold as determined from the classical tests involving large cracks: $\Delta K_{th} = 8.7$ MPa \sqrt{m} in this case. The size-dependence of the threshold is a key effect, causing cracks to propagate that otherwise might be supposed

Fig. 6 ΔK_{th} vs σ_{min}
