**SOME OBSERVATIONS OF FRACTURE SURFACES  
OF Fe-Si ALLOY SINGLE CRYSTALS**

**Ružica R. Nikolić\***

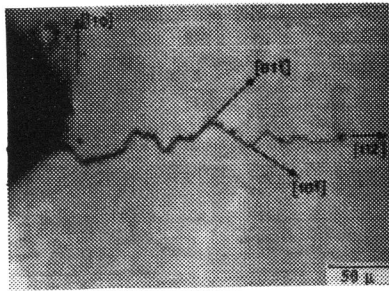
Figure 1 presents the side surface of the specimen # 1 showing the fatigue crack. The crack is growing in the zig - zag way along the slip plane traces forming the macroscopical - "required" growth direction. This specimen did not brake (\*), and this picture is presented only to show the difference in growth directions on macroscopical and microscopical levels. Figures 2 (specimen # 2) and 3 (specimen # 3) show that the blocks of material on the fracture surfaces are either parallel to or make an angle with the macroscopical crack growth direction, depending

Figure 1 Side surface of specimen # 1

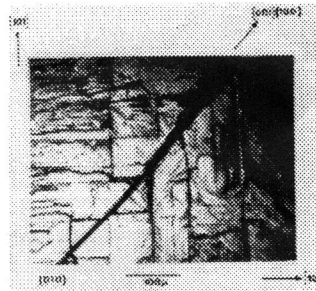
whether the macroscopical and crystallographically possible directions coincide or not, respectively. An attempt was done (Nikolić (2)) to explain this phenomenon as a function of the slip plane traces directions positions with respect to lines of discontinuities between the constant stresses sectors in the full solution for the stress field around the crack tip given by Rice (3). If the slip plane traces are parallel to the stress sectors boundaries the deformation is the regular shear, the dislocations are easily emitted from the crack tip, and the material "blocks" are parallel to the macroscopical crack growth direction (Figure 2). If the slip plane traces are perpendicular to the stress sectors boundaries the deformation is of the kink-type shear, an additional source of dislocations is needed, and the material "blocks" make an angle with the macroscopical crack growth direction (Figure 3).

Figure 2 Fracture surface of specimen # 2

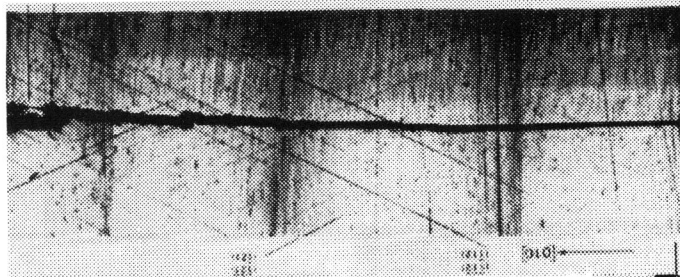
Another interesting feature was observed broken specimen # 3. This was the phenomenon of secondary cracking, Figures 4 and 5. It can be observed how the crack was kinking for 90 degrees several times leaving behind at each "shoulder" secondary cracks of the same direction. From details in Figures 5a and 5b can clearly be observed how the small secondary crack is displaced for the whole crack opening displacement whenever the crack is crossed by an active slip plane. This is better observed in details shown in Figures 5c and 5d. This supports the theory that the crack should arrest at the slip line. Slip lines here disturb small secondary cracks that are in that way losing the energy to propagate.

Figure 4 Side surface of specimen # 3

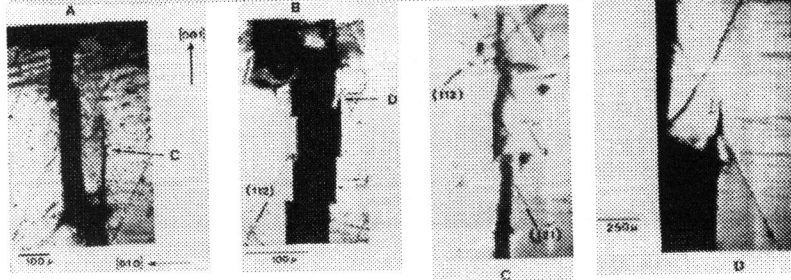
Figure 5 Enlarged details of side surface of specimen # 3

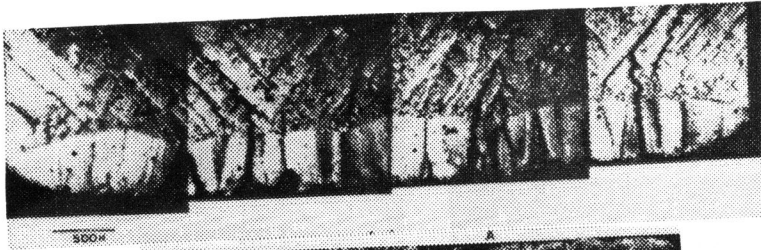
Figures 6 and 7 show the complete fracture surfaces of two specimens of the same orientation, specimen # 3 and 4, respectively. Here one can observe where the fracture starts on the fracture surface itself. Figure 6 shows the fracture surface of one half of the specimen that was broken during the fatigue precracking. It can clearly be observed that there was a small fatigue crack of about 500 microns and that then the fracture continued in the brittle manner across the rest of the ligament. Another important feature is that the front of the fatigue crack is wavy and the angle is neither  $180^\circ$  nor  $45^\circ$  (angles of the slip plane traces). It is obvious that the crack front tended to position itself in the microscopically preferred  $[110]$  but the speed of growth was too large for it to achieve that. Thus the fatigue crack remained wavy with the angle of approximately 15 to 20 degrees with respect to the notch front direction. Figure 7 shows the fracture surface of one half of the specimen that was broken during the four point bending test. There are two reasons for this. The first is that the specimen was loaded at room temperature, and this orientation of the crack is considered brittle. The second reason is that there was a crack-like flaw in the material probably introduced by spark cutting of the notch. It can be seen that the whole fracture had started from point where the

Figure 6 Complete fracture surface of specimen # 3  
Figure 7 Complete fracture surface of specimen # 4

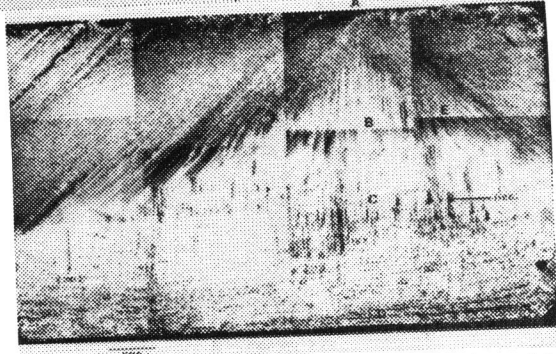
notch was "indented". The fracture spread from that point across the whole ligament in the brittle manner, (Detail A in Figure 8).

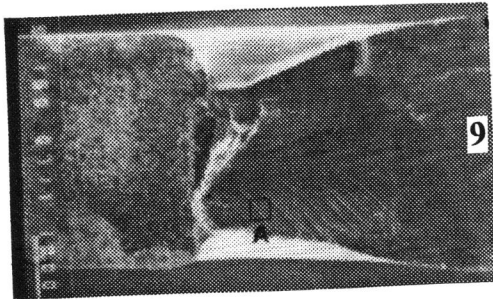
Figures 9 to 11 show the whole fracture surface and two details of it, respectively of specimen # 5, which was of the brittle orientation though it broke in a more or less ductile manner. The specimen was cyclically loaded and unloaded in four point bending, without reversing the bending moment and it broke after 14 cycles. Figure 9 shows the SEM micrograph of the whole fracture surface. The strong necking due to ductile deformation can readily be observed. An interesting feature is shown in next two figures. The material was torn from the surface in such a manner that we can easily make a distinction of the ductile and brittle part of breaking. In the analysis done with the stereo-pair it was concluded that the planes before and after the ductile part of breaking (the white ridge) are on the different levels. The crack thus changes the planes of fracture. They are the planes of the same orientation but at different heights with respect to the original notch surface.

Figure 8 Detail A of fracture surface of specimen # 4  
Figure 9 Complete fracture surface of specimen # 5  
Figure 10 Detail A  
Figure 11 Detail B
