Analysis of Fatigue Cracks Propagation In Complex Structures

***Abstract:** The paper presents the broad study of the fatigue damage of plane wing and its fragments. The point-site, multiple-site, multiple-element and widespread fatigue damage were taken in consideration. It was observed that the design changes could be linked with damage specification. In the case of the object with WFD (Widespread Fatigue Damage) the new designs were applied. When the object did not show WFD type of damage the changes, which improved the only geometry of the designs, were introduced.*

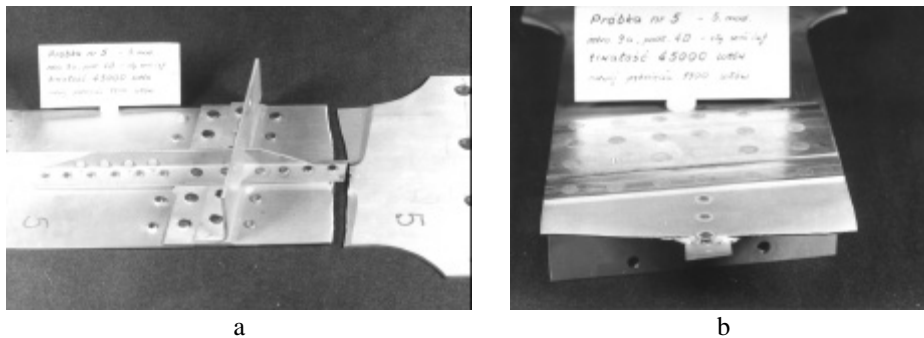
The point-site damages were observed in the skin specimens numbered 1.1.2, 1.2.2c, 1.2.2d, 1.2.2e, 1.2.2f, 1.2.2g, 1.2.2pm and 1.2.2pm_{prim}. In those specimens the cracks occurred in the skin were originated at the rivet hole, where the skin is connected with the stringer. The good example of this type of damage could be specimen 1.2.2pm_{prim} shown in Fig.4. The crack occurred in right skin in the section of the last rivet (nearest to rib No 9) at connection of the stringer link with the right hand skin.

Fig. 4. The course crack in specimen 1.2.2pm_{prim}, a – view from the stringer site, b – the fracture.

five times if one compare it with sample 1.1.1 durability, whereas at the specimen 1.2.2_{pm_{prim}} case the increase was eighteen times against the sample 1.2.2.

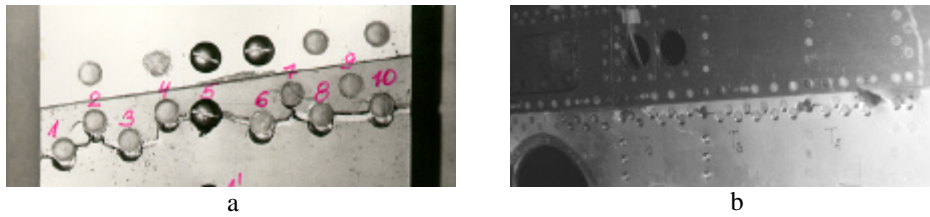
The multiple site damage occurred in specimens 1.1.1pm, 1.1.3pm, 1.1.2.2, 1.2.2a, 1.2.2b and segment 1.2. The course of crack in specimen 1.2.2 was shown in Fig. 5a. The lower skin sheet has fracture along a zigzag pattern situated in between the rivets linking it with the upper skin sheet. The analogous

course of the fracture took place in segment 1.2 what is in show in Fig. 5b. This type of the damage has also occurred in the wing after modification (1pm) in the wall of front wing spar. The cracks originated at the bigger hole for the fuel sensor, Fig. 6 [3, 6]. The cracks started at two holes of severe fastening of the fuel sensor.

Fig. 5. The course of crack propagation, a – in specimen 1.2.2, b – in segment 1.2.

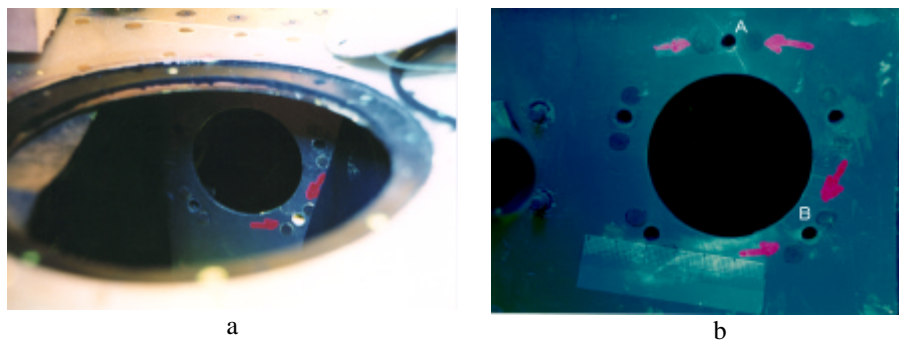
Fig. 6. The course of crack in wing front spar revealed with luminescent-penetrant method (after disassembling of the fuel sensor), a – seen through the opening in nose skin, b – after disassembling of nose skin (UV picture).

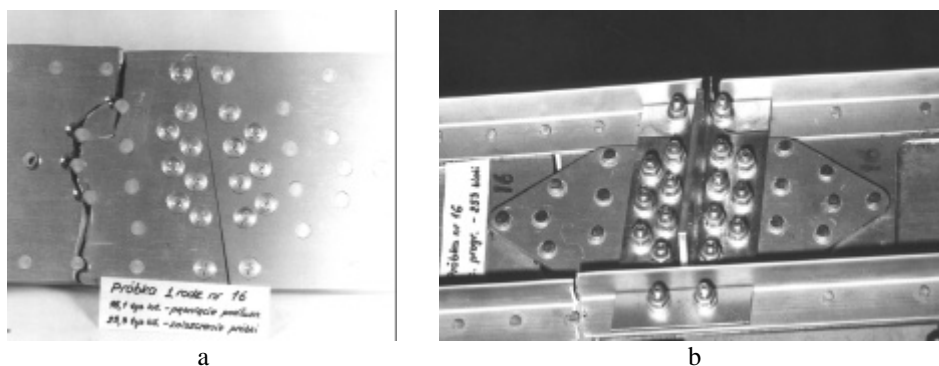
The multiple element damage occurred in specimens 1.1.1, 1.1.1a, 1.1.1b, 1.1.1c, 1.1.1d, 1.1.1pm, 1.2.1 and, in segments 1.1, 1.1pm, 1.2, 1.2pm and 1.2pm_{prim}. In specimen 1.1.1d the fatigue cracks occurred at left skin (see Fig. 7a) and at the upper stringer (see Fig. 7b) [6]. Whereas in 1.2pm case (see Fig. 8) the fatigue cracks occurred at the hatch frames, the circular and oval, and at the skin and stringer 1D [6].

Fig. 7. The crack course in specimen 1.1.1d, a – the skin side view, b – the stringers side view.

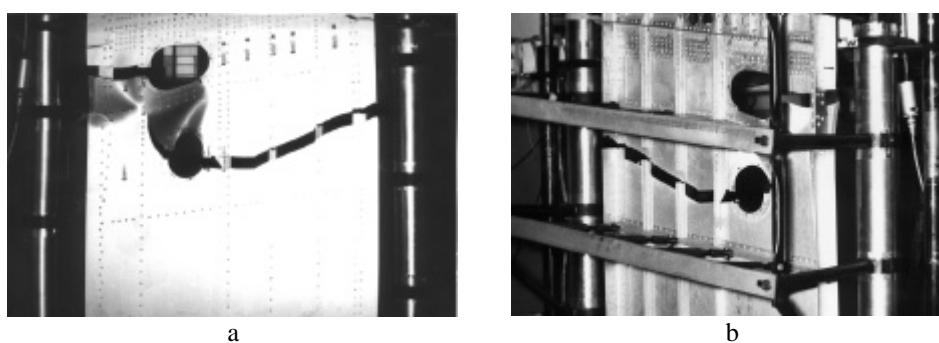
Fig. 8. Crack propagation in segment 1.2pm, specimen No. 5, a - seen from skin side. The crack originated at the rear spar propagates up to the oval hatch frame. The skin between the oval and circular hatches lost of its stability. The crack originated at the circular hatch ends at the front spar. b - stringers side view.

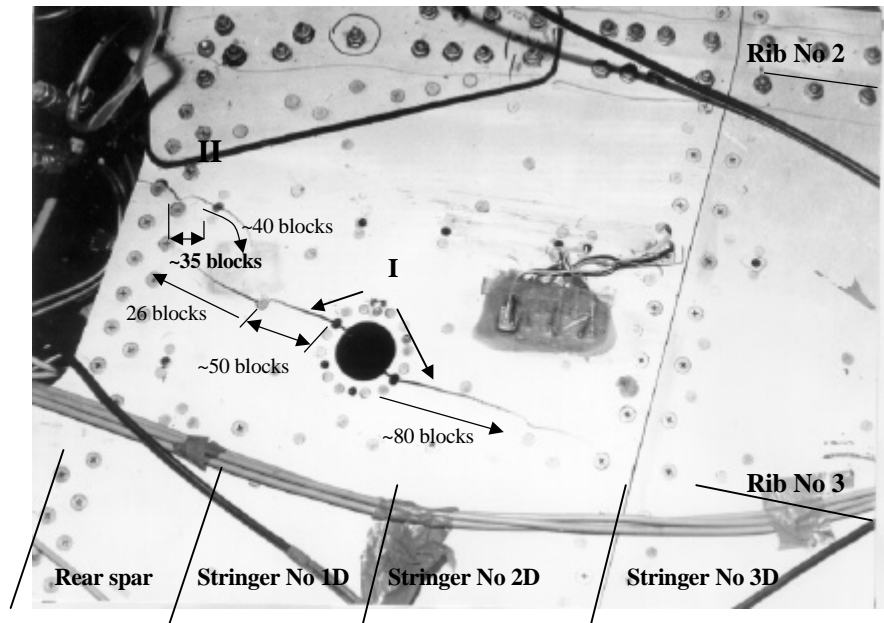
The second *multiple element damage* of wing 1pm [2,6] has the nature of *widespread fatigue damage*. The skin crack was accompanied (see Fig. 9) by the fractures of the rear spar (see Fig. 10a), stringers 1D (see Fig. 10b) and 2D. The full wing destruction was avoided by precise positioning of the limiters of the actuators. Also, WFD character had MED of specimen 1.2.1 and, MSD specimen 1.2.2 (see Fig. 5a) and segment 1.2 (see Fig. 5b).

Fig. 9. Illustration of the crack propagation between ribs Nr 2 and 3 in left wing skin.

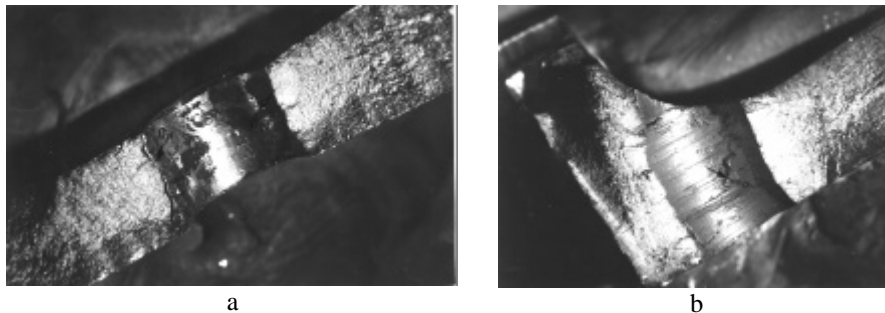
Fig. 10. The fractures at: a – rear beam, b – stringer nr 1D
