Failure Analysis of Two Sets of Aircraft Blades

Abstract. This paper analyses the failure of two blades, coming from different aircraft engines. The first one corresponds to the high pressure compressor manufactured in a 718 nickel base superalloy. The failure analysis carried out on this blade points towards foreign object damage (FOD). The second set belongs to the high pressure turbine of another engine. Scanning electron microscopy attributes the first fail to the premature failure by a thermo-mechanical fatigue mechanism of one blade with an inadequate microstructure. The remaining blades of this set, which possess a correct microstructure, failed due to the impacts of the debris generated by the fracture of the first one.

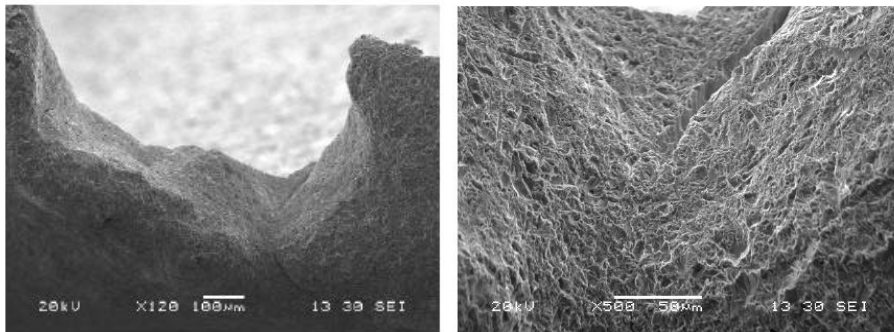
Unfortunately, this thick layer precluded observing the actual fracture surface and detecting the fractographic facets which are present. Consequently cleaning was required to eliminate this layer but this operation can rub out these facets. In order to reduce this risk, firstly, a kindly cleaning was used but most of the deposit remained still adhered. A second cleaning, using a stronger agent, damaged some zones of the fracture surfaces, rubbing out the finest facets, but allowed detecting the ductile dimples which were present in the fracture surface pointing towards microvoid coalescence as the operating mechanism supporting the hypothesis which attributes failure to impact(s). Figure 1 (left) exhibits a low magnification micrograph of the damaged zone of one blade. The morphology of this damage is very similar to that reported in a work where small hard projectiles were fired at high speed against blade like fatigue specimen [7]. This represents a new support for the hypothesis that associates the failure to the impacts of foreign hard objects. On the right hand side of this figure it is presented a micrograph, taken in the same area, confirming the above commented presence of ductile dimples, and the operation of a microvoid coalescence failure mechanism.

Figure 1. Damaged zone of one blade showing ductile dimples (left). Higher magnification of the same zone (right)

One new support to this hypothesis which blames the impacts of foreign objects for the failure of the blades is given by the measurement of Vickers hardness, carried out on these metallographic samples. Values recorded in the impact zone are significantly higher (40HV0.5 more) than those obtained in the material away from the failure zone, this increase being associated to the strong deformation caused by the impacts. A more detailed discussion of this point is offered in reference [6]. Consequently, a conclusion attributing the failure of these blades to FOD was reached.

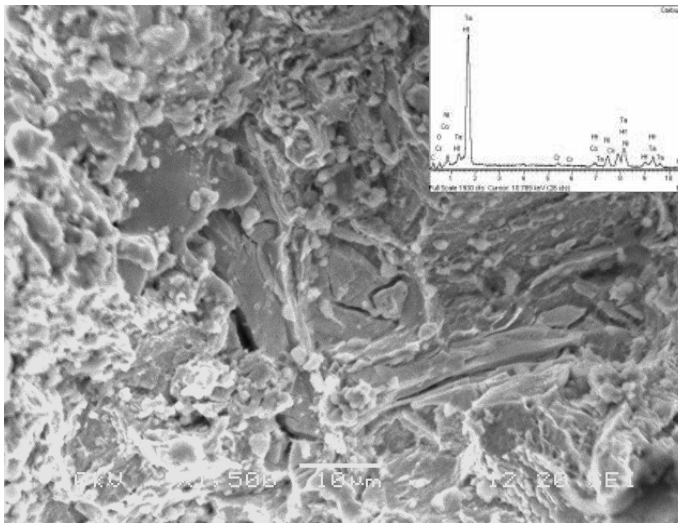
Figure 2. Carbides on the fracture surface of the presumably first failed blade and chemical analysis of one of these carbides.

Once again, visual examination revealed that the fracture surface was covered by a layer making difficult to observe the fractographic facets which are present below. Fortunately, in this case, it was possible observing the different morphology of one blade when compared with the other ones. One of them, which presumably was broken in the first place, exhibited a morphology pointing towards thermo-mechanical fatigue as the operating mechanism. A more thorough examination using the stereoscopic microscope

allows identifying the periphery of one of the cooling holes as the most probable origin of the failure. Nevertheless, this point must be confirmed or denied by the posterior fractographic and metallographic analysis. On the other hand, the remaining blades showed the topography typical of impact fractures, without the presence of so large carbides.

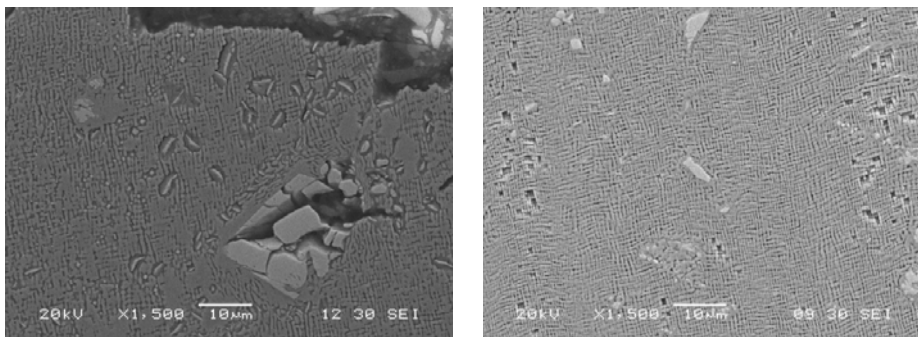
Figure 3. Microstructure of the presumably firstly broken blade (left) and one of those broken by impact (right)

When it was considered that this fractographic analysis would not yield additional information cuts, including the presumably origins of the failures were performed for obtaining the metallographic samples. An interesting microstructural difference was found between the presumably firstly broken blade and the other ones. Figure 3, obtained in the scanning electron microscope examination of the samples clearly shows this difference. On the left hand side of this figure the microstructure of the firstly broken blade can be seen. This microstructure is constituted by a matrix of solid solution and a large number of small γ' phase particles but also very large, broken, primary carbide and some worm shaped white particles are detected. These particles are clearly differentiated from the cubic γ' phase, which is aligned along their axis. X-ray energy dispersive analysis led to a large peak of tantalum, another one, clearly lower, of nickel and a small peak of chromium. Taking into account this composition the identification of these particles as Laves phases or other of the so called topologically closed packed (TCP) intermetallic brittle compounds

looks highly reasonable. On the opposite hand, those blades presumably broken by impact exhibited much finer carbides and no sign of brittle phases. However, γ' distribution is very similar in all the blades pointing towards identical working conditions and rejecting the hypothesis that would have attributed the failure of the first blade to higher temperature associated to a deficient cooling. The micrograph on the right hand side of figure 3 which was obtained at the same magnification, exhibits this microstructure.

As previously commented, metallographic examination of the other blades revealed a completely different microstructure. As it is evident in the micrograph exhibited on the right hand side of figure 2, the microstructure of these blades is constituted by the solid solution of the alloy elements in the crystallographic lattice of nickel, the γ' phase, and some primary carbides. Nevertheless, the size of these primary carbides is significantly smaller than those observed in the firstly broken blade, this fact being easily confirmed by a comparison between the micrographs of figure 2. Moreover, no sign of brittle phases is observed in these samples. Due to all these factors these blades operated much more satisfactorily and they would have not failed if the broken pieces of the firstly failed one had not impacted against them.

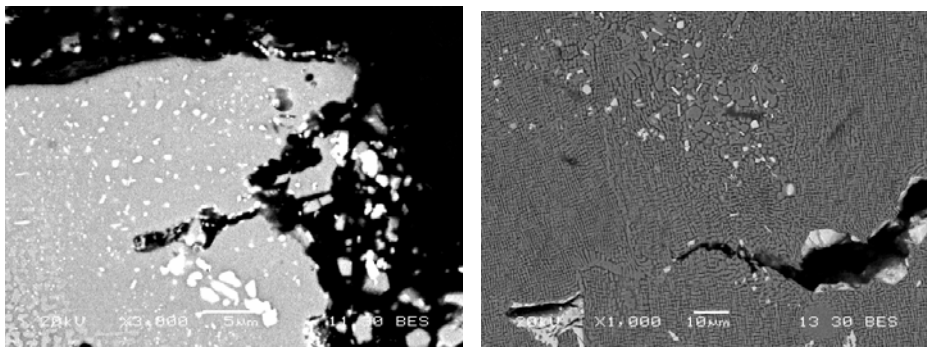
These large carbides, which constitute stress concentration points, are easily broken when subjected to the service stresses. This fracture nucleates a microvoid, which under successive loading fatigue cycles, grows and can coalesce with those at other nearby sited carbides. The final result is a crack which can lead to the fracture. Another aspect that must be conveniently remarked is the presence of the above commented TCP particles, which is considered unacceptable as they negatively affect to the performance of the components. In order to prevent their formation the iron content of the alloys which operate at the highest temperature iron is restricted to a very low percentage. Nevertheless, other alloy elements, such as tantalum, niobium, molybdenum, tungsten or chromium also promote the formation of these phases. The negative effect is not only associated to the nature of these phases but also their geometry plays a role, having been claimed that those of acicular shape promote the failure [8]. In the present case the particles have not an acicular shape but they are elongated enough to promote the failure.

Nevertheless, the most interesting result of the examination of these metallographic samples was confirming that at the origin of the failure of the presumably firstly failed blade a large, broken, primary carbide was present (figure 4, left). Moreover, some other large, primary, carbides can be seen at or near the fracture. Consequently, the hypothesis attributing failure to thermo-mechanical fatigue promoted by the presence of the large carbides is strongly supported. Moreover, it can be observed in this same micrograph the phenomenon designed as alloy depletion, which is the loss of some alloying elements, at the periphery of the blade. However, it was considered that this loss did not contribute significantly to the failure process.

Figure 4. Large size carbides broken at the origin of the failure (left) or along a secondary crack (right)

On the right side of this figure a micrograph showing a secondary crack is presented. Once again the large primary carbides have affected negatively to the in service performance of the blade. This micrograph clearly exhibits that the crack has preferentially progressed along this large broken carbides and some TCP compounds have also contributed to the cracking process. Consequently, a conclusion linking the failure of this blade to an incorrect microstructure is reached.
