Mechanisms of Fatigue Crack Initiation and Propagation in Hydropumps NP-89D of Aircraft Tu-154M of Cast Aluminum Alloy AL5.

Abstract. The paper demonstrates results of quantitative fractographic analyses of in-service fatigued hydropumps NP-89D of cast AL5 Al-based alloy. The model that better describes microcracks threshold taken place from cast porosities is based on Vickers hardness of metal matrix and the $\sqrt{\text{area}}$ of defects (the « $\sqrt{\text{area}}$ model»). Crack growth period estimated by the result of meso-beach marks spacing measurements and stress equivalent calculated by the « $\sqrt{\text{area}}$ model» used to discuss causes of the in-service cracking of the pump casing. Shown that damping of self-oscillations with simultaneous decrease in an equivalent stress level of the hydrounit will allow increase operating time up to pump probable failure to more than 10^{10} individual cycles. It will lead to increase in the period of operation of casings without their fatigue cracking more than on two orders.

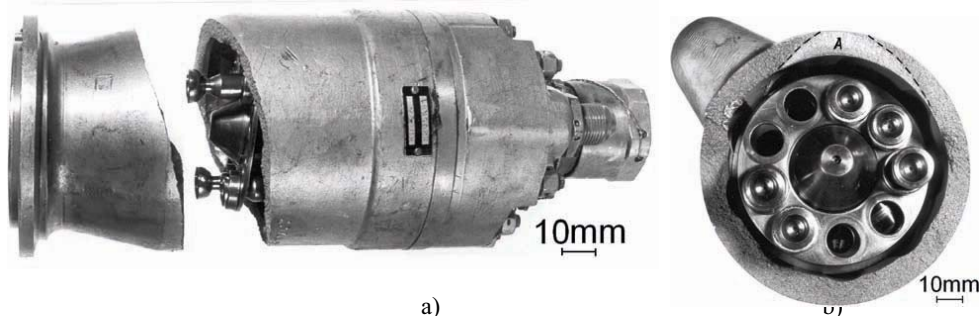
Failure of casings of hydropump NP-89D occurred only on engines of the first power plant (PP №1) and only by planes of a type Tu - 154M. Cracks passed through the section of the casing, shown on Fig. 1. Originally, attempt of the constructive decision of a problem and exception of in-operation casing failures for the account their amplification has been undertaken.

Fig. 1. Overview (a) of the fatigued hydropump NP-89D after in-service time 384 hours, as it followed from the documents, and (b) overview of the fracture surface. The fatigue fracture area shown dashed line and identified by “A”.

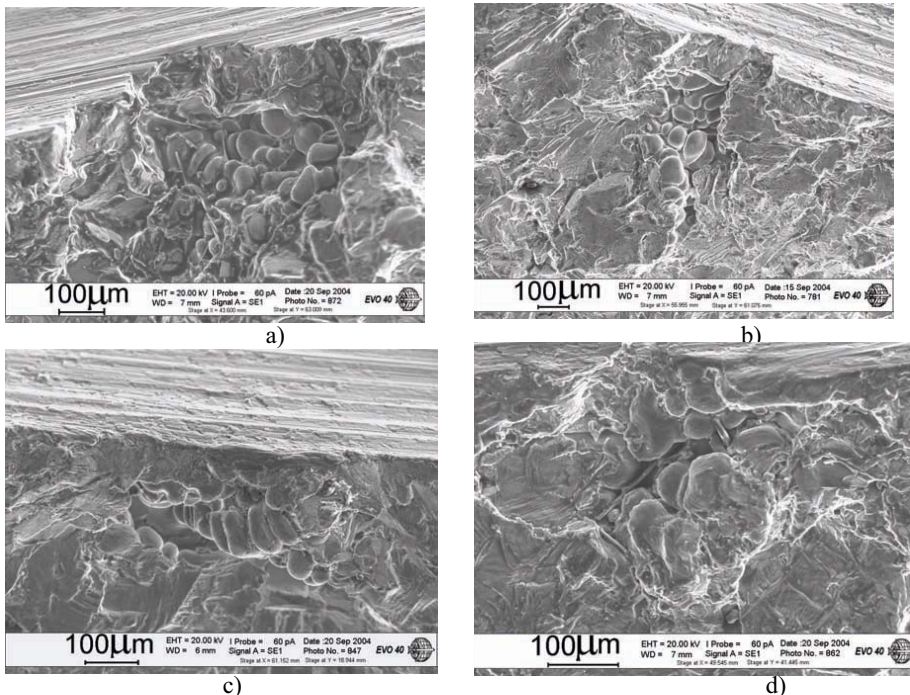
Model of fatigue cracks origination and growth. Performed fractographic analyses of all fracture surfaces have shown that origin of fatigue cracks occurs from several casting defects such as ensemble of porosities, which are located on the short distance from an internal surface of a pump, or is direct about an internal surface of the casing, Fig. 2.

Fig. 2. Cast porosities (a) - (d) placed at the different areas along the circumference of the internal surface of the pump casing. Areas (a), (b) with porosities disposition exactly at the surface, but areas (c), (d) with porosities placed subsurface, but near the internal surface.

Similar casting defects of a material are located on an internal surface of a pump near and far from a fracture surface. That is why, there was seen multi origination of fatigue cracks from defects in pumps during permitted in-service operation time for the first power plant (engine) only is placed on aircrafts Tu-154M.

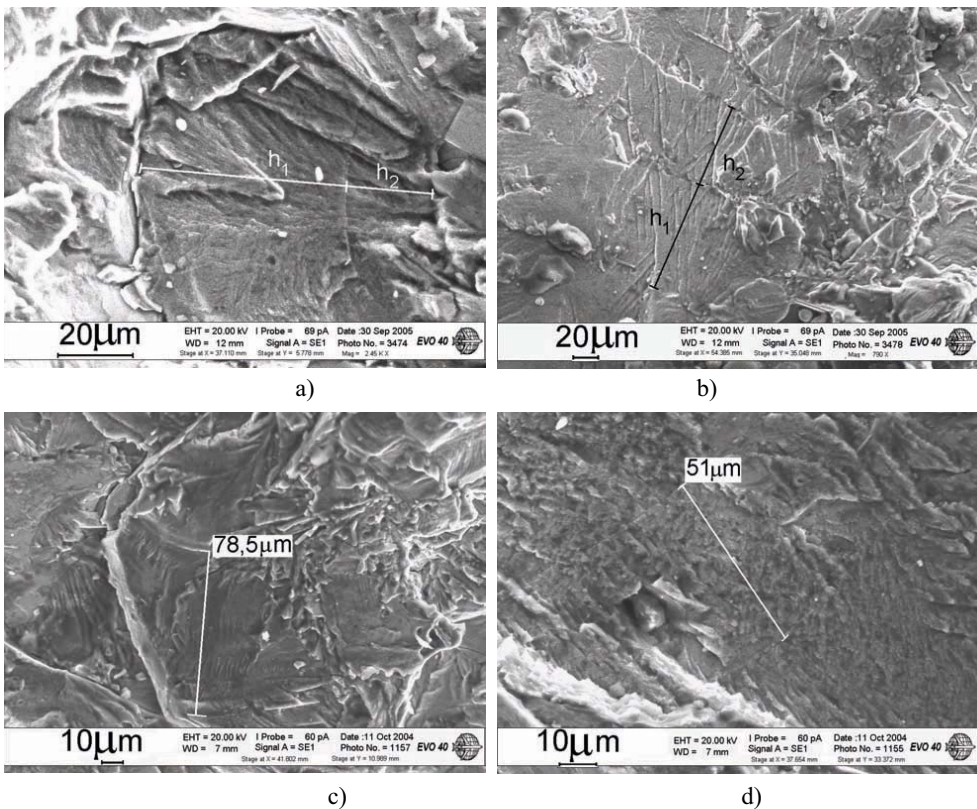
Fracture surface analyses have shown that it is characterized striated features with pseudo-striations, which intersected meso-beach-marks (MBMs), Fig. 3. The revealed morphology of the fracture surface specifies development of pumps fatigue cracking under vibrations in the field of high-cycle-fatigue (HCF). In the direction of the fatigue crack growth from an internal surface «MBMs» have different intensity of their expression on different distance from the origin and tend small increase in spacing, Fig. 4. It specifies that difference between cyclic loads levels, which realize on a transitive regime of in-service operation from flight to flight, is not significant when there is «MBM» formation [1]. The revealed regularities of fatigue cracks origination and propagation in the direction through the casing wall have allowed calculate number of flight-cycles for crack growth period. In considered cases, duration of pumps operation during fatigue cracks propagation in hours has made 587, 717, 1584, 6013 and 2730 (See Table 1.).

Fig. 3. Meso-beach marks with pseudo-striated pattern (a) - (d) discovered on the different distance from origins. Meso-beach marks spacing marked by, h_i , or spacing values indicated for the crack length at the distance near 8 mm.

The minimal growth rate of a fatigue crack makes about 10^{-6} mm/cycle, as it follows from specimens test data of aluminum alloys in the regime of HCF [1]. The maximal in-flight increment of a fatigue crack, according to the lead measurements of a «MBMs» spacing (See Fig. 3), has made about $50\mu\text{m} = 5 \cdot 10^{-2}$ mm. In result we can calculate number of cycles that have been spent during one flight for the fatigue crack propagation - $5 \cdot 10^{-2} / 10^{-6} = 50000$ cycles.

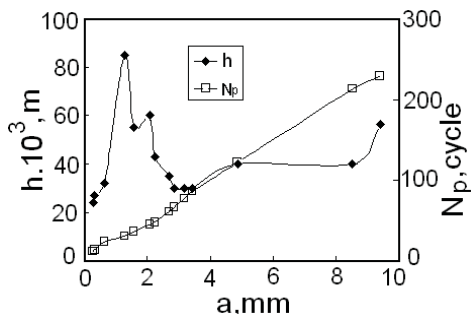
Fig. 4. Meso-beach marks spacing, h , and crack growth period, N_p , in versus crack length «a» in the direction from internal to external surface of the hydropump.

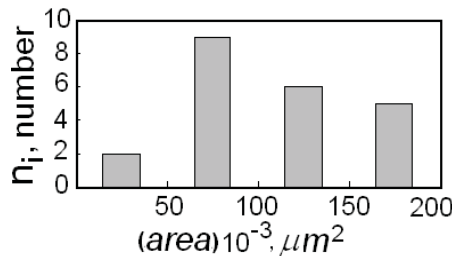
To calculate stress level by the Eq. (1), the area of the concentrator "area" = "A" (μm^2) and hardness of a material «HV» (kg/mm^2) have been measured. The area sizes distribution of the zones of casting defects for all investigated casings and calculated stress levels presented Table 2 and Fig.5. Three values of the area were taken: minimal (min), maximal (max), and average (mean). In addition, three values of material hardness were used: 71, 81 and 95, which also revealed as the minimal, average and maximal values in investigated cases.

Fig. 5. Histogram of number, n_i , zones with material cast defects of indicated and measured «area», discovered in origins of fatigue fracture surfaces of investigated hydropumps after different in-service operation times.

Evidently that the crack initiation in pump casings took place under equivalent stress level in the range of 97-127MPa. The received results correspond to the observed fracture surface patterns and test results of casings in which their stress intensity was equivalent to in-service failed pumps in the HCF regime.
