BRITTLE FRACTURE DURING FATIGUE LOADING AT -10°C OF A FULL-SCALE TUBULAR X-JOINT. INFLUENCE OF AGEING.

J.J.W. Nibbering* and Ren Zijin*

A full-scale cross connection between two tubes has been subjected to high-stress low-cycle fatigue loading at -10°C . A brittle fracture developed after a small number of load cycles. The yield point of the material which originally was equal to 810 N/mm^2 , had obtained a value of 885 N/mm^2 after 5 years of rest. Therefore special attention has been paid to the ageing characteristics.

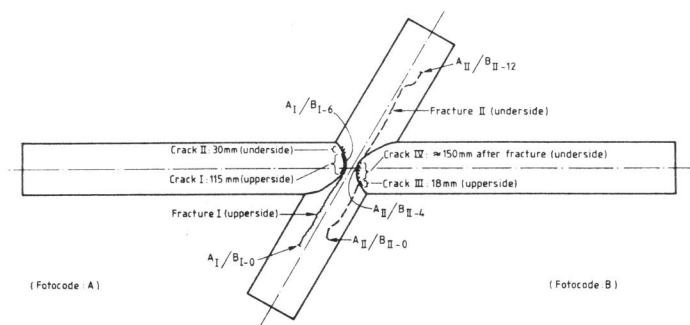
Figure 3. Situation of cracks (view from top side).

Crack initiation. After 1100 fatigue cycles, three cracks were found at three toes of welds where peak strains occurred. The depth of the cracks was very shallow (about 1 to 2 mm). These cracks could only be seen with a magnifying glass under a tension load above 275 ton. The places where cracks occurred are shown in Figure 3.

1) Crack with a length of 115 mm (crack I).

This crack first propagated along the toe of the weld in the wall of the continuous tube. Then one tip of this crack left the toe of the weld in the neighbourhood of gauge 164 and propagated into the longitudinal direction of the continuous tube. It stopped at a point about 80 mm from the toe. Another one left also the toe of the weld and propagated as a brittle fracture in the longitudinal direction of the continuous tube.

2) Crack with a length of 30 mm (crack II).

This crack did not propagate through the wall; in fact the propagation in depth was small.

3) Crack with a length of 18 mm (crack III).

This crack did not propagate through the wall.

4) Crack IV.

This crack had not been detected after the first fatigue stage. It propagated completely through the continuous tube in a brittle way.

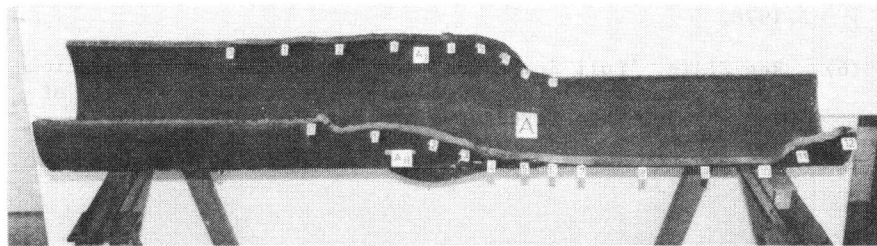
Figure 7. Brittle fractures in transverse tube.

The test ended with a spontaneous brittle fracture. Figures 5 and 6 show the crack paths on both sides of the specimen. Figure 7 shows how far the brittle fracture extended in the transverse tubes. This is astonishing bearing in mind that in the greater part of the transverse tubes hardly any stresses were present perpendicular to the crack path. The starting point(s) of brittle fracture can be seen in Figures 8 and 9. The fracture probably did not develop in one moment but in stages. This can be seen in Figure 8. It seems that at least four partial fractures developed prior to the final one. The strain gauge records confirm this more or less. Of six strain gauges a continuous record was made during the fatigue loading at low temperature. Unfortunately they were not situated close (enough) to the part of the structure shown in Figure 8. But the gauge near point A II-4 in Figure 8 was connected to a peak detector (double amplitude of strain) which became active once in 12-13 load cycles. The result is shown in Figure 10. (The number of cycles refers to those effectuated at -5°C and -10°C). At 1000 there is a clear change in slope which might be due to a

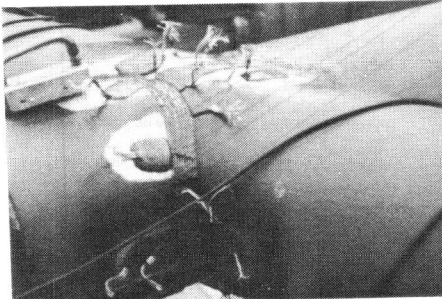
After fracturing of the specimen inspection of the crack surface revealed that there were several points where cracks had started (Figures 5 and 6). This is of interest because it shows that the low fatigue result was not caused by a single, incidentally serious defect. For all cracks started - as usual in defect-free welds - at the fusion line of the welds. Therefore the fatigue result of the specimen may be considered as rather characteristic for this material in its longitudinal direction (crack path). Not any fatigue crack has initiated at the fusion line on the side of the welds in the interrupted tube. Apparently cracks did not develop as easily transverse to the tube axis as they did in line with it; the resistance to crack initiation seems to be better. But it should be acknowledged that the stresses at the fusion line of the interrupted tube were some 20% lower than those at the fusion line of the transverse continuous tube (Ren Zijin (6)).

Figure 5. Crack I (key Fig. 3).
Figure 6. Crack IV (key Fig. 3).

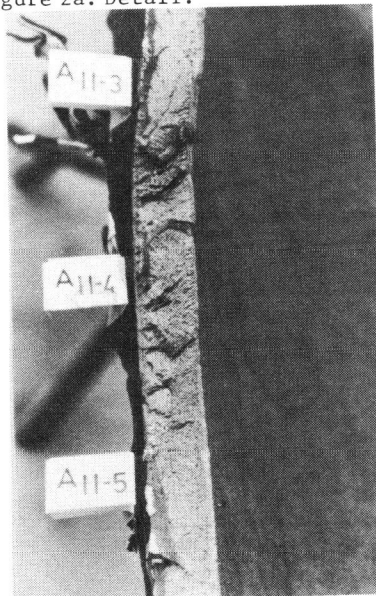
sudden extension of the shallow rusty fatigue crack at the edge of the plate. A second change of slope (to three horizontal points) occurs at about 1130 cycles. Next a small shift of the record is visible (two points), which again can only be caused by rather abrupt crack extension. The starting point of the final fracture will have been either at the left or the right side in Figure 8. It is of interest that the partial brittle fractures occurred mainly in the welded region (weld and H.A.Z.) and not in the base metal of the transverse tube. This confirms what will be discussed in the next section, that the resistance of the unwelded base material against longitudinal cracking was worse than that of the weld and H.A.Z.!

Figure 8. Brittle fracture initiations and arrests. At the right edge shallow fatigue cracks (IV).

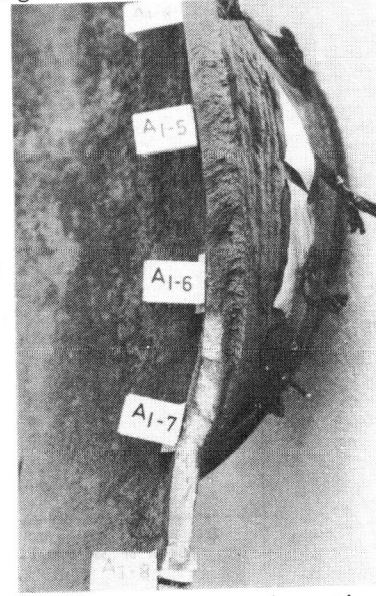
There is a possibility that primary cracking has started at the other side of the specimen (Figure 9), because the surface was more corroded than the one discussed before. Figure 11 which gives the record of the strain gauge in the vicinity of A 1-6 in Figure 11, supports this view. The shear lips all over the length of the fracture surface were rather small (Figure 8 left and right). Only at the origin and at a few intermediate spots and of course at the arresting points the shear lips were thicker. This confirms that the propagation of the brittle fracture occurred very 'easily'. It suggests that the material of the transverse tube would probably also not have been able to arrest cracks at somewhat higher temperatures, say 0°C. This is confirmed in the next section.

Figure 9. Crack I (key Fig. 3).

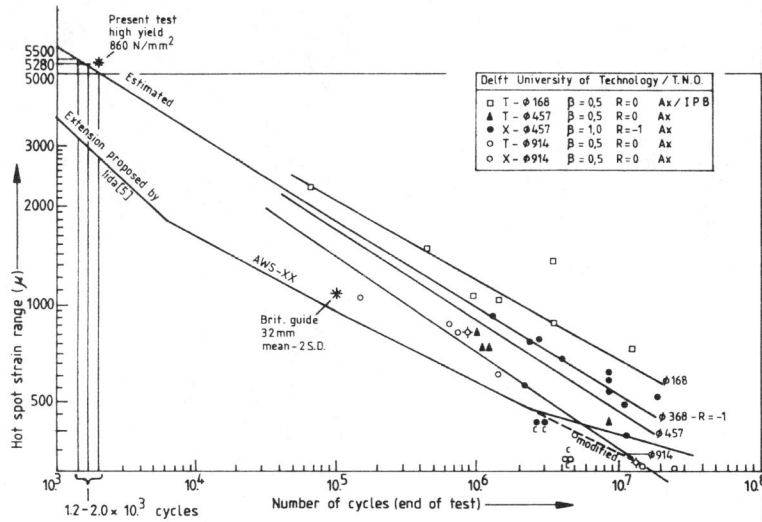
Figure 4 shows results of Dutch experiments by Dijkstra (3) and De Back et al. (4) with tubular joints of various diameters. The well known influence of scale appears clearly. In the figure the AWS-XX curve is also given together with one point of a new British fatigue guidance note for 32 mm thick tubular joints (mean less two standard deviations). The present result is in line with the curve for \emptyset 457 for steel with yield point 350 N/mm^2 and with the one estimated for \emptyset 368.

It would be of interest to know whether the transverse constant compressive load of -400 tons has perhaps had a negative influence on the fatigue behaviour. At this moment no answer can be given, but it should be realized that 400 tons conforms to a stress of only $27\% \sigma_y$, (in (4) no influence was found). However it may be, it is confirmed once again that the fatigue strength of joints made of high strength steels is not superior to that of joints made of lower strength steels. That this is also true for the high stress region is disappointing because when benefits from the use of high strength material are hoped for, it is in that region. That this hope is not fulfilled is due to the residual welding stresses.

Figure 4. Dutch test results on T- and X-joints of circular hollow sections (3), (4).

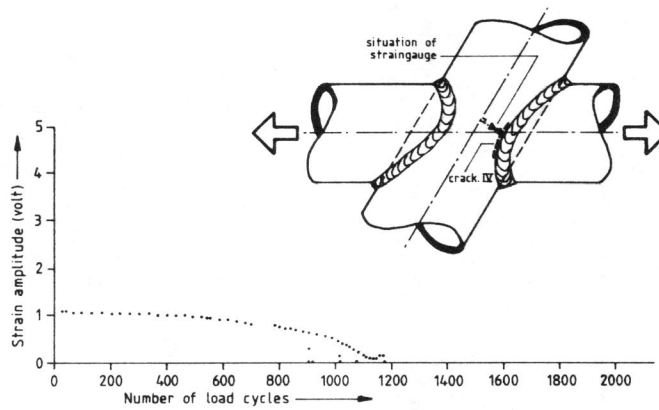
Figure 10. Strain amplitude close to A_{II-4} (Fig. 8).

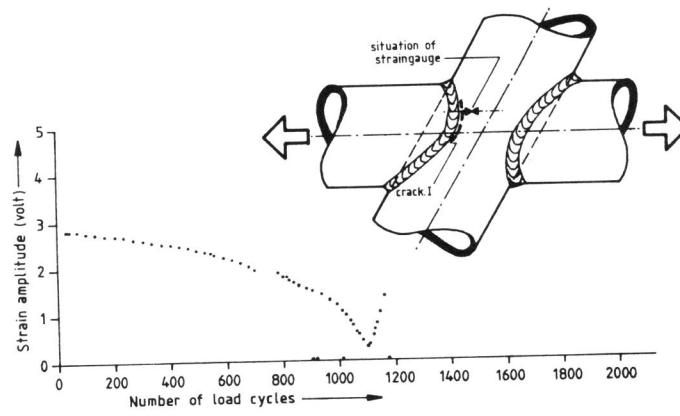
Figure 11. Strain amplitude near A_{I-6} (Fig. 9).

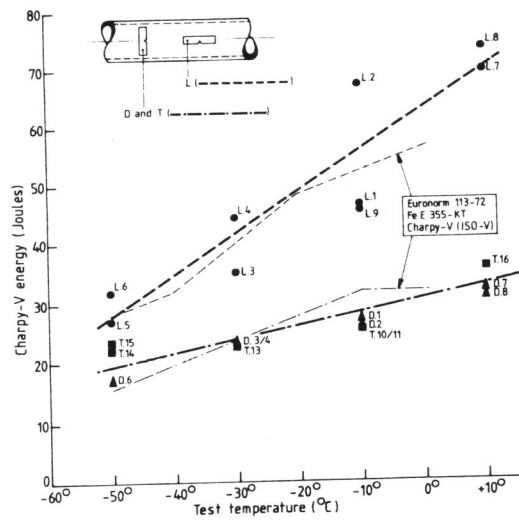
After the experiment described in this report new Charpy bars were fabricated and tested (Figure 12). Now only 32 J was obtained at -40°C. It is curious that also the yield point and the tensile strength had changed during the course of 5 years:

An alarming thing is that the Charpy value for bars with notches in the longitudinal direction was as low as 22 J at -40°C. At -10°C (the testing temperature of the full scale specimen) the energy was still only 28 J. In Figure 12 are included requirements for this type of material according to Euronorm 113-72 (Fe E 355-KT). The correspondence is good. Then it must be concluded that for offshore applications - especially for parts above sea level - these requirements are not satisfactory. Figure 13 gives information about the fracture surface of the Charpy bars. For the tube thickness concerned (20 mm) at least 50% shear surface will have to be required, when crack arrest capability of the material is desired. But even for the L-bars this will only be possible at about 0°C. From the D- and T-results, which are indicative for the full scale test result, it may be concluded that crack arresting will only be possible at temperatures above +20°C.

Figure 12. Charpy-energy for tube material as compared to Euronorm values.

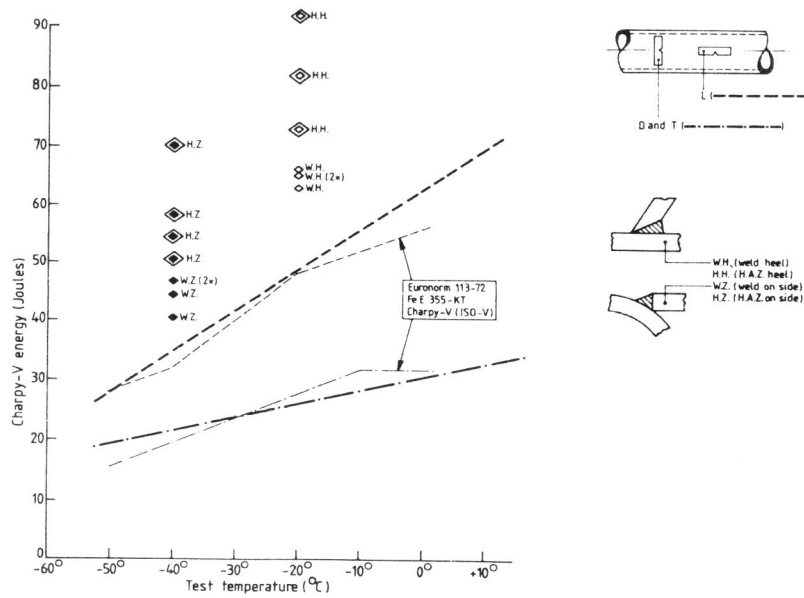
A point which needs consideration is whether the initiation of the brittle fracture was influenced or not by the quality of the weld and the heat-affected zone. In Figure 14 Charpy results for weld and H.A.Z. of a similar structure as tested, made by the same firm, are added to the values for the tube material of Figure 12. It may be concluded that the poor result of the full scale test was not due to inferior welding.

Figure 14. Charpy-energy of welds and H.A.Z.'s.

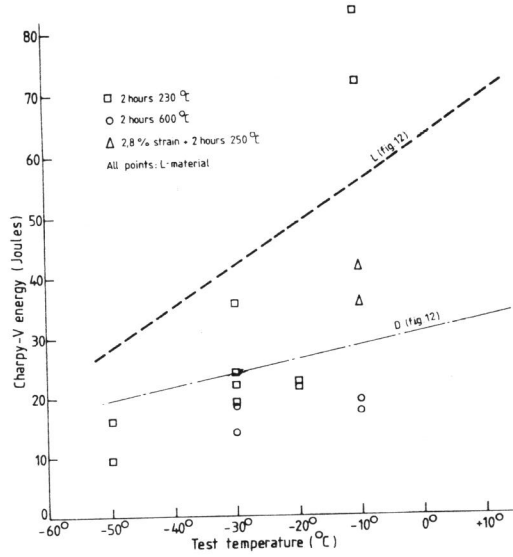
The Charpy results were a bit surprising. Two hours ageing at 230°C led to a reduction in toughness in the low temperature region (Figures 15 and 16). At -10°C the toughness was improved in terms of energy (Figure 15) and did not change in terms of fracture appearance. But on the whole it is evident that the toughness of the L-material has been reduced to that for the D-material.

The results for specimens heated at 600°C are bad. The treatment has certainly not restored the properties up to the 1980 level as was hoped for. This is not surprising as it is known that for this type of steel long lasting heating at 600°C may be as well detrimental as beneficial. Therefore, although a positive result would have been of significance, a negative one - as found - says nothing.

The last treatment, being strain ageing, proves to be at least as detrimental as two hours heating at 230°C. But now the reduction in toughness appears at -10°C, where heating alone had little effect.

Figure 15. Influence of various ageing treatments in terms of Charpy-energy.

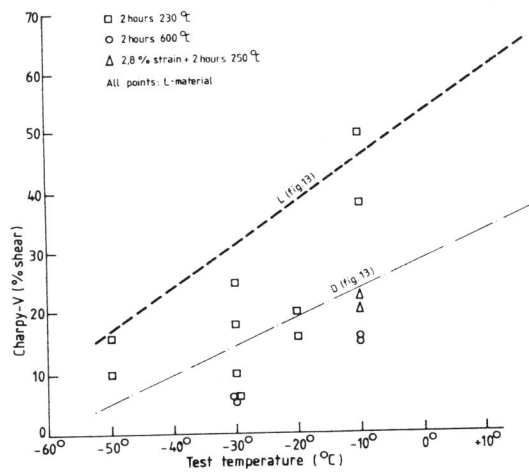
Figure 16. Influence of various ageing treatments in terms of fracture appearance.
