STUDY ON THE FATIGUE FAILURE OF A COBALT HARDFACED STEEL SHAFT

A.A. FERNANDES, V.T.A. ANTUNES, P.M.S.T. DE CASTRO*

The present study describes a failure examination conducted on a shaft of an oil-extracting press. The causes of the failure were traced to manufacturing faults and service loading conditions. Crack growth under Mode III conditions occurs. An attempt was made to use fracture mechanics principles to predict the fatigue behaviour of the shaft. Limitations in using these techniques are apparent due to lack of data on Mode III crack growth and K_{III} solutions.

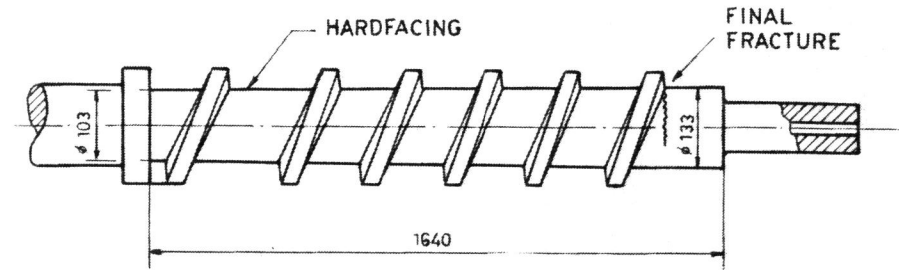
Several superficial cracks could be observed on planes perpendicular to the axis. The location of the final fracture is shown in Figure 1.

FIG. 1 - Shaft showing location of final fracture

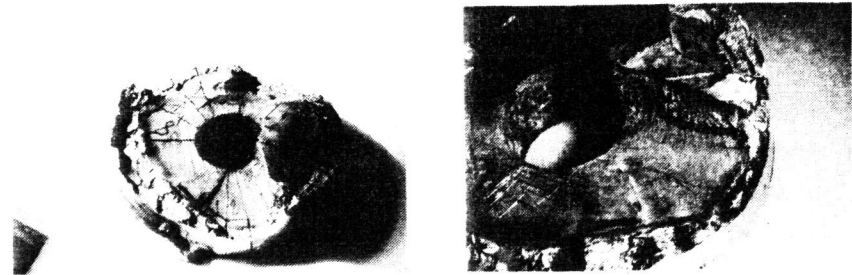
A detailed failure examination was conducted on samples taken from the fracture surface as shown in Figure 2.

FIG. 2 - Final fracture surface

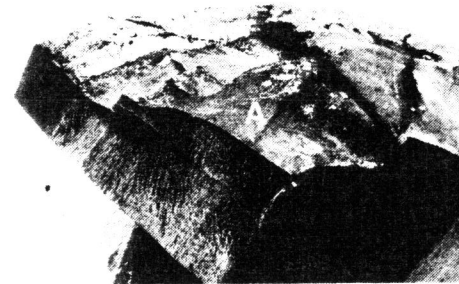
Main cracks were found to be located at points of high stress concentration near the root of the helicoid. Cracks propagate through the wear-resistant overlay into the base material and extensive crack branching was found. The fracture surfaces presented tightly adherent compressed seeds, as shown in Figure 3.

FIG. 3 - Crack branching

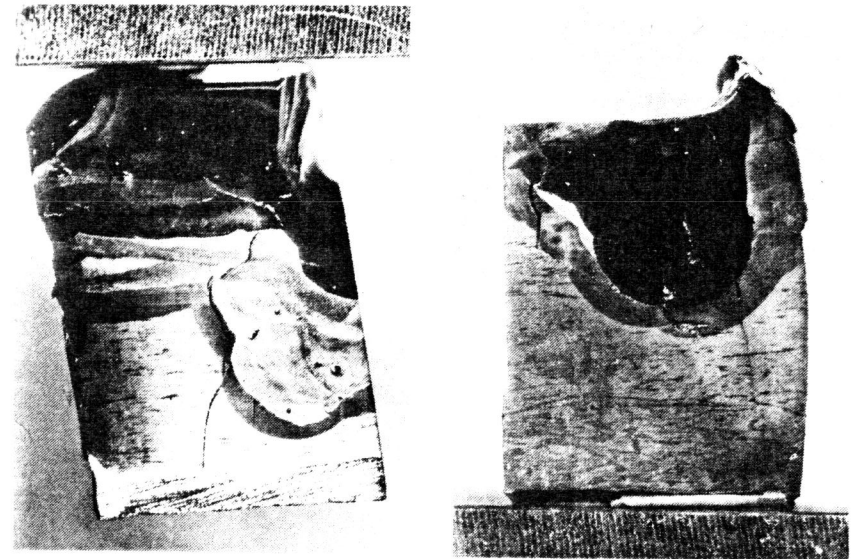
Sections through the root of the helicoid are presented in Figure 6. The analysis of these macrographs revealed interesting points, namely:

- the helicoid is not machined, but built up by welding.
- the original shaft was reclaimed in successive operations, as revealed by the identification of several different alloys. The chemical composition of these alloys is shown in Table 2.

The welding operation used to build the helicoid produced a heat-affected zone, with hardness above 400 HV, clearly shown in Figure 6. The extensive cracking observed in the heat-affected zone leads to the conclusion that an inadequate welding procedure was used. They appear to be hydrogen-induced cold cracks. A probable cause of their occurrence would be, among others, lack of preheat during the welding operation.

FIG. 6 - Heat affected zone cracking produced during helicoid build up

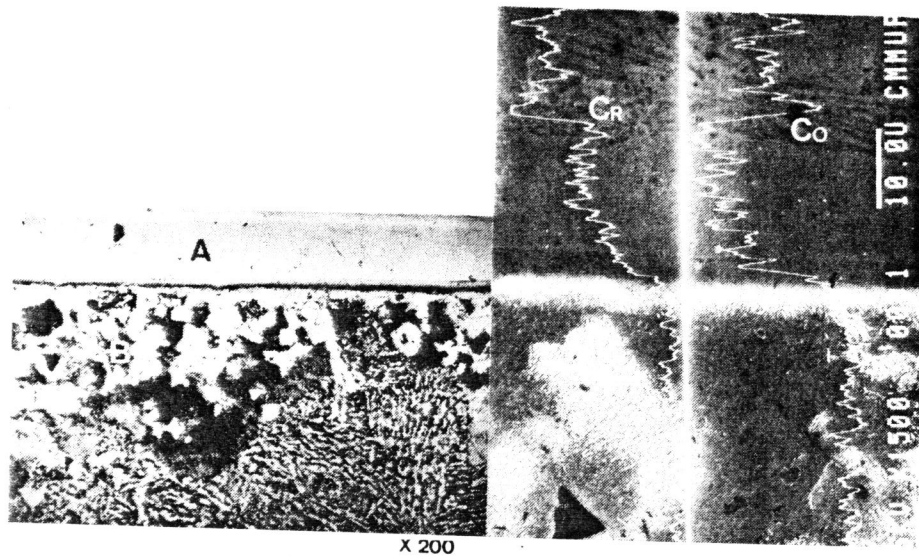
Optical metallography was carried out in a section of the body of the shaft as sketched in Figure 4. The sample revealed a 1.5 mm-thick wear-resistant overlay. This overlay was deposited using a spray technique which gives a very low dilution with the base material as can be seen in Figure 5. The hard facing operation produced a heat-affected zone displaying two distinct zones marked B and C on Figure 5. Zone B, with a width of approximately 0.1 mm, corresponds to austenitized material. The microstructure is essentially formed by ferrite and fine perlite. Zone C, approximately 7 mm wide, has not reached austenitizing temperature and presented a tempered microstructure. Hardness tests in these two zones gave the following values:

- Zone B - 286 HV5
- Zone C - 303 HV5 (max.)

FIG. 5 - Heat affected zone produced by spray hardfacing (left):
A - Co alloy
B - Austenitized base material
C - Non - Austenitized base material
Interface Cobalt alloy - base material with two line scanings for Cr and Co (right).

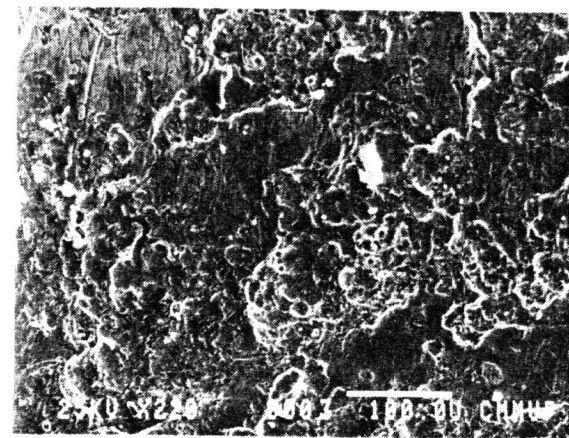
The observation of the fracture surfaces using a Scanning Electron Microscope revealed a smooth flat fracture without any morphologic features which could help to identify the failure mechanism, as seen in Figure 7. The fracture surface shows signs of severe rubbing which is fractographically identical to pure cyclic Mode III surfaces reported by Ritchie (1) for an identical steel. The shaft base material has a low toughness, as concluded by final fracture surface appearance, illustrated in Figure 8, where cleavage facets are clearly visible, indicating a brittle-type fracture.

FIG. 7 - Microfractography of fracture surface

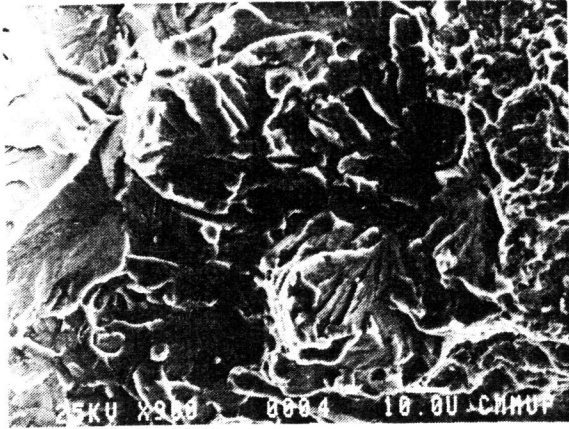
Metallographic and microfractographic analyses indicate that inadequate manufacturing and repair procedures were adopted, as proven by the extensive internal and external cracking present in the shaft. These cracks were the initiation points of main cracks which propagated throughout the shaft until final fracture. The presence of the external helicoid in the shaft introduced an additional stress concentration which, coupled with the presence of cracks, created the conditions for their propagation. No definitive conclusions as far as the adequacy of shaft base material could be drawn since no mechanical tests were carried out. Figure 8 suggests that the base material had a low toughness.

FIG. 8 - Brittle type fracture showing cleavage facets.
