INVESTIGATION INTO THE CAUSE OF CRACKING IN DEAERATORS IN ORDER TO MINIMIZE THE RISK OF COLLAPSING

J.G. Bolten

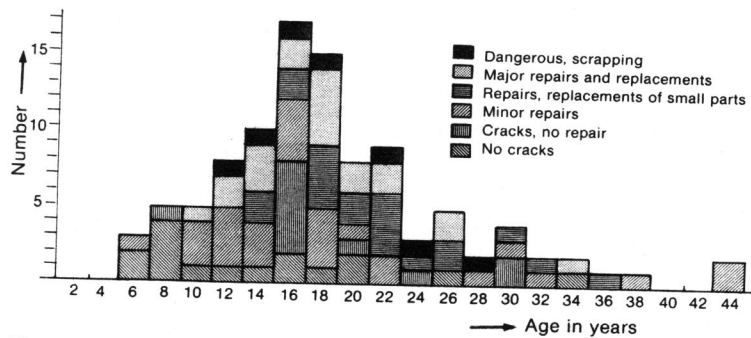
Figure 2 Relationship of service life-extent of damage for 102 deaerators.

To date, (March 1988), Stork have inspected more than 125 deaerators manufactured from unalloyed steel (carbon or manganese steel) with outside diameters ranging from 2,000 to 4,500 mm, lengths from 6,000 to 30,000 mm and wall thicknesses from 7 to 22 mm. The safety pressure varied from 0.25 bar to 17 bar gauge. The relationship between service life and damage for 102 of the deaerators inspected is presented in figure 2. The inspection results sorted by material type, pressure rating, decade of manufacture and a classification of the inspection results by damage location can be found in (2).

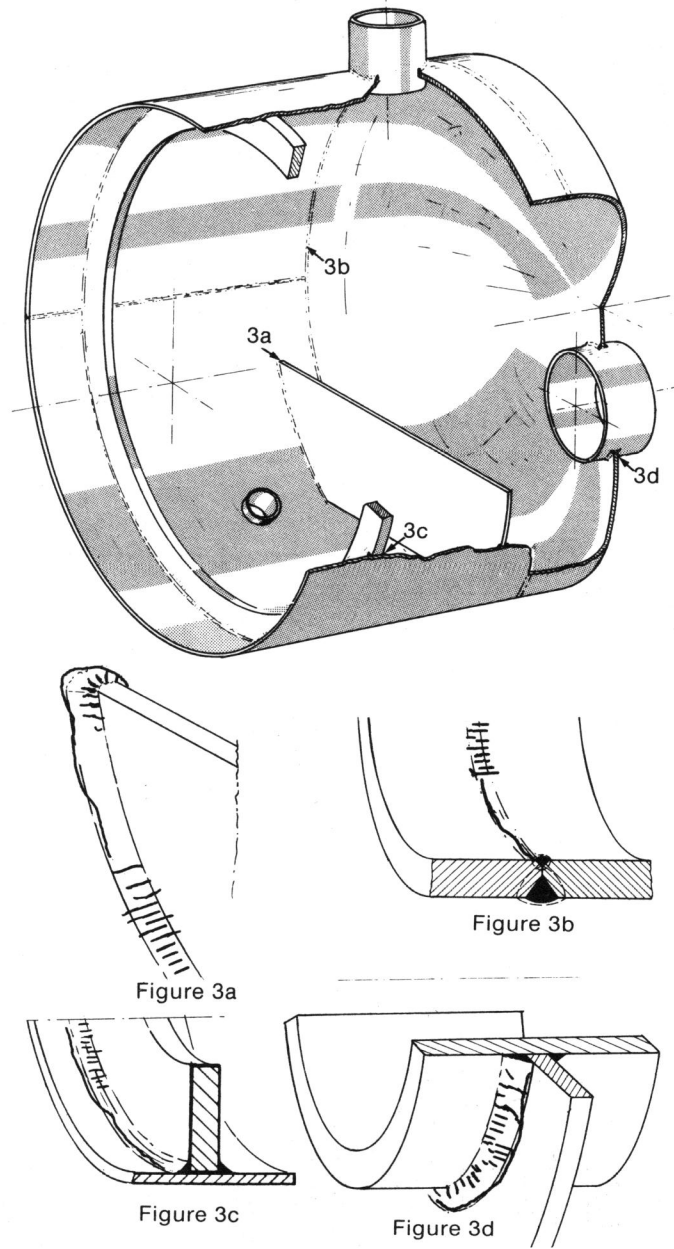
Figure 3 Review of most critical welding details in dearators

In 1987, Stork Boilers inspected four deaerators which had been stress-relieved after manufacture. They were manufactured from HII, the diameters varied from 2,100 to 4,000 mm, the wall thicknesses from 18 to 21 mm. The design pressures were 5,5 to 17 bar gauge, the ages of the vessels respectively 15, 20, 25 and 36 years. One deaerator was subjected to a 100% inspection, for the others the inspection (10-20%) covered selected critical spots. None of the deaerators showed typical deaerator cracks. Only at the connections between large baffles and vessel walls fixed by fillet welds, were cracks detected in the longitudinal direction at the baffle/weld transition (stress concentrations caused by rigidity transitions, figure 3a).

- circumferential seams, particularly in shell/head joints and in longitudinal seams with large longitudinal cracks of a considerable depth in addition to transverse cracks (figure 3b).
- Fillet welds of a circumferential stiffener, of large nozzles or manholes, transverse and longitudinal cracks local to the heat-affected zone in the shell (figure 3c respectively 3d).

After repair, the deaerator should be crack-free. All indications detected have to be removed by grinding out. If the required residual thickness is insufficient reconditioning by welding will be necessary. In cases of serious damage the complete welds and adjoining parts will be replaced. If possible, fully root-penetrated joints are applied instead of fillet welds. A reinspection by WFMPPT should be carried out after 4 years, at critical spots after 2 years. The first reinspections two years after repair have resulted in:
