INVESTIGATION OF FRACTURE FEATURES IN Cr-Mo STEEL AFTER
DIFFERENT THERMOMECHANICAL TREATMENT

A. Ljevar*, V. Šijački-Žeravčić**, R. Milinković***,
M. Radulović****

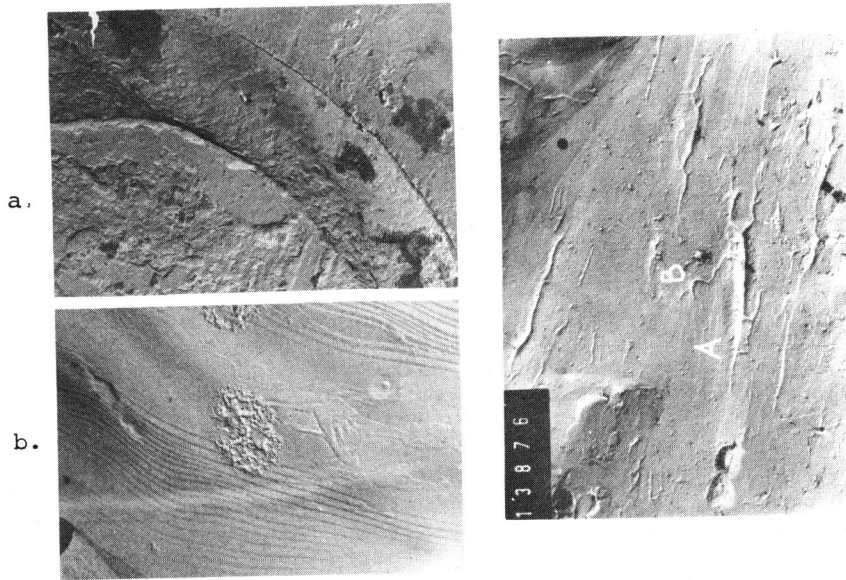
After forging fracture feature is as one can expect, except for the porosity appearing as small shiny flake-like regions, Fig. 1a. At high magnification some areas of porosity show the step-like geometric patterns, as shown in Fig. 1b, indicating poor quality of either forging or material (3). Fig. 2 shows characteristic brittle fracture after quenching, although some other areas contain inclusions (MnS and carbides) of different sizes, distributions and shapes, as well as a small amount of porosity (2).

Fig.1 Fracture feature after forging a.3400x b.9000x Fig.2 Fracture feature after quenching, 6000x

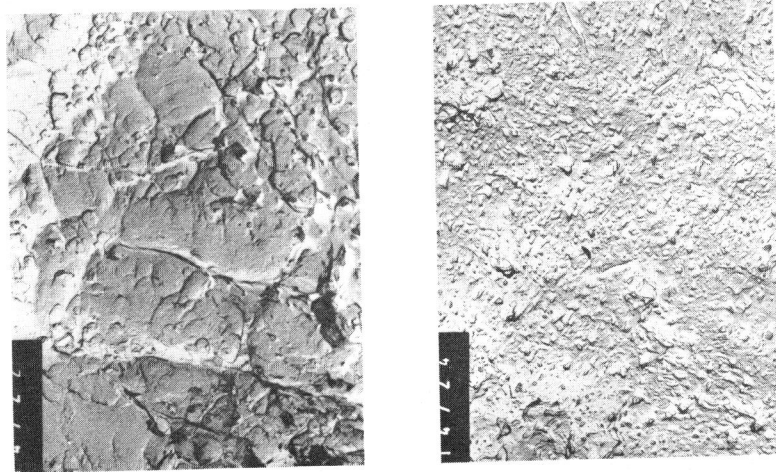
Fracture surface of the tempered sample is typically ductile, but with different features regarding existence of dimples of different sizes, Fig. 3a, or with large flat facet, Fig. 3b. The facet contains fine shallow conical-like dimples, but perhaps two of many possible systems of slip (3).

Fig.3a Fracture feature after tempering, 6000x Fig.3b Fracture feature after tempering, 6000x
