MICROSTRUCTURAL AND MECHANICAL CHARACTERISTICS OF
DESTRUCTED METAL TAKEN FROM ELEMENTS SUBJECTED TO
CREEP IN THERMAL POWER STATIONS

Conclusions about the destruction of three elements of steam pipelines used under creepage conditions in thermal power plants based on characteristics and microdefects of samples of Cr(1%)-Mo(0.3%)-V(0.2%) have been made.

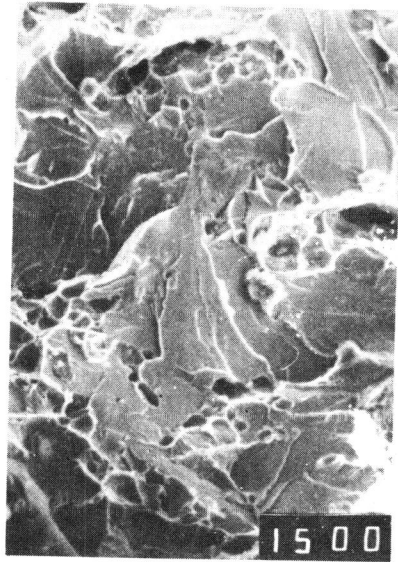
Fig. 1

Pores number in the area of the breaks next to bend's external surface is up to 1000 per sq mm with size $3\ \mu\text{m}$ in the case of bend 1, and size $6.2\ \mu\text{m}$ in the case of bend 2, ref. Fig. 1. In the wall their amount decreases, namely up to 200 per sq mm with size up to $2.1\ \mu\text{m}$, Figure 2, in the case of the internal surface of bend 1 and up to 30 per sq mm with size up to $1.8\ \mu\text{m}$ in the case of bend 2. At a distance of 120 mm from break the amount of pores increases from 440 to 1400 per sq mm with size up to $3.1\ \mu\text{m}$ from outside to the internal surface in the case of bend 1, Fig. 3. In the case of bend 2 the pores are considerably less - from 70 to 220 per sq mm with size up to $0.07\ \mu\text{m}$ in the intermediate sections and practically single at the internal surface. Pores in the header in the area of the break are about 5 times less than in the same sections of the bends, their size being up to $6\ \mu\text{m}$. At 120 mm from they are even less, their size being up to $2\ \mu\text{m}$. No pores in the metal of the healthy sections of bend 1 and the header were detected; in bend 2 single pores with size up to $0.07\ \mu\text{m}$ were detected next to the external surface. Other differences were also established, namely round pores along the boundaries of bend 1 and wedge-shaped pores at the joint among three grains. Pores in the header next to the break combine into intercrystalline microcracks without prior concatenation, Fig. 4.
