RESULTS OF ULTRASONIC INSPECTIONS OF FATIGUE CRACK
PROPAGATION IN A PWR VESSEL MOCK-UP

C.GONDARD * , A.LUCIA ** , J.ELBAZ **

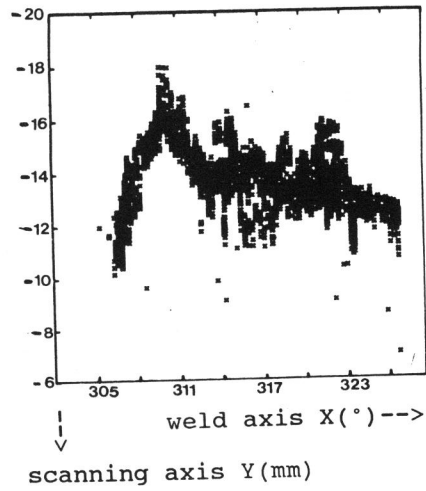
Figure 2 : CSCAN (top view) of defect F(CB) from inside

The figures 2 and 3 show the C and DSCAN of the defect F in CB. It is not rectilinear, with a smooth undulation along the X axis; this factor must be taken into account in order to avoid an over-sizing. The DSCAN indicates an elliptic shape, though the lower tip is rather irregular.

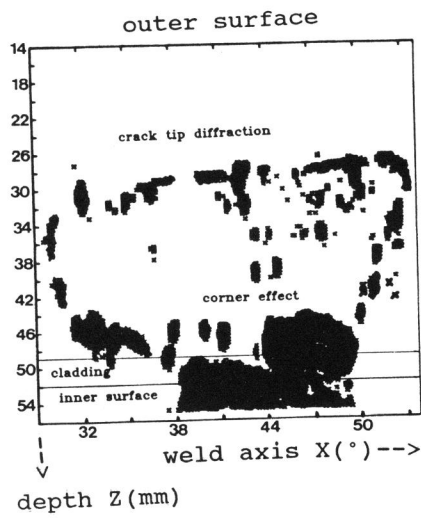
Figure 4 : DSCAN (side view) of defect F(CB) from outside

They are in good agreement with those of the inspections performed from inside (Table 2), except for the parameter 2b for defect A, and parameter 2a for defect F. In the two cases, the new inspection discovered new diffraction zones which were not detectable during the IS3. The figure 4 shows the DSCAN on defect A : this is a complex image which mixes strong "corner effect" from the initial defect (between 38° and 50° on X axis) with many diffraction points, not necessarily lined out. The growth of the defect seems not regular on all the length, with branched cracks on the sides.
