COMBINATION OF CORROSION AND FATIGUE IN AIRCRAFT
COMPONENTS

J. Woodtli*

The service failures in aging aircraft components due to corrosion and fatigue will be discussed using actual case histories. Of prime importance for avoidance or minimizing such failures is to establish the dominating mode of failure mechanism. This can be achieved through careful failure analysis involving different techniques such as metallography, fractography or microanalytical investigations.

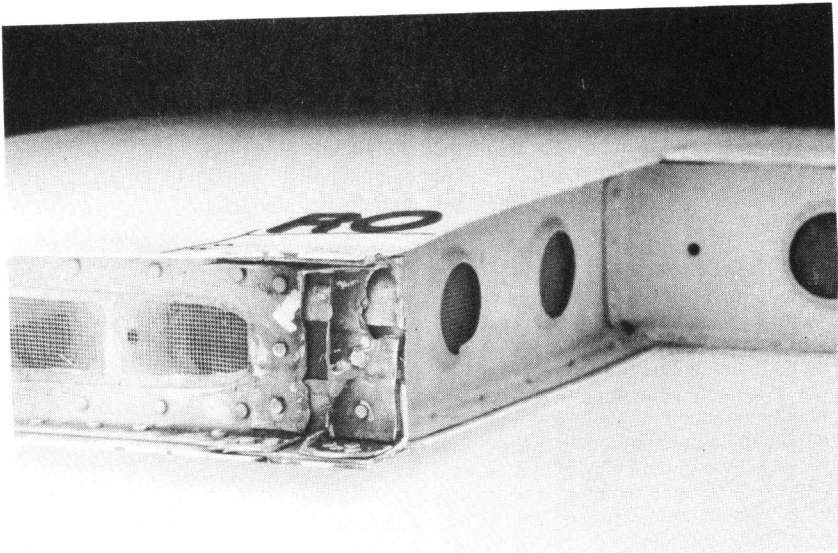
A particular problem which has already caused some incidents, was investigated in the emergency landed aircraft. This aircraft was a twin-engined turbopropeller, six seats, low-wing with retractable landing gear. This plane was manufactured in 1970 and had 6000 flight hours when it went out of control during climbing after take-off for a cross-country flight. The failure occurred suddenly and was accompanied by a loud report. Inspection after the emergency landing revealed failure of the two outer elevator hinge brackets attaching the elevators to the horizontal stabilizers. The wall thickness of the broken angular profile, which is made of wrought Al-Alloy 2024, was approx. 0,8 mm. Both the hinge components and the elevator skin are covered with several layers of paint, which have peeled to a certain extent, above all in the vicinity of the rivet heads and fracture zones. The fractures are situated mainly in the rectangular corners of the hinge bracket (Fig. 1). With exception of one rivet, no rivet is missing from either hinges. In fact in some parts of the metal skin, intact rivets can still be seen which have only separated from the skin due to tearing out of a rivet hole. Traces of intensive corrosion and multiple cracks were revealed in several rivet holes in various sections of the skin (Fig. 2). Although all fractures were examined under the SEM, the fractographical findings were limited to sporadically intact fracture zones, because of heavy secondary damage due to the abrasion. Nevertheless it was established conclusively that incipient cracking in holes is partially intercrystalline. Clear indications of fatigue in the form of fatigue striations, were discovered in the rectangular longitudinal hinge edges. Moreover, these areas also exhibit zones with partially intercrystalline fracture

Fig 1 View of fractured outer hinge bracket

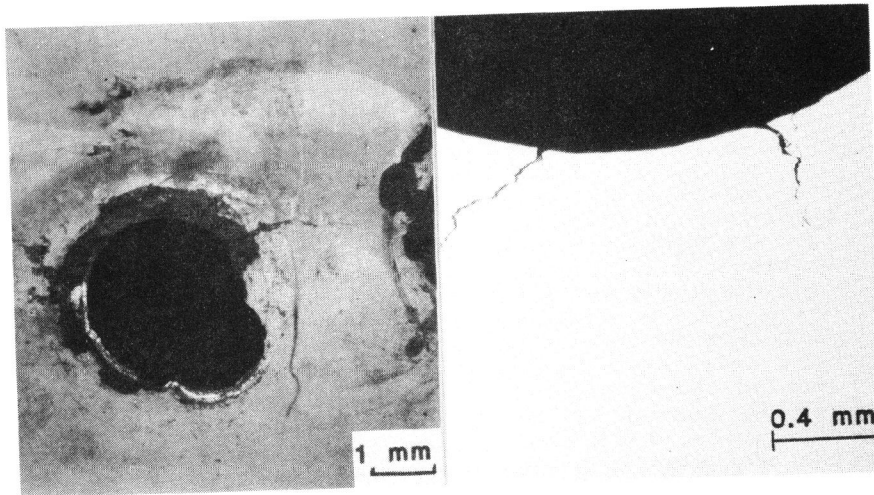
characteristics mixed with void structures. This type of fracture characteristic indicates corrosion effects at the crack initiation and during crack propagation. These findings could be confirmed by the subsequent metallographical examination. All the cracks discovered in the vicinity of the holes are slightly branched and partially intercrystalline, which is characteristic of corrosion cracking (Fig. 3). They originated under the rivet heads, where the Alclad layer is damaged. In order to determine whether aggressive media had any effect on crack formation and propagation, the bare surface of the hinge and the end of some cracks were thoroughly examined by the electron probe microanalysis. Chlorine enrichment up to several percent was detected.

It must thus be assumed that the corrosion occurring in the rivet holes was significant, at least indirectly, to the initiation of fatigue failure. The relatively high mechanical loading of the hinge brackets would also favour loosening of the rivets and the initiation of fatigue. Metallographical examination of the rivet holes showed that these holes were seriously damaged by corrosion pitting and stress corrosion cracking. Peeled-off paint over the rivets as well as abraded Alclad layer under the rivet heads allowed the corrosion to start. The role of the internal stresses caused by tightening the rivets may also be considered, but was not investigated.

Fig 2 Corrosion underneath rivet heads

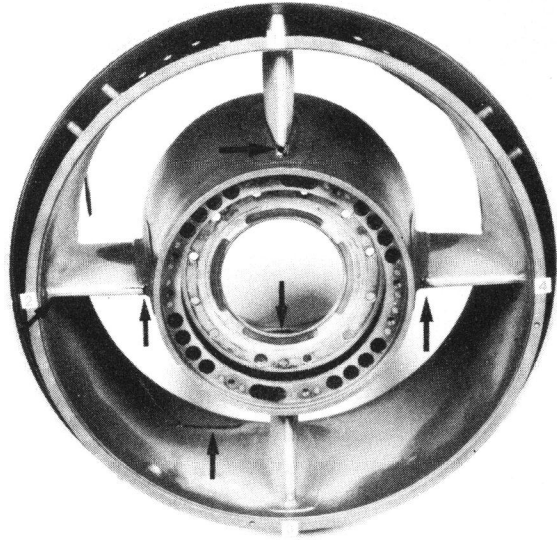
This part stems from a gas-turbine of a jet engine which suffered a total power loss during a cross-country flight. The operator heard a dull "thump" as he tried (unsuccessfully) to restart the engine. Thus the aircraft flew gliding for 40 km and finally had to make an emergency landing. Taking into account the function and damage of each part of the turbine, the aircraft user suspected the main cause of failure to be the fracture of the bearing sitting on the compression shaft or the fractures within the diffuser (Fig. 4). In this paper only the second possibility (damage in the diffuser) will be discussed. The high quantity of cracks can be divided into two groups, according to their location: 1. Cracks near to the welding seams and 2. Cracks in the bended areas. Some cracks at different places were opened and investigated fractographically. The typical appearance of one free crack is shown in Fig. 5. The jagged edges

Although the diffusor revealed a high number of fatigue cracks initiated on multiple SCC sites, this damage was very probably not the main cause of the turbine failure. It could be shown that the rubbing of the blades on the peripheral ring already occurred at the service temperature. If the diffusor had been deformed due to a displacement of the cracks, than an increase of the axial play of the transmission shaft would have taken place. This would necessarily have caused a rubbing of the leading edges of the air turbine blades with the stator. However, no damage of this kind was observed on the stator blades.

Fig 4 Gas-turbine diffusor with cracks (arrows)

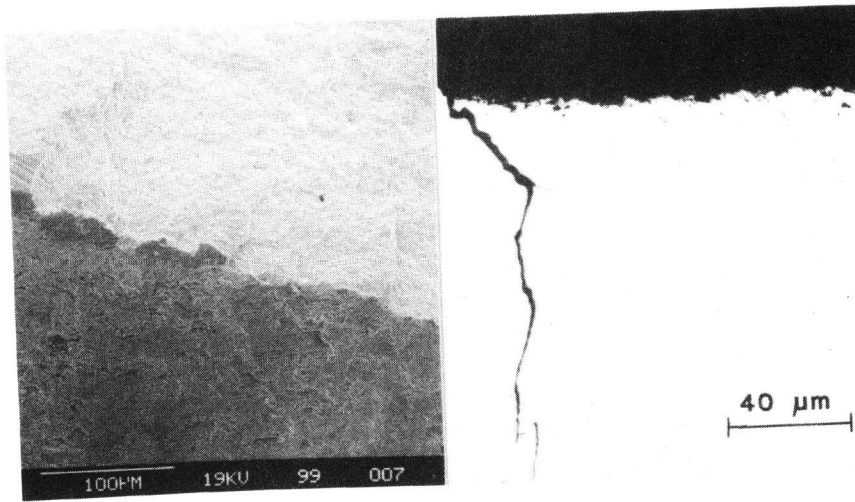
of the cracks, together with the dark deposits on the surface, indicate older corrosion cracks, which started on the inner surfaces. The beach marks form half ellipses, with an origin at the dark corrosion cracks, exhibit evidence of fatigue.

The metallographical cross-sections revealed extensive damage due to SCC. As the micrograph Fig. 6 shows, the cracks are transgranular and branched. The martensite microstructure shows many finely dispersed carbides. The hardness is 330 ... 340 HV.

Fig 5 Free crack with jagged edge due to corrosion **Fig 6** Transcrystalline, branched cracks
