ANALYSIS OF FAILURE IN BOILER DOWN-PIPES

A. Krajczyk* and R. Żuchowski*

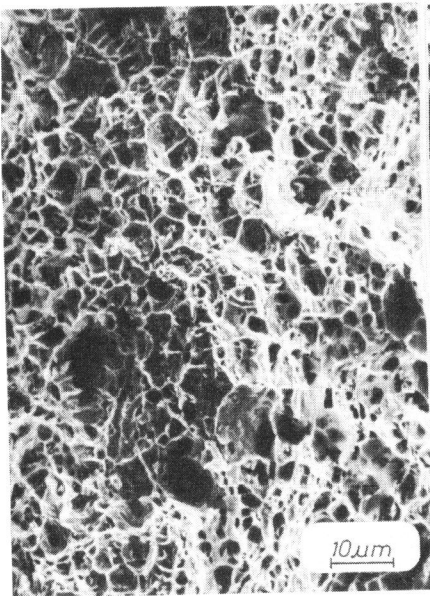
Figure 1 Virgin material
 $D_w = 0$

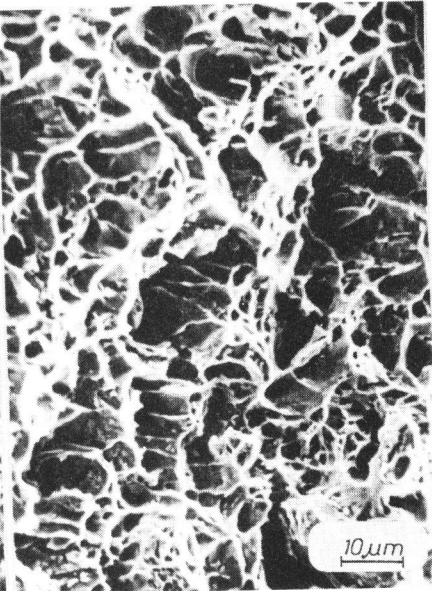
Figure 2 Exploited material
 $D_w = 0.26$

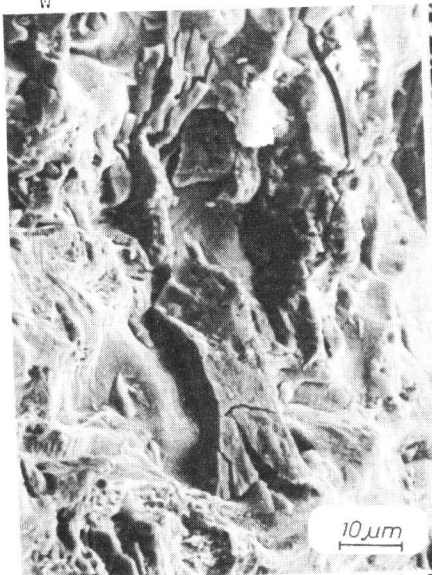
Figure 3 Exploited material
 $D_w = 0.51$

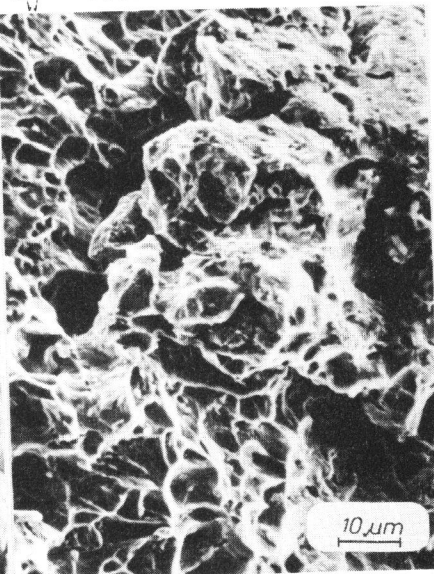
Figure 4 Failed material
 $D_w = 0.56$
