ANALYSIS OF UNDERCLAD CRACKING ON EXPERIMENTAL RING OF  
REACTOR PRESSURE VESSEL

V. Magula - T. Smida\*

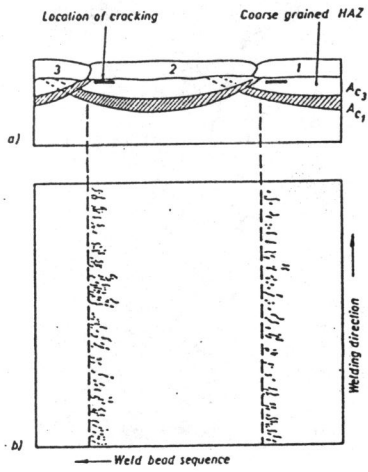
Fig.1 Location and orientation of underclad cracks

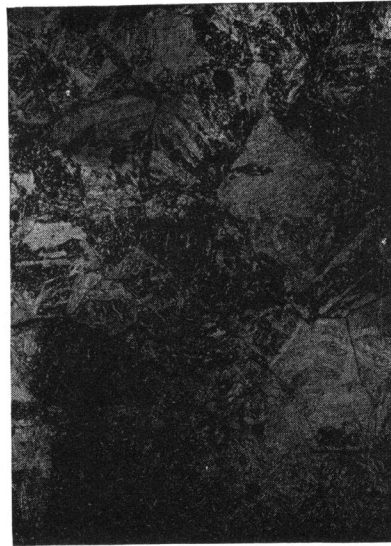
Analysis of the specimen A. After clad removal such cracks were identified (Fig. 2), which corresponded to the scheme in Fig. 1 by their geometrical configuration. In the zone of cracks an increased concentration of inclusions occurred. Intercrystalline character of cracks is evident.

Fig.2 Characteristic intercrystalline cracks

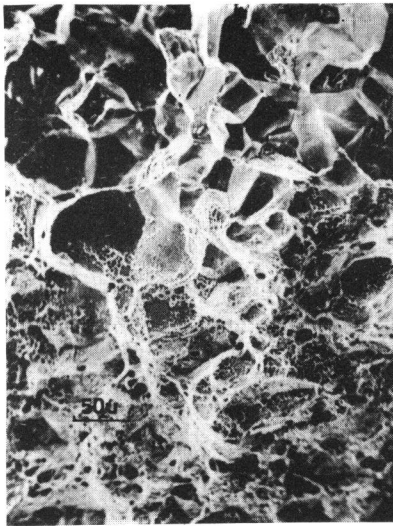
The chosen crack was opened and analysed fractographically. Overall character of the crack is demonstrated in Fig. 3. Grains coarser at the surface, gradually become smaller, in the lower part there are already intercrystalline facets of dimple morphology and finally the crack passes to transcrystalline one with dimple morphology. Fine particles, containing Mn, Fe, S and Si were identified on the facet surface.

Fig.3 Intercrystalline underclad crack

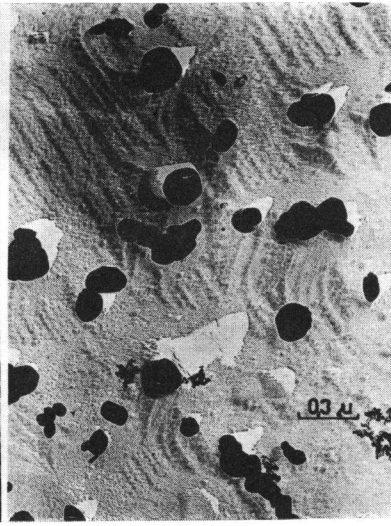
From the crack a carbon replica was extracted. Its intercrystalline character was demonstrated again and fine structure of the facet surface was analysed. Probably slip traces on grain boundaries were identified (Fig. 4). On other places the slip band marks were identified (Fig. 5), which reflect plastic strain of a material (4). It is presumed, that besides plastic strain of individual grains they can cause grain boundary failure (5). Carbide phase was also extracted on the replica (Figs. 4,5). Prevaillingly  $M_7C_3$  carbide is concerned,  $M_3C$  carbide occurred in the minority.

Fig.4 Slips on grain boundaries

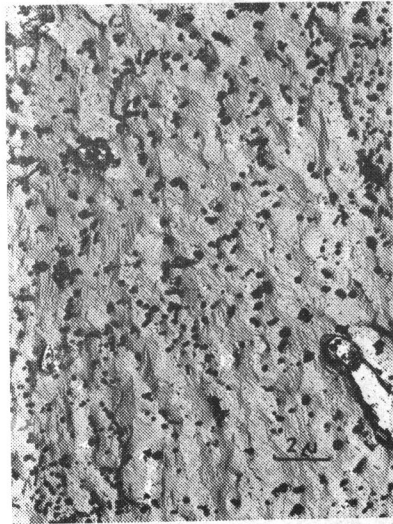
Fig.5 Slip band marks

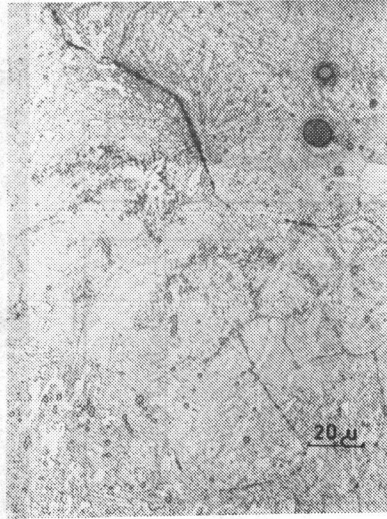
- a/ in the zone of segregates, where great amount of inclusions and eutectic phases was identified, the zone with intercrystalline facets was localized (Fig. 6)
- b/ after opening these cracks it could be stated, that the crack has intercrystalline character, but with expressive dimple morphology. The surface of these facets was covered with great amount of oxysulphides (Fig. 7)
- c/ cracks on the specimen B were caused by surfacing of a corrosion-resistant strip, but decohesion was caused first by abnormally high contamination of grain boundaries with oxysulphides and/or eutectic.

Fig.6 Intercrystalline cracks in a segregate

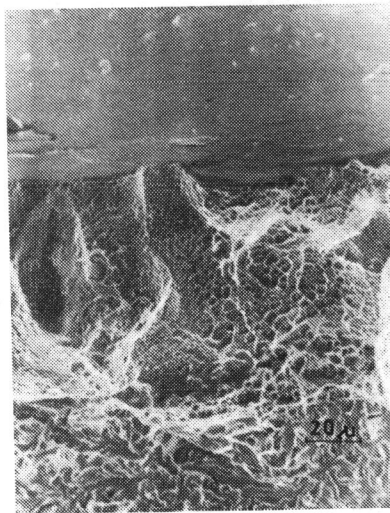
Fig.7 Intercrystalline crack after opening

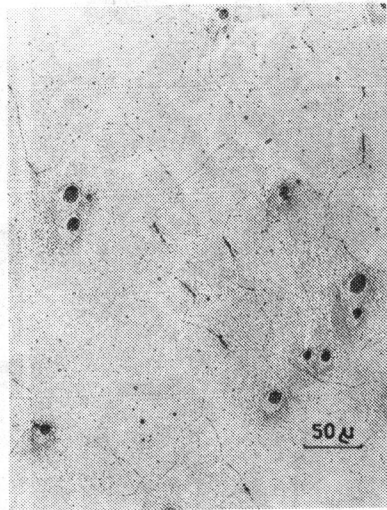
Fig.8 Intercrystalline cracks induced in the jig with forced rigidity
