B. Aleksić, J. Kurai, A. Fertilio and Ž. Vojvodić*

Crankshaft fracture by fatigue in corrosive environment is presented. The recommendation for ultrasonic in-service inspection of growing crack up to practically defined size is proposed.

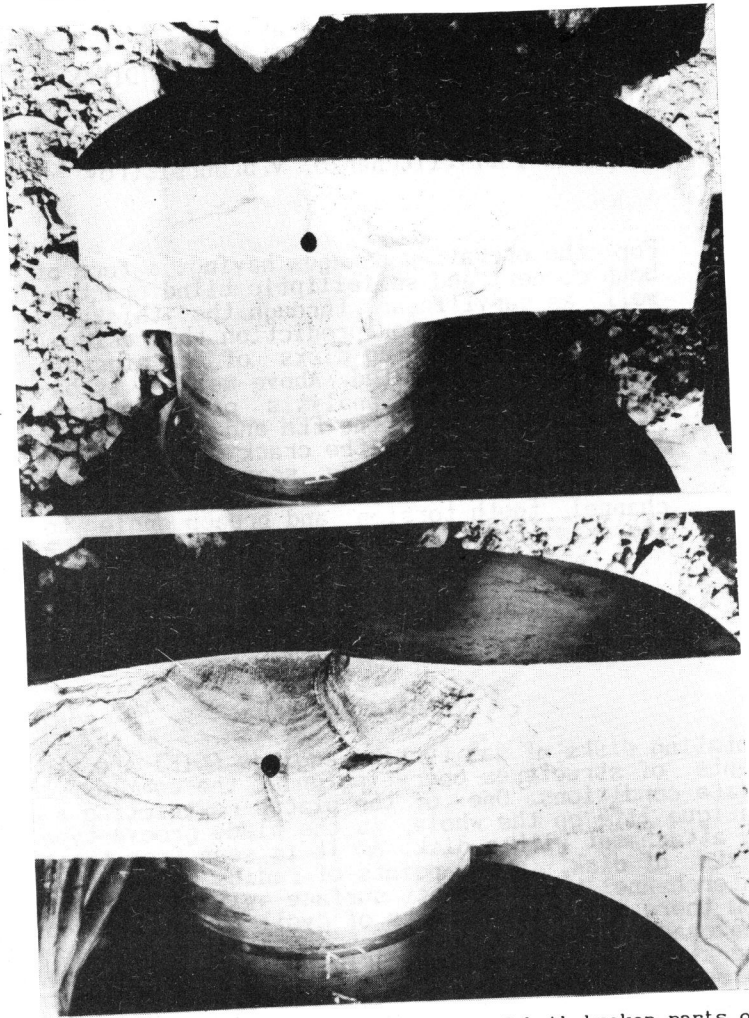
Visual inspection revealed that fracture surface is slant to longitudinal shaft axis. Larger part of fractured surface has smooth "shell" view, covered by corrosion products, and smaller part is rough with typical surface view (Fig.1). Fractured surface appearance corresponds to fatigue fracture. Smooth surface portion corresponds to fatigue crack propagation, since during successive openings and closures due to variable loadings separated surface faces are in successive contacts, causing friction and wear of highest surface parts and consequent flatness. Final brittle fracture is a consequence of reduced load carrying cross-section area.

Both fractured surfaces can be seen in Fig.1. Typical smooth "shell" fracture surface is divided in two clearly visible zones.

Carbamide pump crankshaft was fractured in transition radius between shaft and wheel on wheel side by fatigue, initiated in two locations in long time period.

Figure 1 The view of fracture surfaces of both broken parts of a crankshaft.

With exposed experience in mind, a technique of ultrasonic testing is defined for early fatigue crack detection. By preventive periodic control, once or twice a year during long time stoppage or maintenance it is possible to detect crack indication in an early stage and follow its propagation up to the critical size, when replacement or repair can be required. In considered case, critical crack size can be defined by lubrication hole position (Fig.1) and when crack tip reaches this position repairing actions have to be undertaken.
