V. Šijački-Žeravčić¹, A. Marković¹, Z. Stamenić¹

The aim of this paper was to determine the influence of welding process in inlet pipeline-drum joint. Failure causes of boiler drum after 60.000 hours were investigated. Drum mantle was fabricated from steel micro alloyed with niobium, but the pipe was of 15Mo3 steel. Several samples from fracture area were taken. Determination of chemical composition, hardness measurement in various zones of welded joint and it's surrounding, optical microscopy, as well as scanning electron microscopy of fracture surface was carried out. On the basis of the obtained results it was possible to define the structural state of welded joint and it characteristics. The structure of needle morphology with high values of hardness is dominant in the heat affected zone that means that the beneficial conditions are induced for origination of cold late cracks.

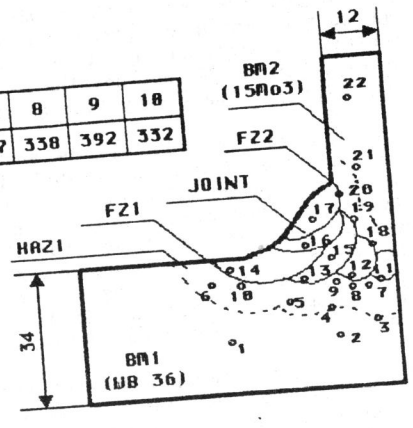
Figure 1 Distribution of measure positions

Hardness: Results of hardness measurement in different zones of welded joint with measure positions are given in Table 2. and Figure 1.

Comparing with standard data, it is obvious that base material hardness is in range of 182-226.5 HV for WB 36 and 130-160 HV for 15Mo3. However, the HAZ hardness on the boiler side is in very wide region and goes from 215 HV to 392 HV, with conclusion that maximal values of hardness can be find near to the fusion zone FZ1.

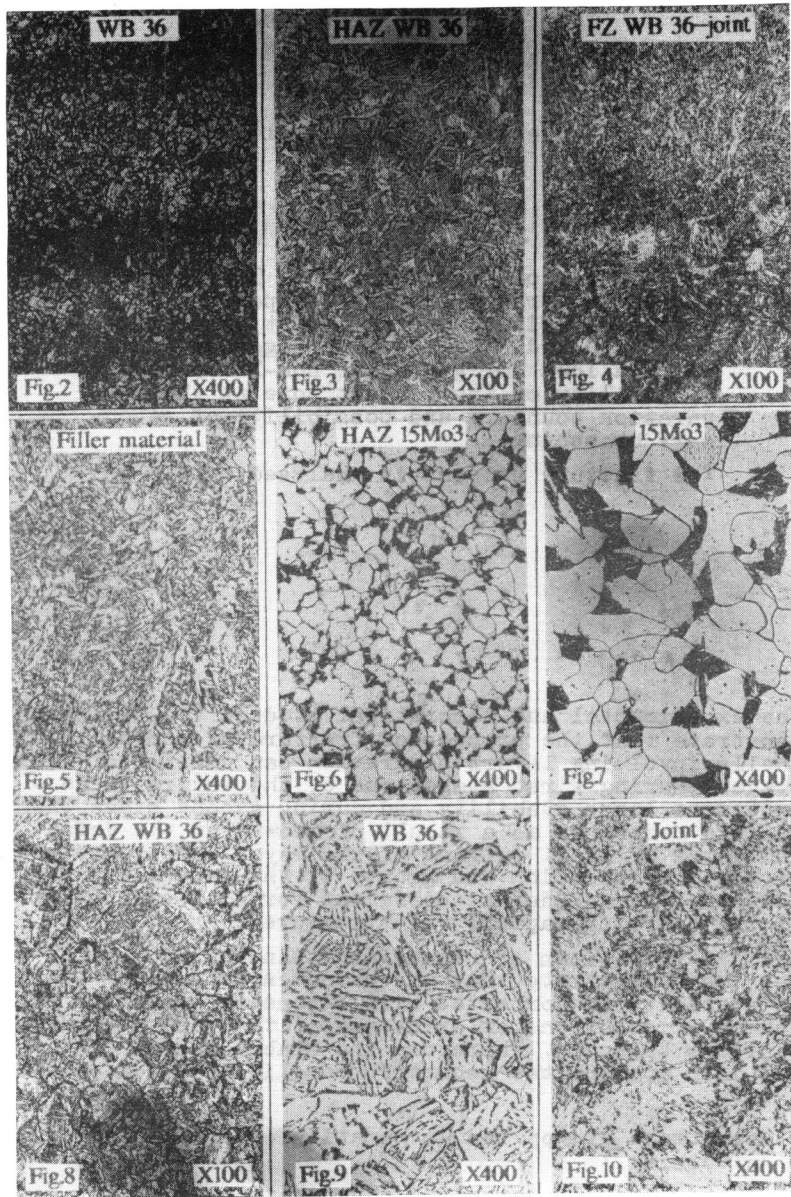
Figures 2-10 The Appearance of structure surface

Metallography: Three specimens for metallographic analysis were taken from every one of 6 inlet joints. They were prepared by standard techniques and obtained data are presented on Figures 2-10. These photos are showing the structures from different areas of welded joints as well as the base material structures. Structure of the micro alloyed steel is fine grained, as it is expected (No ASTM-10), Figure 1, and it is consisted of the fine grained polygonal ferrite with the secondary phase particles of iron carbides and the fine grain particles of the Nb base. Fine grained normalized structure is included in heat affected zone (HAZ), as well as an overheated area with a mixture of Widmanstatten ferrite, acicular ferrite, martensite, secondary phase particles and segregation on the grain boundaries, Figures 2,3,7,8. Weld structure is mostly consisting of acicular ferrite, Figures 2,3. On various points it is visible that the ferrite is formed on former austenite grain boundaries Figure 9. Structure of the pipe base material is common ferrite-pearlite type, No ASTM-8, Figure 6.

Obtained data clearly indicates that in investigated case neither of this crucial conditions weren't satisfied. At first, calculated CE for investigated compositions, according to the MIZ relation, is 0.67-0.68 what is significantly more than allowed. This data is simultaneously showing possibility of welding difficulties, respectively to the great heat amount. Extremely high hardness values in overheated area of HAZ are indicating that neither the second limiting factor, hardness, is not fulfilled because the all obtained values are higher than 320 HV. Great hardness values, as well as a great residual stresses in HAZ are a consequence of quenching structures, which are shown on a metallographic photos. As a consequence of presented structural characteristics great number of late cracks has occurred in investigated drum.
