V. Šijački-Žeravčić¹, L. Baćanji², A. Ljevar³, Z. Stamenić¹

Case study of valve fracture of diesel engine locomotive of 641-013 type, was carried out. Design of this type of engine belongs to the early construction types, from 1934., with 600hp and 16 cylinders in V arrangement. Fracture occurred on the outlet valve trunk, more precisely near the interface section between the trunk and the valve head. Trunk valve material belongs to the class of steel with austenitic structure. The large part of the fracture surface was damaged during the accident which happened after the downfall of broken valve part into the engine. Undamaged part of the fracture surface, investigated by scanning electron microscopy, is characterized with ductile failure with a great number of inclusions, chromium carbides. EDAX analysis is showing the presence of sigma phase also. Hardness measurements, as well as the structure investigation by optical microscopy for the purpose of case studies were carried out.

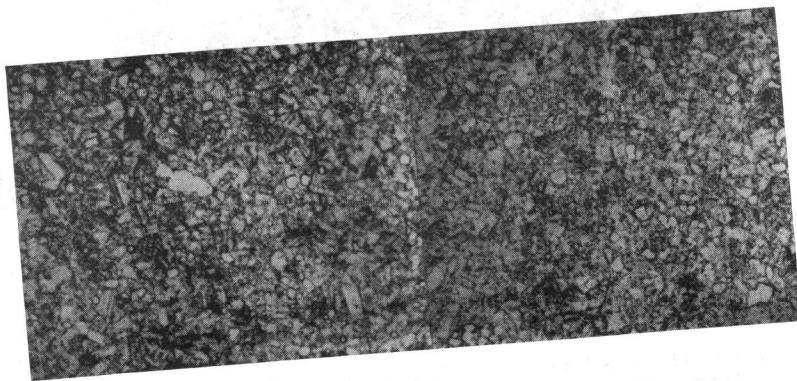
Optical microscopy. Usual metallographic preparation and investigation techniques for stainless steel specimen provided us valve trunk structure, Figure 1. Same structure was discovered on complete trunk cross section area, which consists of prior austenite grains, δ -ferrite (big white areas), carbides (dark spots) and σ -phase (thin needle structure).

On the basis of these investigations, it can be concluded that the σ -phase is present in the structure of investigated steel. That is a very frequent phenomenon in the steels where the chromium is one of the major alloying elements. Presence of σ -phase in the structure is disadvantageous, because it decreases ductility of material. According to the atomic structure, it is presenting equiatomic FeCr

On the basis of investigation, we can conclude that the thermal treatment of engine valve wasn't done correctly, what produced the σ -phase segregation. Because this segregation is taking place along grain boundaries, accompanied with appearance of secondary cracks, as well as acting of the variable loads which were affecting the valve, fracture occurred on the valve trunk after the relatively short period of time.

Figure 1. Microstructure of valve trunk

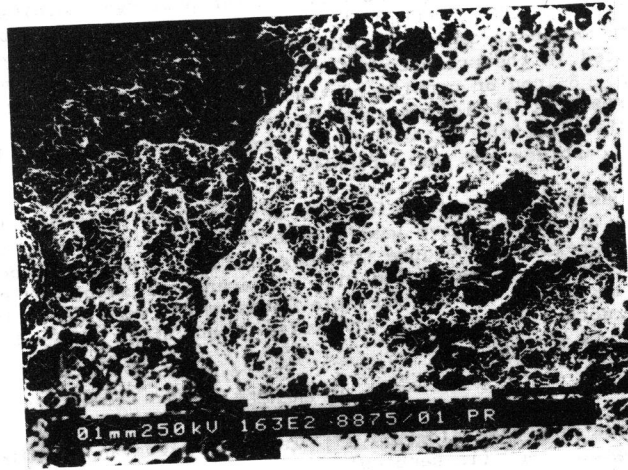
Scanning Electron Microscopy (SEM). By studying of fractured area by SEM method, it is visible that all characteristics of ductile failure are present, although certain presence of secondary cracks is discovered in the middle of the specimen. That indicates some possibility of material brittleness, Figure 2.

Figure 2 Secondary cracks in the middle of the sample. Ductile fracture.

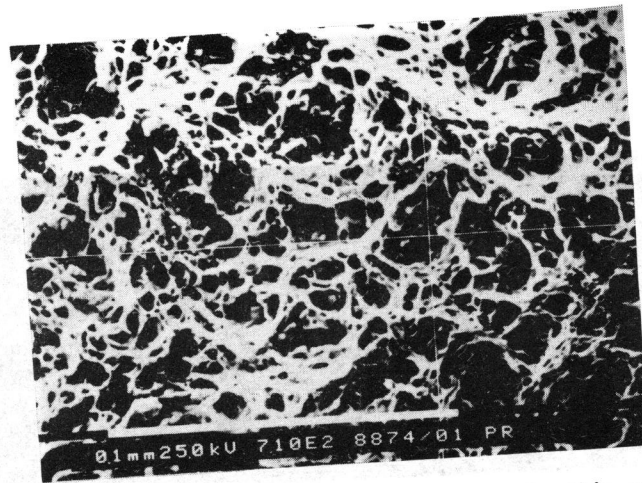
Figure 3 is presenting the ductile fracture with a lot of carbide inclusions, broken carbide inclusions and δ -ferrite, or places wherthey were before failure. EDAX analysis (Energro Dispersive X-ray Analysis) indicates the presence of σ -phase, carbide of Cr_{23}C_6 type, as well as places with high concentration of Al with small amount of Si.

Figure 3 Ductile fracture. Carbides, σ -phase and voids at the places where carbides were before.
