IN-SERVICE CRACK DETECTION AND REPAIR IN SPHERICAL STORAGE TANK

A. Fertilio, B. Aleksić, J. Kurai, B. Vujović-Dorđević*

During regular in-service inspection and non-destructive examination of spherical storage tank for vinylchloride monomer (VCM), of 2000 m³, on inner wall in weldments area numerous cracks, different in size and location, had been detected. In order to assure safe operation of storage tank, after testing and analysis, optimal procedure for repair by welding has been established for typical kinds of cracks. Paper presents inspection procedure and results and repair procedure by grinding and welding.

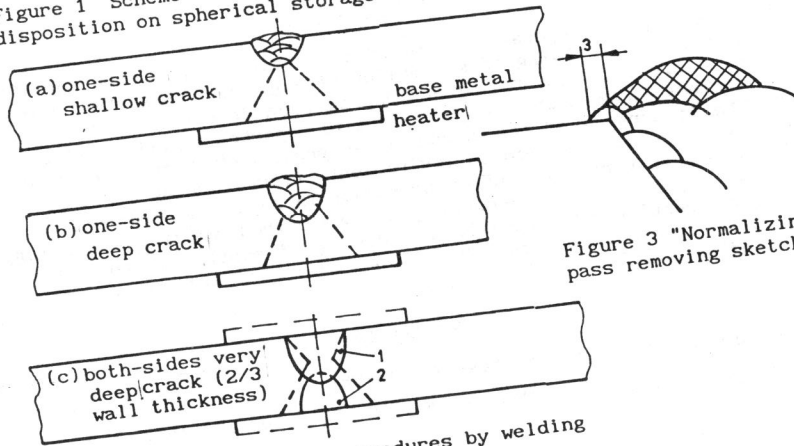
Figure 2 Typical repair procedures by welding

For cracks deeper of 5 mm repair by welding had been applied. In this case the rotation axis of grinding stone coincides with the crack indication direction. Welding preparation had been formed by grinding. Depending on crack depth, repair had been performed from one or from both (inner and outer) sphere surfaces.

Typical repairing procedures by welding are presented in Fig.2. Repair welding had been performed using MAW procedure and AWS E 8018-G electrode $\phi 3.25$ mm. Calculated minimal preheat temperature 142°C was continuously controlled during welding. Heaters were positioned before welding on the opposite wall side.

Prescribed welding regime parameters and welding passes sequences were strictly followed. Final "normalizing" pass was applied and after controlled cooling it was flat grinded (shaded area in Fig.3). For microalloy steel the determination of transition thickness limit from 3D to 2D heat conduction (d_t) is important. According to the d_t value cooling time $\Delta t_{8/5}$, affecting microstructure and mechanical properties, can be evaluated. Cold crack occurrence can be a consequence of short cooling time $\Delta t_{8/5}$, whereas for long $\Delta t_{8/5}$ toughness values can be too low. According to standard JUS C.T3.102 calculated values are $d_t = 19.4$ mm and $\Delta t_{8/5} = 4.83$ sec.

During welding, temperature had been measured by contact thermometer at the preparation edge on the inner wall side and evaluated cooling time as $\Delta t_{8/5} = 7.5$ sec corresponded well with calculated value, indicating correct prescribed parameters of welding technology and from this point of view one can expect avoidance of cold cracks and convenient impact toughness level.
