V. Šijački-Žeravčić¹, A. Milosavljević¹, A. Marković¹, P. Smiljančić¹

Macro and micro structures as well as the characteristics of fracture features of simple boiler steel were investigated. Welded boiler steel joint with high alloyed heat resistance steel and with low alloyed steel as a filler material was exposed to the service conditions of heat resistance steel, i.e. working temperature was 540°C and working pressure 180 bar. In high parameter working conditions, after about 20.000h, the complete fracture occurred. Welded joint, from the side of boiler steel, totally failed after the crack propagation through the heat affected zone (HAZ). After investigation by optical microscopy and scanning electron microscopy, as well as mechanical properties, it was obtained that the creep fracture was taking place. Creep process was followed by extensive deformation and the dimension changes of the observed parts.

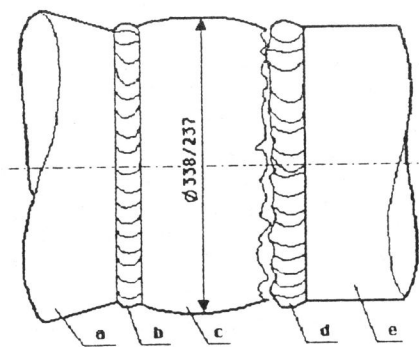
On the connection of the overheated steam pipeline, made of X20CrMoV121 steel, and the valve chamber, plain boiler steel of the St45.8 type was incorporated instead (that was not known until chemical composition was verified), Figure 1. As a filler material CM2-IG electrode was used for a root pass, and E-V329 electrode for all other passes. Welding parameters, complete technology and filler material choice were selected according to the characteristics of low carbon low alloyed steel of the 14MoV63 type. After 19710 h in exploitation and under the working parameters at T=540°C and P=180 bar, catastrophic failure occurred. Failure take place in the inlet pipe area very close to the assembly weld. Inlet pipe is significantly deformed ($\phi_1=338/237$ after failure related to the nominal diameter, $\phi=330/220$) with variable gap between inlet pipe and weld after failure, and it's value goes up to 5mm, Figure 2 (a,b), measured from outer circumference, i.e. up to 8mm on the inner one. During the failure analysis, all possible investigation techniques are applied, but in this paper only the results of chemical analysis and metallography are presented.

Figure 1. Schematic view of failure position: a) valve chamber b) manufacturing weld, c) append pipe, St 45.8 steel d) assembly weld, e) overheated steam pipeline, X20CrMo121 steel

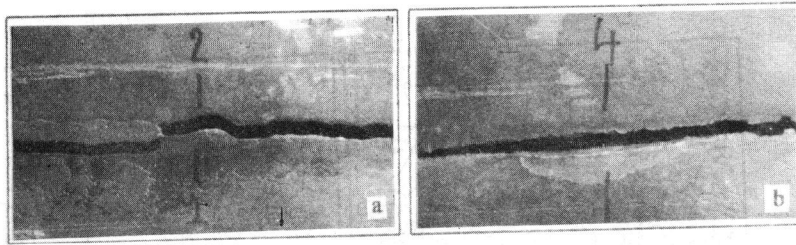
Figure 2 Gap view after failure in positions 2 (a) and 4 (b)

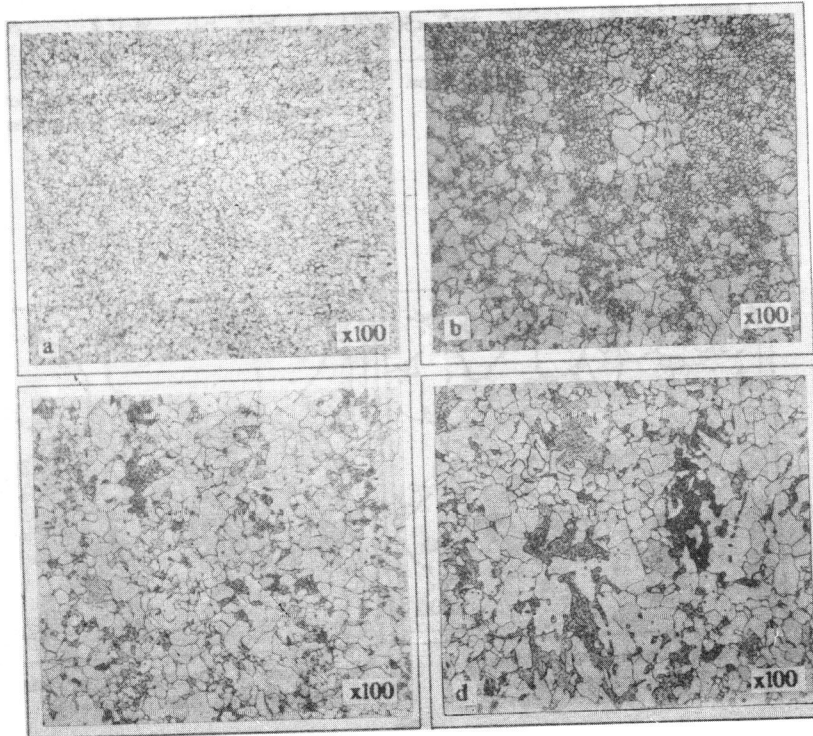
Optical microscopy: Specimens for metallographic analysis are taken from the fractured area. Obtained structures are shown in Fig. 3-7. Figure 3 presents structure array from the plain carbon steel side, beginning from fracture surface, following direction to the valve chamber. Regarding that the fracture occurred on the whole pipe circumference, mainly through the overheating area in HAZ, it isn't possible to observe it's structure because it is completely destroyed during burning. Therefore, the first visible area near the fracture is fine grained normalized HAZ area, Figures 3a, 4. Structure is of the ferrite type with coagulated carbides along the grain boundaries, pores and grain boundaries cracks. Transition area between normalized HAZ zone and plain carbon steel base material is shown on Figures 3b and 5. Basic structure in both area is of ferrite type with coagulated carbides along the grain boundaries and significant boundaries damages. Further to the valve chamber plain boiler steel base material structure is observed, Figures 3c and 6, which are defining the starting structure of ferrite-pearlite type. Namely, processes of spheroidisation and carbide coagulation are taking places, but there are still some visible areas of former pearlite islands, but with destructed structure. Beside, pores appear and along the grain boundaries and in the grains. Figures 3d and 6 are presenting the base material microstructure with not completely destroyed pearlite structure and creep elements, too.

Figure 3 General view of creep gradation

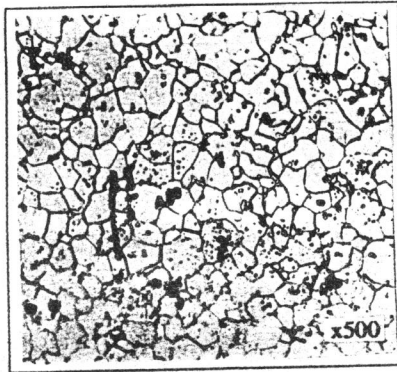
Comparison of particular structural regions, Figures 4-7, and observed creep gradation inevitably inflicts one more notice. Creep process, with its visible characteristics, is completely finished in areas where complete disintegration of pearlite and coagulation of carbides along the grain boundaries occurred, Figures 4 and 5. In regions where this disintegration process isn't completed, Figure 6 and 7, particular pores and/or pore groups in grain or in grain boundaries, are visible, but without appearance of distinctive cracks.

Figure 4 Normalized HAZ zone

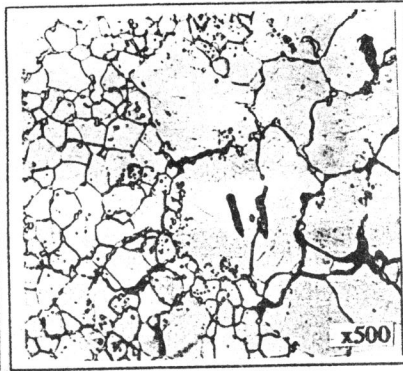
Figure 5 Transition area between normalized HAZ zone and primary structures

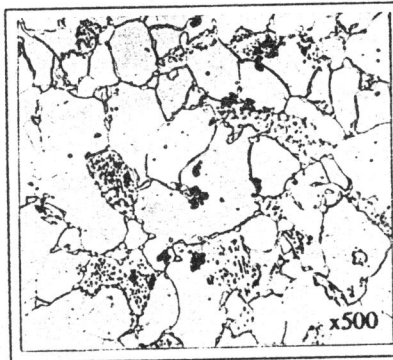
Figure 6 Damage of primary structures during creep

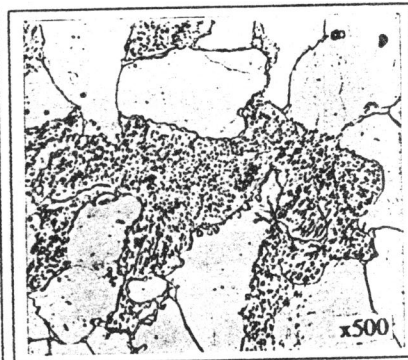
Figure 7 Damage of primary structures during creep
