IN-SERVICE CRACKS GROWTH IN SHAFTS OF AIRCRAFT STRUCTURES
UNDER SIMULTANEOUS ROTATION OR TORSION AND BENDING

A.A. Shaniavski* and A.L. Toushentsov*

Several cases of aircraft shafts failures produced in service under bending-torsion condition were studied. There were three situations of the mode I, III, and mixed I/III failures of shafts depending on the shear stress value. Various mechanisms of cracks development which caused structure failures in service under combined bending-torsion are discussed.

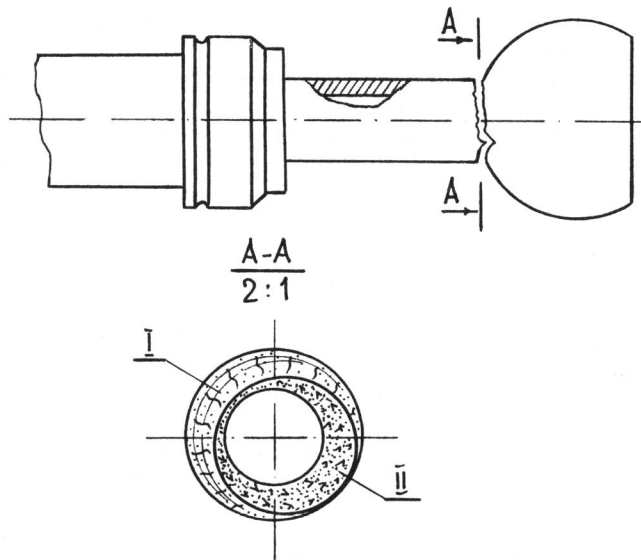
The structural component was manufactured from Cr-Ni-Mo steel, having Yield stress and Ultimate stress 1500MPa and 1800MPa respectively. Its failure has developed throughout a section of the transition from cylindrical to spherical parts of the component, as shown in Fig.1. The fracture surface, placed near the component face, had roughed relief with wear marks oriented along the ring traces. Traces were the result of mixed processes of a metal fracture and tearing between produced surfaces. There were two zones of various features on the investigated fracture surface.

First zone "I" placed directly near the component face, Fig.1. This slightly destroyed zone had flat dimples oriented along component face with scarce appearance of their depth. There were oriented dimples on the surface of the second zone "II" with usually observed depth appearance for the material of middle plasticity. The macro-boundary between these two zones correlated to the transition from flat to deep in the direction toward the centre of the shaft.

The discovered sequence of fracture surface features reflected the fatigue crack growth process in the case of cyclic torsion without evident bending (1). This process realised in the low cycle fatigue area of loading. The fracture surface developed as a result of pores creating and growing along the circular direction under torsion, as shown in Fig.2. Pores had small sizes in the radial and axial directions, but the size in the circular direction under the torsion is very high. The pores volume have increased under the mode III cyclic loads from torsion. An increment of crack propagation in the radial direction took place at the moment of several pores coalescence. The developed crack have no evident opening in the direction of rotated component's axis. That is why dimples are not expressive in their depth direction, being in parallel to the component's axis. Fast fracture develops under the bending mode increasing. That is why the volume of plastically deformed material increases, and dimples deep increases too.

Investigation revealed that the main cause of component failure was its malfunctioning because of seizure in its hinge part. The shear stress from torsion exceeded the material's shear Yield stress in each cycle of the component's loading. That is why it was true low cycle fatigue fracture under shearing.

Figure 1 Overview on the fractured shaft, and schematized fracture surface with (I) fatigue and (II) static fractured zones

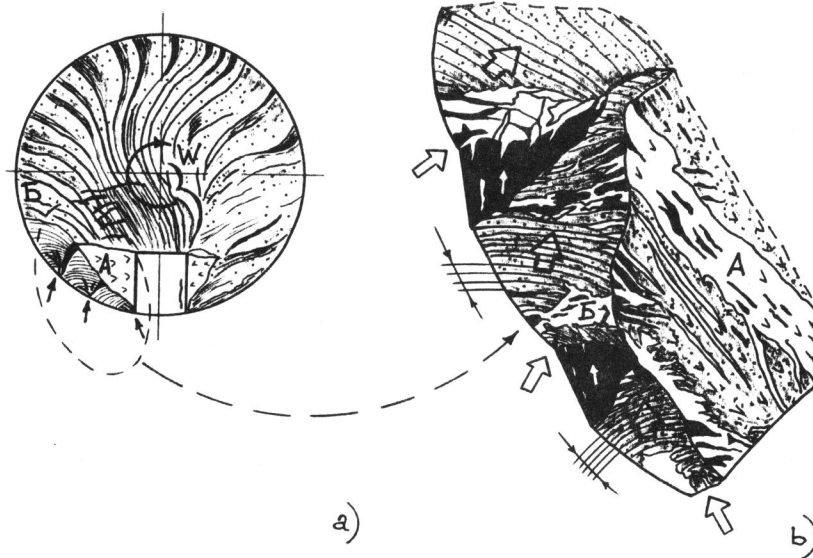
The shaft of the oil pump failed in transverse direction across a keyway designed to place a key joining the shaft with pump gear. The component had flown 768 hours or 730 flights from the last repair. The shaft was manufactured from the Cr-Ni-Mo steel with Yield stress and Ultimate stress 1200MPa and 1600MPa respectively. The fracture process had next features, as shown in Fig.4. The fatigue macro-lines have S-shaped form. There were two zones without lines placed at the keyway, having an area between them in the form of a tongue with very rough relief. Several steps were seen around of the fracture surface.

The performed fractographic analyses under scanning electron microscope discovered next fracture features. There were small dimples on the fracture surfaces in two zones without macro-lines. It is correlated to static or repeatedly-static fracture. The first part of fatigue fracture was developed from the corner with place of origin shown by arrow in Fig.4. It was small crosspiece between shaft surface and zone of static fracture that fatigued under combination of tension-shearing from bending-torsion respectively. The crack trace laid not exactly in plane. That is why there were two places of a new crack initiation near to the shaft surface as shown by arrows in Fig.4. Origins were placed on the shaft face because there were maximum of stress concentration from the bending-torsion.

Therefore, the fracture process of the shaft was developed in the next consequence. The static fracture zones were created first and a big stress concentration was introduced. The highest stress existed around of the shaft face from the bending-torsion loading. The crack growth rate along the face under this loading was higher than for any place in the depth direction from the face. That is why the crack front had S-shaped form. This was the same situation as shown for the steps formation in Fig.3, but in the case of cyclic loads.

So, it was not only the torsion that produced fatigue fracture. The bending can not be only one to produce the fatigue fracture too. That is why the bending-torsion can not initiate static fracture zones from the keyway because of the highest stress at the shaft face. Therefore the fatigue fracture can be initiated only after the static fracture was developed. This static fracture should be discovered during repair when a key was introduced into the keyway.

To confirm this conclusion the crack growth period was calculated by the number of macro-lines. The regularity of their formation correlated to the regularity in cycles of pump working. It was shown that one line forms by one flight (2),(3). There were not less than 100 flights of the engine with working pump during fatigue crack growth. It is near to 13% of the shaft durability after the static zones were introduced during repair. This estimation is in a good accordance with the well-known phenomenon for a low level cyclic load in the high cycle fatigue when fatigue crack develops from the stress raiser.

Figure 4 Fatigue surface of shaft (a) with static fracture "A" zone, and (b) magnified initial zone of the fracture surface with origins pointed out by arrows
