FAILURE ANALYSIS NELLA PRODUZIONE E TRASPORTO IDROCARBURI
S. Donato Milanese - 3 Dicembre 1966

NICKEL ALLOY STUD BOLTS FAILURE : A CASE HISTORY¹

P.Fassina, M. Marangoni and G.Toffolo
AGIP SpA, Milan, Italy

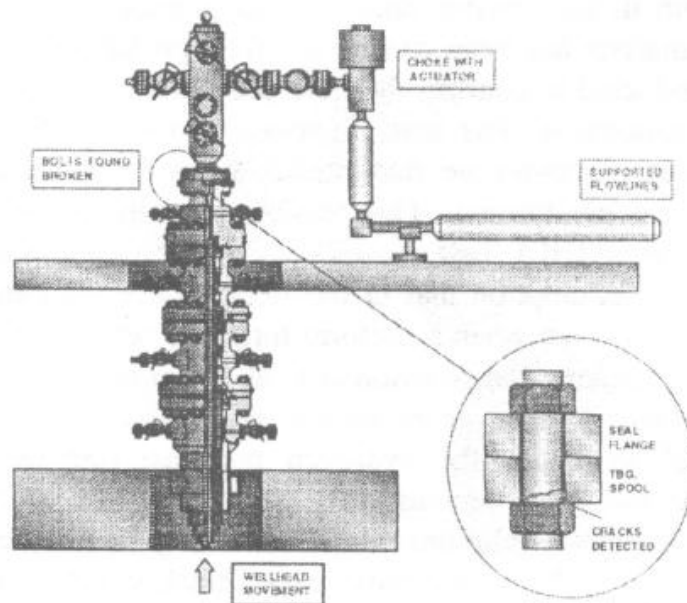
Fig. 1 - Wellhead and flowline scheme

This paper discusses a problem occurred in Bouri Field, Offshore Libya on February 1993. During a routinely maintenance of one wellhead, two bolts on the 13" 5/8, 5000 psi flange connecting the wellhead and the tubing spool (Fig. 1) were found failed. The flange has 16 Inconel X-750 bolts size 1 5/8". After a check on all the wellheads, three other bolts were found failed on another X-mas tree : one was in the same position of the previous failed bolts, while the others were between kill line and flow line connection, on the same side. The total number of failed bolts was 5. The failure incidence is 0.6%, and it occurred in only two wells (3.6 %). The wells where failures occurred were completed between 1989 and 1990.

The bending moment generated by the actions described in 1, 2, 3 and 4 caused an extra tension on those bolts located on the opposite side with respect to the flowline. This justifies the fact that almost all broken bolts were found in that sector.

- The mechanical actions on the wellhead must be considered carefully. Very often happens that completion and flowlines design are done by different departments. Engineers that design flowlines system do not consider the wellhead as a fragile structure with possible weak points, while completion engineer design up to the choke and interacting forces are neglected.

After connecting the flowline, routine checks must be done to make sure that the movements between all the parts are minimised and the flowline is supported correctly in production and during shut-in period (especially for very hot wells).

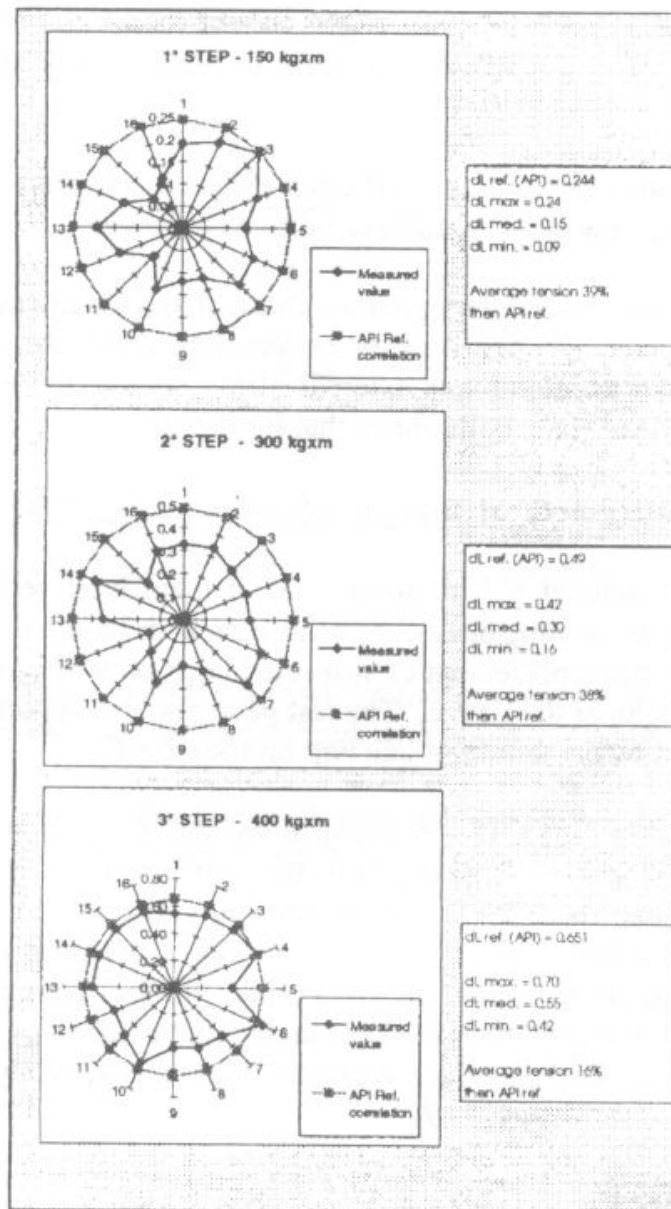
Fig. 2 - Determination of the actual tension on the bolts

Results have been presented by radar-type diagrams for a better understanding of the bolts behavior according to their position. (Fig. 2). For every bolt the diagram shows the measured elongation at the three different steps and the reference value obtained from API (API RP 6A correlation), supposing an ideal make-up between bolts and nuts. In Fig. 2 it is possible to see the comparison between the elongation corresponding to the theoretical tension (due to torque applied) and the actual one at steps 1, 2 and 3. It is easy to see that for all three steps the maximum tension was almost matching the API reference, while instead the average was always well below that value. It was 39 % below in the first and the second step and 16% smaller in the third step, indicating a large dispersion of tension values among bolts. The more uniform elongation value reached in the third step can be explained with the fact that friction between nuts and the flange surface affects less the individual bolt make-up, since the elevated specific load flattens localized imperfections (a smaller value of about 20% has been observed also during a second nipping up done the following day at 400 kgxm with all bolts correctly greased).

The influence of the lubrication is important. The average tension on the bolts made up with the grease was about 10 % higher than the others.

It is evident from above extra-torque and from results of third step of simulation done (Fig. 2) that in some cases few bolts could have been overstressed.

For what concerns the distribution of the values, it is evident in all steps a tension difference over the 16 bolts. The phenomenon becomes critical if the tensions are near the yield value. In that case an additional external stress caused for example by flowline movement, could easily lead some bolts above that limit.

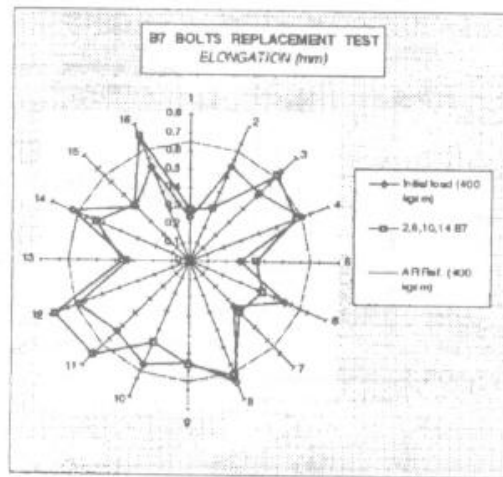
Fig. 3 - Bolts replacement test results

Results are reported in Fig. 3. It is possible to see that the tension over the other bolts has increased due to the smaller tension left in the four new ones. This must be properly evaluated before removing the bolts for a replacement, particularly if the unchanged bolts are already near the yield limit. Only if the tension induced in the new one is similar to the others or all of them are clearly below the yield point, this fact is negligible, otherwise the tension over the unchanged ones must be kept under control and, if necessary, in some of them the tension must be decreased according to the others (paying attention not to de-energize the flange).

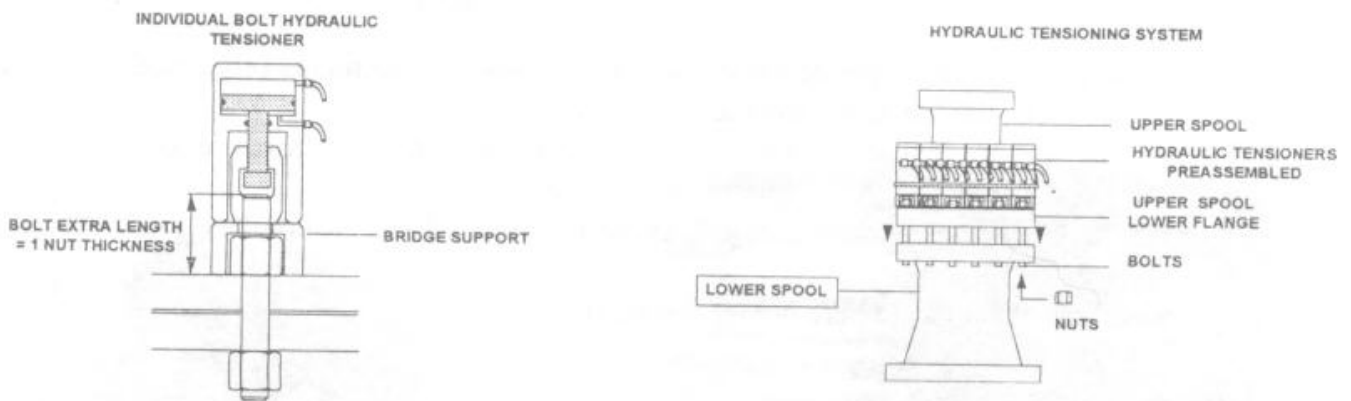
Fig.4 - Hydraulic tensioning device

The fourth test was carried out to evaluate the performance of the hydraulic tensioning device and the possible applications in the field, particularly for Bouri wellheads (Fig. 4). The elongation has been measured by means of a micrometer comparator. Pressure steps of 100 bars have been applied up to 1000 bar final pressure (yield limit was reached at about 900 bar) and for each step the length of the bolt was measured before and after releasing the pressure.

The system works with extended bolts, and consists of a hydraulic jack which grabs and lifts the extended bolts above its nuts reacting with the flange surface. Exerting the correct hydraulic pressure which corresponds to 50% of yield (according to API), and then mating the nut to the flange surface manually, allows for an even energization of the flange itself.

Since the available tensioners on the market did not satisfy the API flange bolting arrangements, a special design has been performed in house and at the moment the hydraulic tensioning system (Fig. 4) is being spread over all domestic operations, on a standard basis.

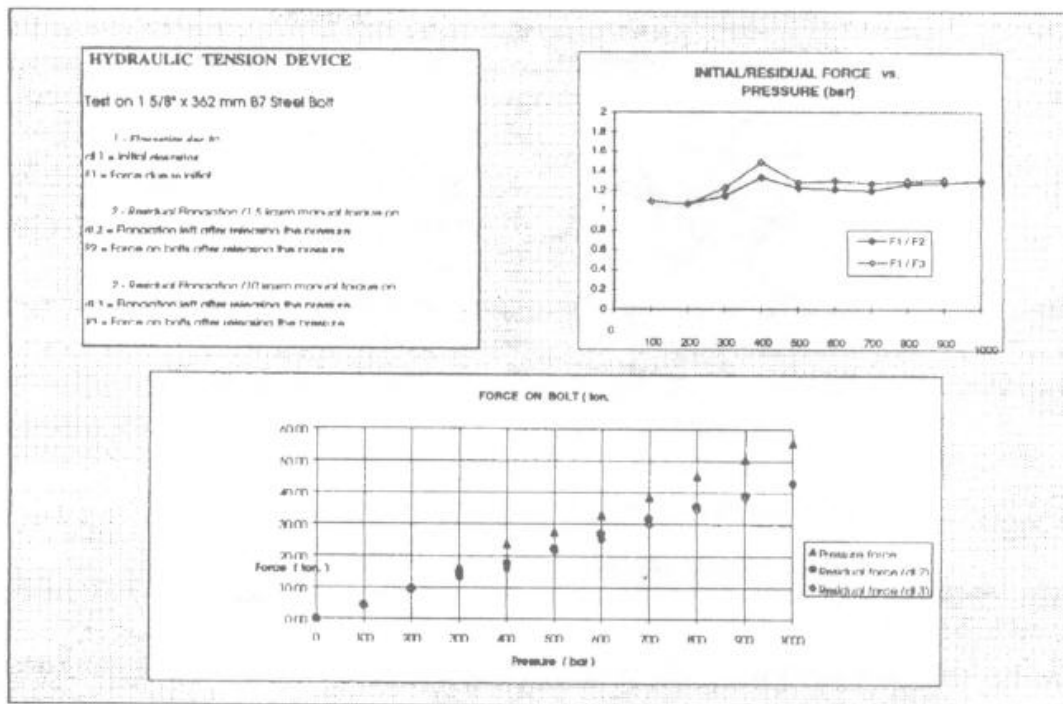
Fig. 5 - Test results on tensioning system

Results are reported on Fig. 5. This ratio suggested by the tensioner supplier was confirmed by the test. This is an average of several values obtained during the test, taking into account the last part of the graph, after ring joint plastic deformation (400 bar). Finally it can be said that the different manual torque applied lead to a negligible difference in the final result.

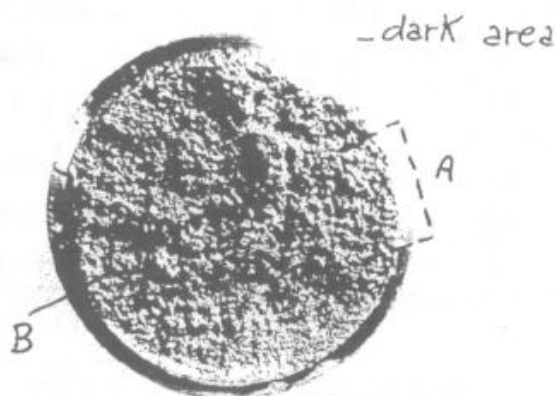
Fig. 6 - Failed bolts

The fracture is intergranular with no area reduction (brittle fracture). In a bolt there is a secondary crack in the thread, intergranular too, in correspondence of some corrosion points (Fig. 6). No secondary branches are present in the other examined failures.

There is some contamination (S, Cl, Zn) in the zone of crack initiation and (S, Pb, Fe, and Al) in the localized corrosion points. This is mainly due to the sea water and grease in contact with threads.

The failure analysis brings to the conclusion that the main cause of the failure was the hydrogen embrittlement (HE), where the corrosion is due to the environment in pit / crevice situation and the stress comes from the loading of the bolt at higher stress than the yield one. This conclusion has been verified by some additional tests: fatigue and corrosion test assisted by stress (Tabs. 2 - 3). To produce the hydrogen needed to the hydrogen embrittlement, some tests have been carried out under cathodic protection (CP).

The causes responsible for the failures are several, but mainly due to the concurrence of a mechanical stress that led the bolts above the yield point and a pit crevice condition in the environment surrounding the wells that justifies the brittle failure of the bolts at a stress smaller than the expected (Hydrogen Embrittlement).

- Operators in charge of nipping up with hydraulic wrenches should know very well the physical limits of the bolts and should be aware of the damage caused by an overtorque. They should also check frequently the torque wrenches calibration. They must also refer every problem caused during this operation.

- As a result of the incorrectly applied field procedures, the uneven tension in the bolts induced by standard torque tools and as a further result of the test performed with hydraulic tensioners, the overall Company procedures for flange nipping up have been modified.
