FRACTURE OF EPOXY BONDED DYNAMIC PEEL SPECIMENS  
CONTAINING INTERFACIAL LAYERS.

- H.Taylor, W.C.Law and D.L.Chadwick

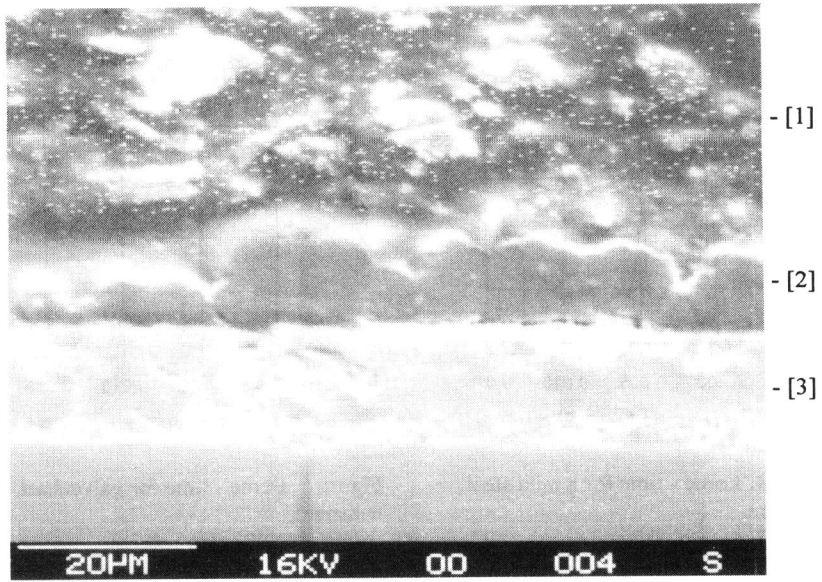
Figure 1 shows a secondary electron SEM image of a section through a galvanised steel bond, the interfacial layer [2] is clearly visible between the zinc coating [3]

and the bulk adhesive [1]. Energy dispersive X-ray analysis showed the interfacial layer to be barren of the calcium silicate filler found within the bulk adhesive. The dot mapping for Si and Ca is overlaid in figure 1. The micro hardness of the bulk adhesive was found to be  $1.85 \text{ Hv} \pm 0.11$  compared with  $4.59 \text{ Hv} \pm 0.45$  for the interfacial layer, showing that the interfacial layer is significantly harder than the bulk.

Figure 1. SEM image of the interfacial layer.

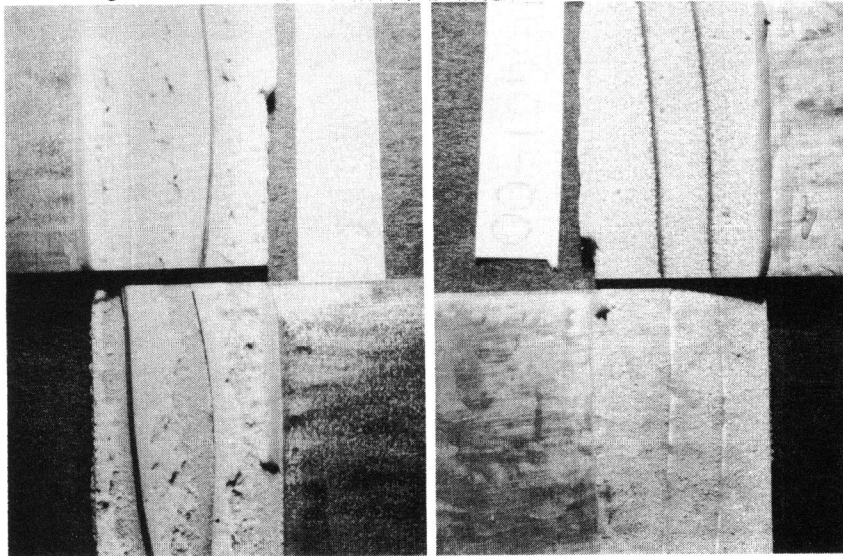
Static Tests. Force/displacement characteristics for lap shear tests show that fracture occurs at a lower level of force and extension in the galvanised sample than in the case of the mild steel substrate. It is also evident that significant plasticity occurred of the mild steel substrate, resulting in a much larger energy to fracture (31J) than in the case of the galvanised substrate which appears to fail in a brittle manner (9J). Observation of the resulting fracture surfaces, figures 2 and 3, shows that both failures are predominately cohesive and that the nature of the failure in the case of the galvanised substrate is considerable more brittle than that in the case of the mild steel substrate. The fracture of the galvanised sample is continuous along one interface, while that of the mild steel initiates on one interface and alternates to the opposite interface. The results appear to be consistent with the formation of a hard brittle interface forming between the zinc layer and the bulk adhesive.

Figure 2. Fracture surface from static test on mild steel.

Figure 3. Fracture surface from static test on galvanized steel.

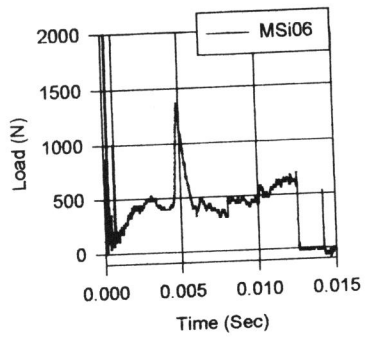
In figure 4 the fracture load for the mild steel specimen rises sharply and then stays approximately constant for some time followed by a sequence of less sharp rises in load until the specimen fractures completely. The load peaks occur due to initiation of a fracture which then arrests after propagating rapidly at a lower load in each case. The fracture surface exhibits stress whitening at each point of crack initiation corresponding with an increase in load. The total fracture energy of this specimen was found to be approximately 10 Joules

Figure 4. Force - time for a mild steel substrate.

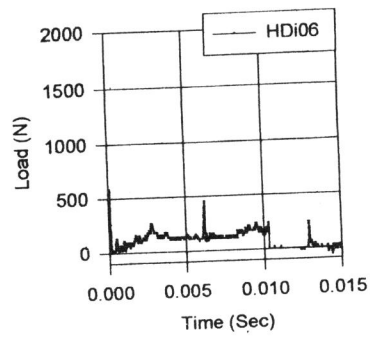
Figure 5 shows a sample load trace for a galvanised specimen which shows a low fracture load with increasing propagation. In this case there is little increase in load during propagation and the crack appears to propagate rapidly almost constant load. The total fracture energy in this case was found to be approximately 3 Joules.

Figure 5. Force - time for galvanised substrate.

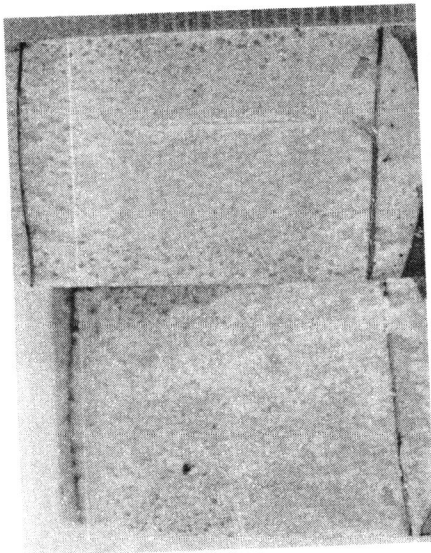
The fracture surfaces from samples of the impact peel tests in figures 6 and 7 show that fracture was always cohesive in the mild steel specimens and interfacial

Figure 6. Cohesive fracture of mild steel substrate.

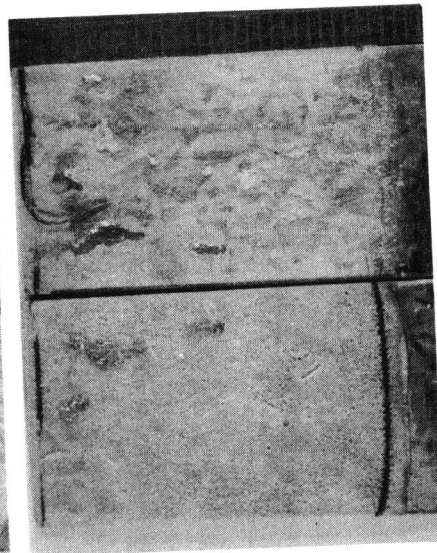
in the galvanised steel. Some small regions of failure in the galvanised layers were also seen in the galvanised samples, these show as bright white patches on the fracture surface. The fracture surface from the galvanised substrates are also dominated by bubbles in the interfacial layer. Similar bubbles are absent in the specimens with a mild steel substrate, suggesting a reaction occurring between the curing adhesive and the zinc coating of the galvanised steel.

Figure 7. Interfacial fracture of galvanised substrate.

Bubble formation was suppressed in one sample by curing the bond under a pressure of 2 bar. The energy absorbed in this case was also reduced but only to 6 Joules, which although higher than that without pressure, is still much lower than the mild steel substrate.
