DAMAGE IN A SiC/LAS COMPOSITE UNDER DYNAMIC LOADING.

E. Nazarenko *

Quasi-static and dynamic bending tests have been performed on a SiC/LAS composite. Microstructural observations using SEM and electronic microprobe techniques show some differences between the failure modes, depending on the rate of strain. Some hypotheses are discussed to explain these differences.

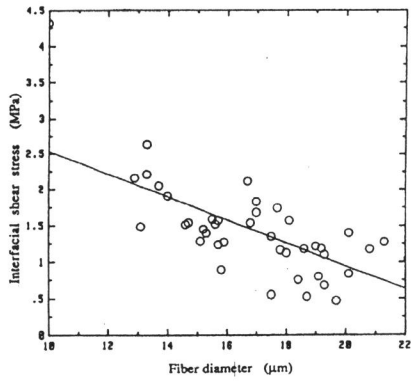
Preliminary tests and observations on as-received samples have shown a marked non-uniform distribution of the fibers. Measurements of the interface shear stress by micro-indentation techniques, following the assumption of a frictional fiber-matrix interaction, are shown on Figure 1. They give values ranging from 1 MPa for thick fibers ($\varnothing \approx 20 \mu\text{m}$) to 3 MPa ($\varnothing \approx 12 \mu\text{m}$) (2) (3). The decrease in these values can be related to the mismatch of the thermal expansion coefficients of the fiber ($\approx 3 \cdot 10^{-6}$) and the matrix ($\approx 1.5 \cdot 10^{-6}$) which leads to fiber-matrix decohesion on part of the interface, larger decohesion occurring for larger fibers.

Figure 1 Micro-indentation measurements of the interfacial shear stress.

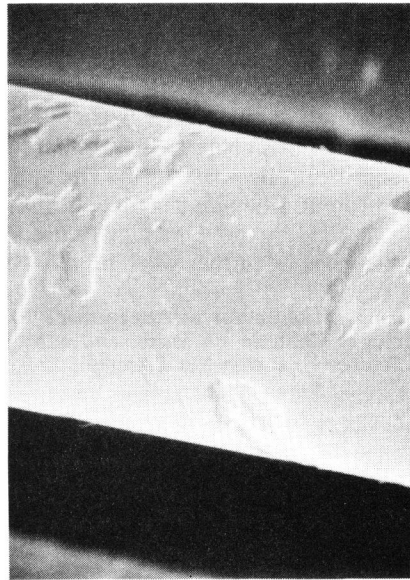
First, for a given residual bend, dynamically loaded samples exhibit larger damage along the main crack than statically tested samples. Secondly, fibers lying along the crack show a partially peeled surface, as shown in Figure 1, while they look smooth after quasi-static failure test. Fiber-matrix decohesion seems to be quite dependent on the rate of strain. Thirdly, some dust can be observed after the test.

Figure 2 SiC fiber extracted from a dynamically tested composite.

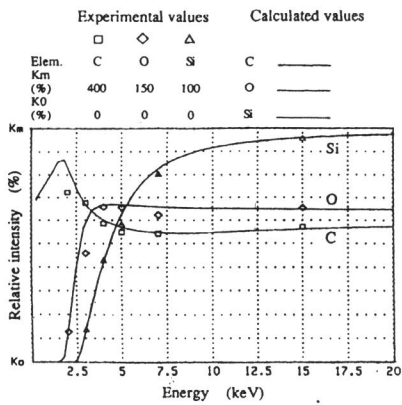
The interpretation of the second characteristic feature of dynamic failure requires further microstructural analysis of the interfacial zone. An electronic microprobe analysis has been performed on both polished cross-sections of the composite and post-test extracted fibers. The latter analysis gives the relative intensities of the $K\alpha$ rays of carbon, oxygen and silicon of the structure as shown in Figure 3. Different layered structures are examined until the calculated values they give match with the experimental values. The analysis has revealed the interphase structure given in Table 2, which is consistent with the results of Chaïm and Heuer (7), Bischoff et al. (6) and Ponthieu et al (5). One may notice that the

Figure 3 Multi-tensionmicroprobe analysis of the interphase.

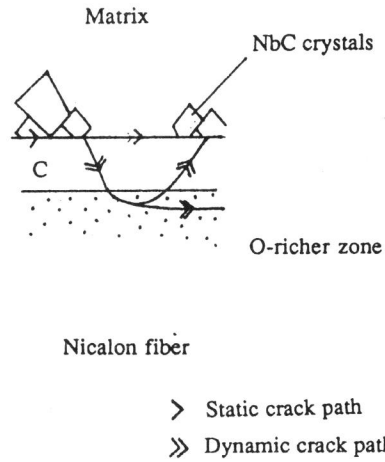
X-ray and electronic microprobe analyses on polished cross-sections of the composite have also shown a non-uniform NbC layer between the C layer and the bulk of the matrix. The NbC seems to be crystalline and strongly bonded to the the matrix, while the results of the micro-indentation tests can be related to a very weak bonding between the C layer and the NbC layer. The micrographic observations and electronic microprobes measurements on fibers extracted from dynamically tested composite are consistent with the assumption that the crack occurs between the C and NbC layers ("high" steps) or between the C layer and the bulk of the fiber, in the oxydized layer ("low" steps) as shown in Figure 4. This is confirmed by the measurements performed in the peeled zones ("low" steps), which show a composition almost identical to the bulk of the fiber. The point is that during static tests, no crack occurs between the C layer and the bulk of the fiber but always between C and NbC layers. During dynamic tests the unstability of fast propagating cracks (8) (9) and the non-uniformity of the NbC layer, which gives a non-uniform fiber-matrix bonding, leads to the peeled fiber surface appearance. It is generally admitted that no chemical bonding occurs between fiber and matrix - i.e. between the NbC layer and the C layer - in these composites, but this assumption may prove false in the zones where NbC is lacking. This could explain how unstable cracks running along the C/NbC interface undergo branching phenomena when reaching tougher bonding zones and penetrate the C layer, as well as it could explain the wide dispersion in the measurement of the interfacial shear stress. A micromechanical modelling is under way to test this statement.

Figure 4 Quasi-static and dynamic crack path through the interphase.
